REPORT ON THE CONSERVATION AND RESTORATION PROJECT OF
LION AND NAGA BALUSTRADES

AT THE CAUSEWAY AND OUTER GALLERY OF BAYON
ANGKOR, UNESCO WORLD HERITAGE SITE,

2012-2020

November 2024

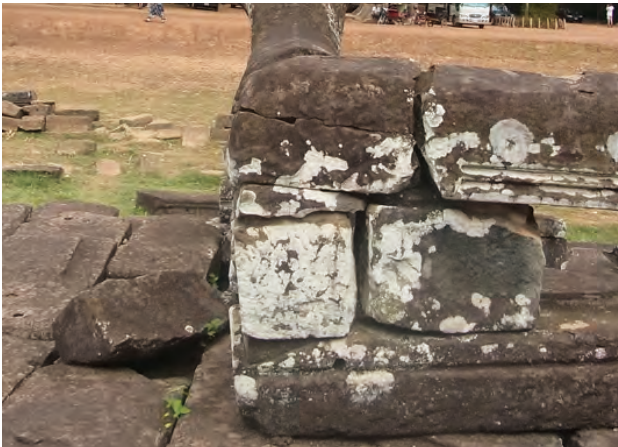
Fig.2.2 Collapsed section due to deterioration of restoration material

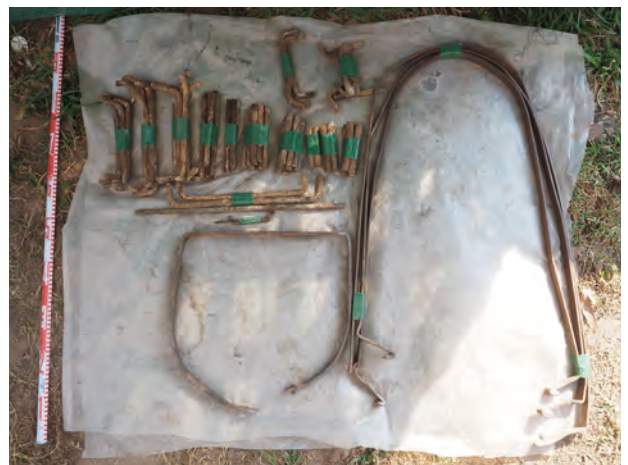
Fig.2.6 iron materials used for repairing by EFEO

concrete mortar and iron pins and belts. Some iron pins were processed into staple shapes to ensure they stayed in place. Iron belts were used to stabilize the rails by securing them to the coping stones or platforms. Where rails or naga statues still exist without supporting coping stones or posts, substitute materials or concrete supports were used (Fig. 2.1-2.6). This project's restoration policy had to be considered based on these existing restoration conditions.

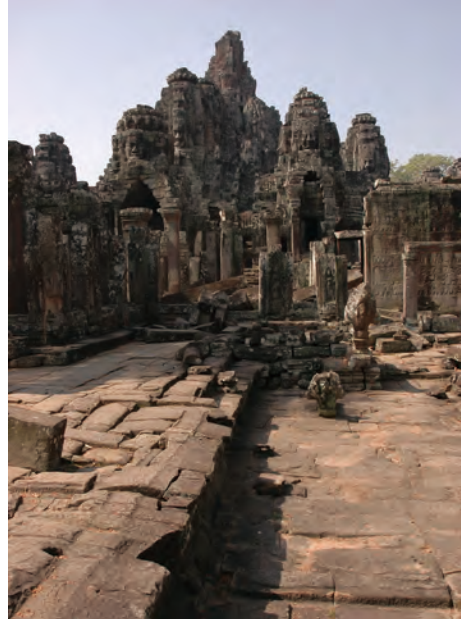
Fig. 2.8 Situation before present restoration

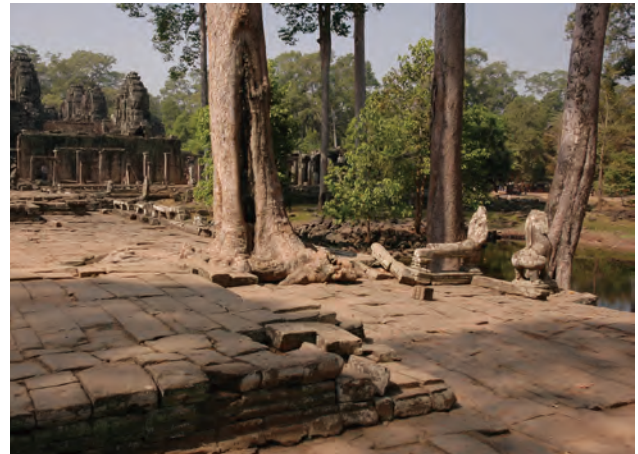
Fig. 2.10 Situation before present restoration

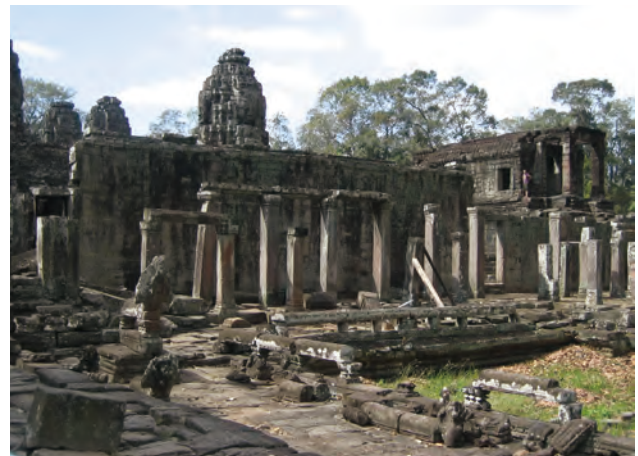
Fig. 2.12 Situation before present restoration

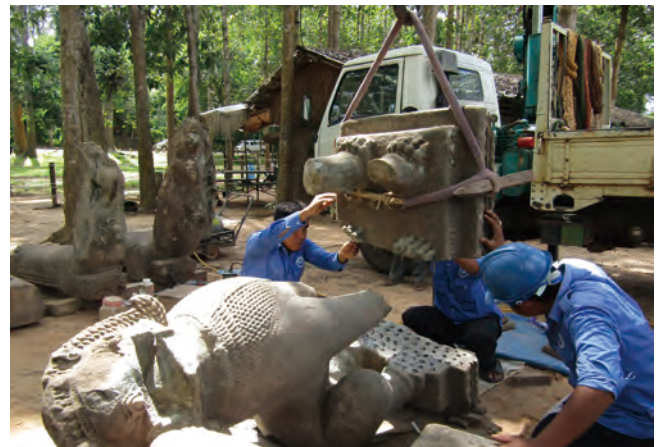
Fig.5.31 Repairing of Lion statues at T67.4. It was broken in twoparts without previous treatment.

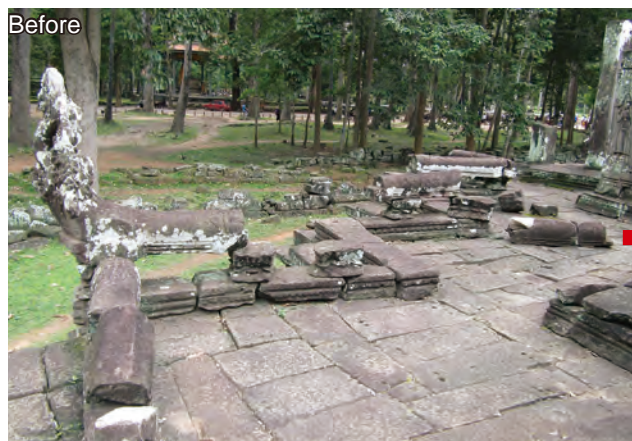
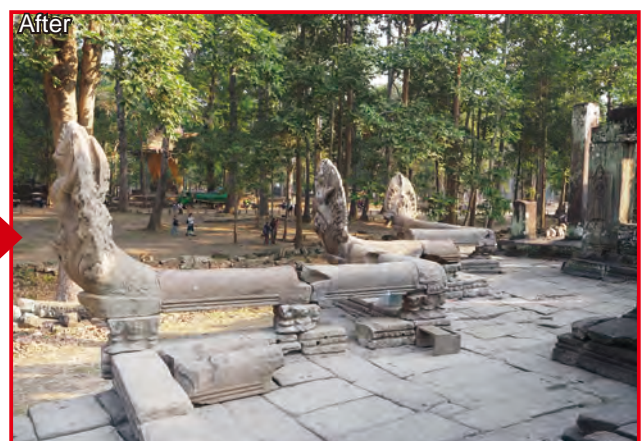
Fig.5.36, 37 Before restoration, the Naga statue at T65.3 had no trunk and couldn't stand without many iron pin inserted in previous restoration. However, we could found piece of trunk from scatter stone near this area, so that this statue could stand without support oafter restoration.

Fig.5.38, 5.39 [T65.4]Before(left) and after(right) resotration

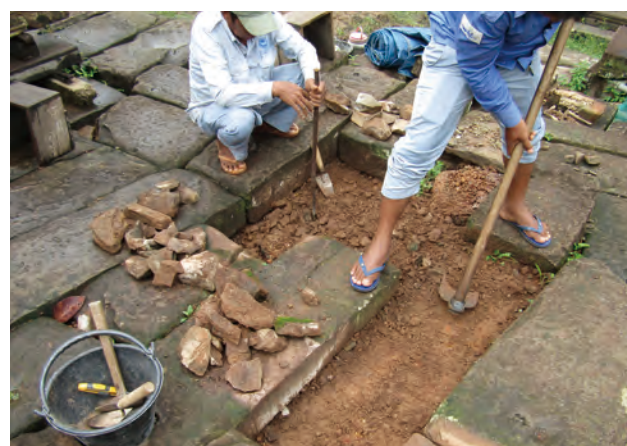
Fig.5.42 [T62.1] Before restoration, Support by concrete pillar was deteriorating.

Fig.5.43 [T62.1] Maintenance and improvement of platform floor before install the bulastrades

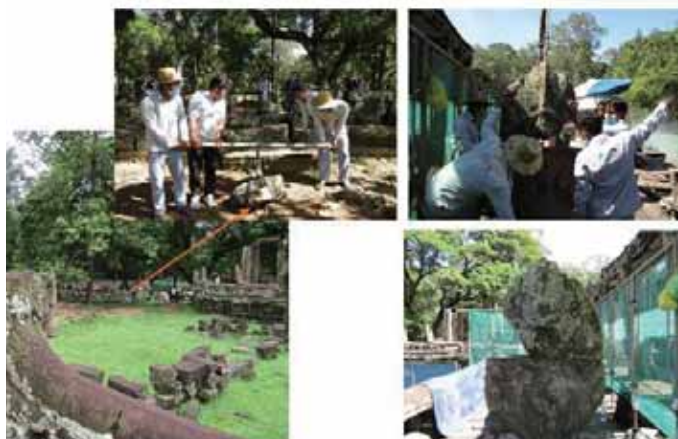
-The head of the Naga statue on the north side (62.1.8.1.6) was hung over, thus it was supported by concrete support by previous restoration. From our perspective, after dismantled basement and first layer of the platform, and reconstruct removing extra

soils and gaps between the floor of the platform, upper balustrade including this southern Naga statue can be moved backward. Thus it seems that Naga statue can be set without support after restoration.

For the northern Naga statue, due to the improvement work in order to reduce large gap between floor of the platform under the northern balustrade of this Naga statue, we could bring these balustrades near to wall of the outer gallery. Thus Naga statue no more needs concrete support inserted at previous restoration. Also for the southern Naga statue, before restoration, upper half was broken and already lost. Though after survey by workers, they could found that one scatter stone lying in front of T63.2 would be connected with this Naga statue. Some of the elements of platform around these 2 Naga statue were already lost and distortion could be seen at this area, new sandstone plate were needed when reconstruct Naga statues.

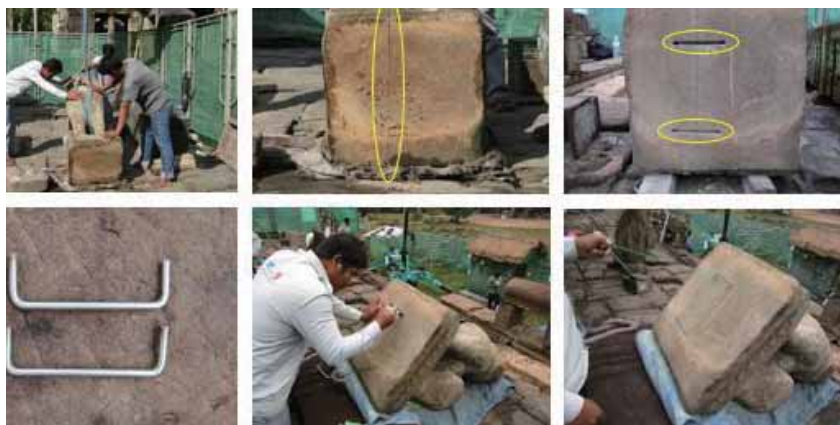
Area : T61.2 work period :9 weeks

In this area, 1 Lion statue was restored(61.2.8.1.1).The base of the pedestal was completely cracked, which could lead to further collapse of the entire statue, so it was fixed by grazing.
