REPORT ON THE CONSERVATION AND RESTORATION PROJECT OF
LION AND NAGA BALUSTRADES

AT THE CAUSEWAY AND OUTER GALLERY OF BAYON
ANGKOR, UNESCO WORLD HERITAGE SITE,

2012-2020

November 2024

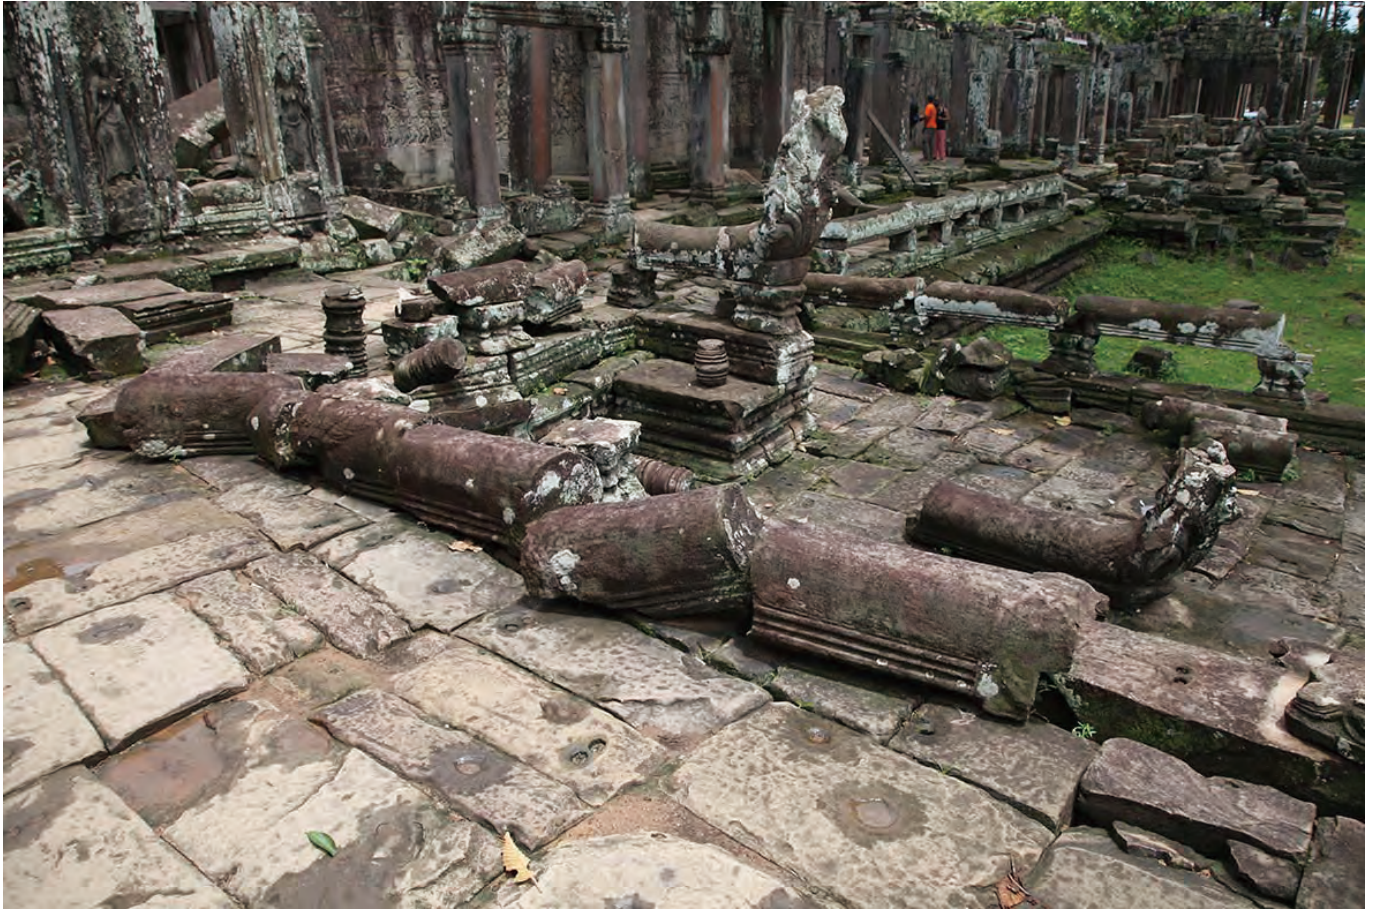
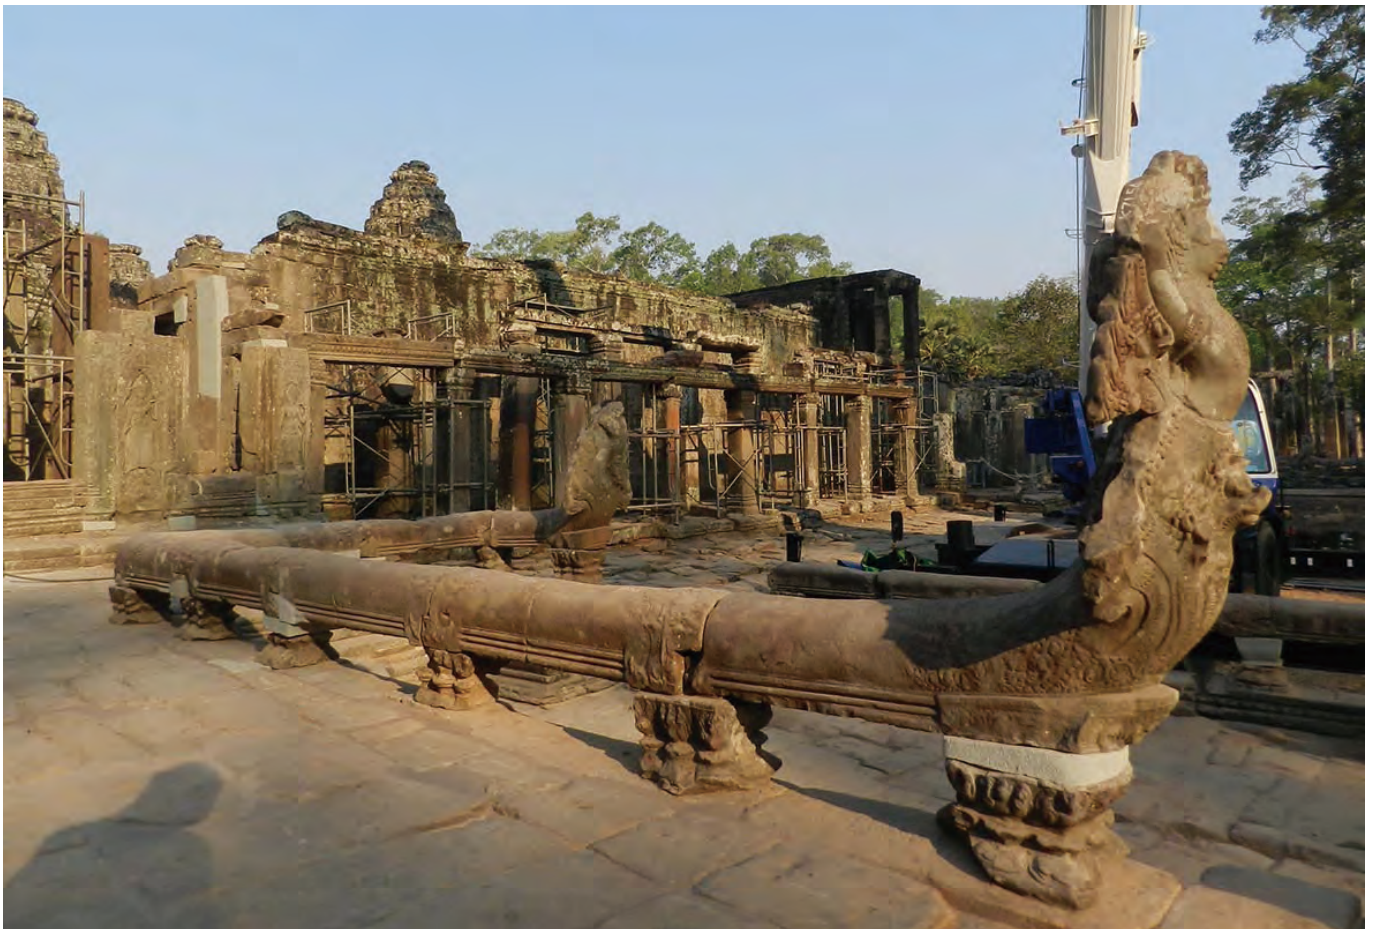
PHOTOS 1&2 C71.4.1, Before and After Restoration

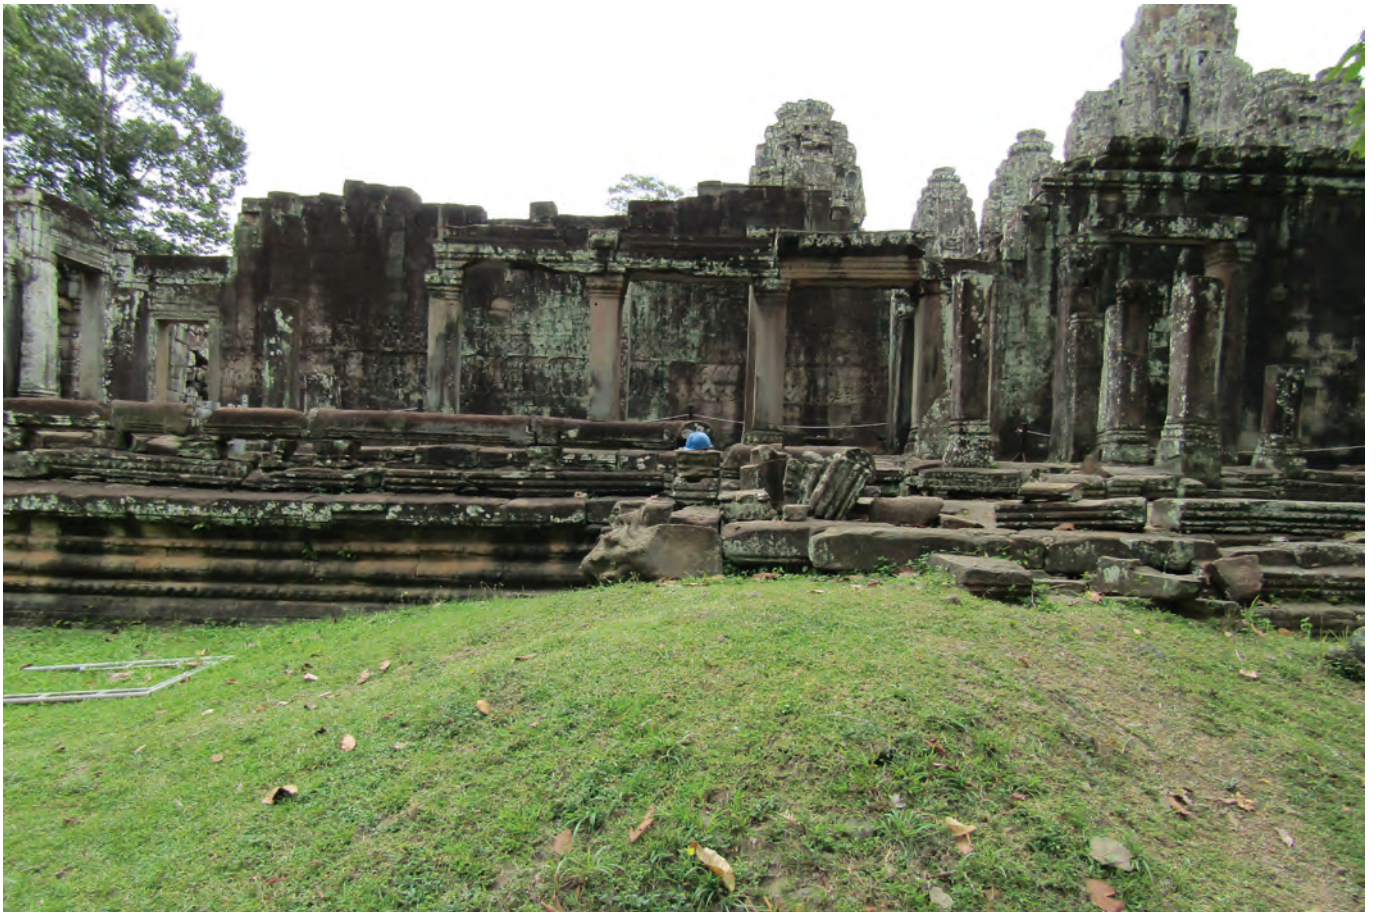
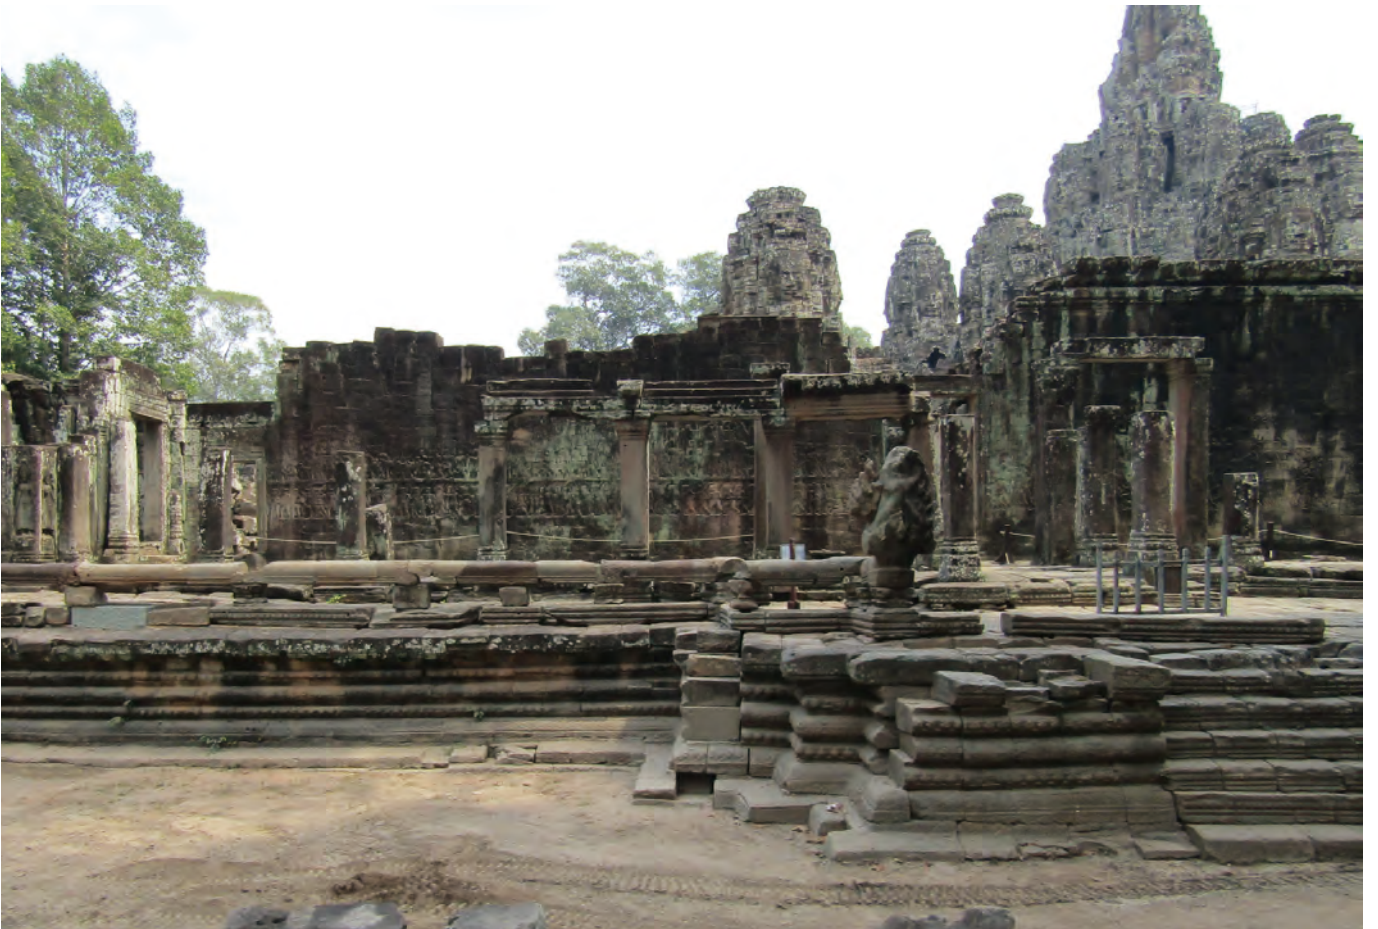
PHOTOS 3&4 G64.1, Before and After Restoration

This made it possible to fully repair and reinstall the T64.1 parapet (Figs.5.65, 5.66). In addition, parts of the parapets of T63.4 and T65.4 in the vicinity were also discovered and their original locations were identified, which enabled the replacement of the materials in these areas and many of the parapet members to be returned to their original positions. As for the Naga statue, in addition to the head that was already visible on the mound, another head fragment was excavated from within the mound, so it was joined and reinstalled on the base. As described above, this clearance work resulted in the excavation of many parapet members and the removal of the mound, leading to a significant improvement in the landscape around the T64 area (See p.6 Photos 3, 4).

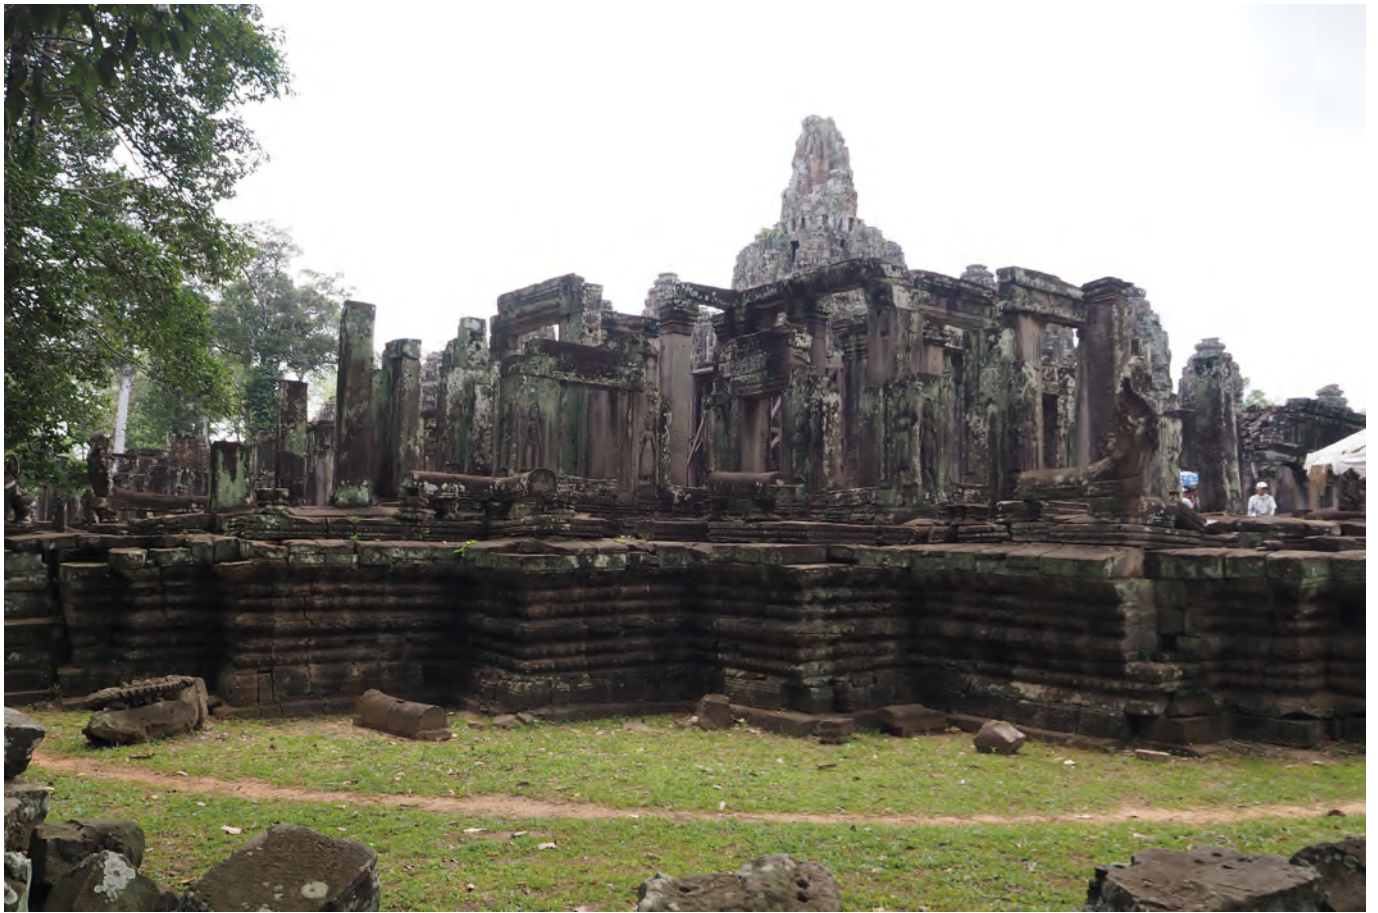
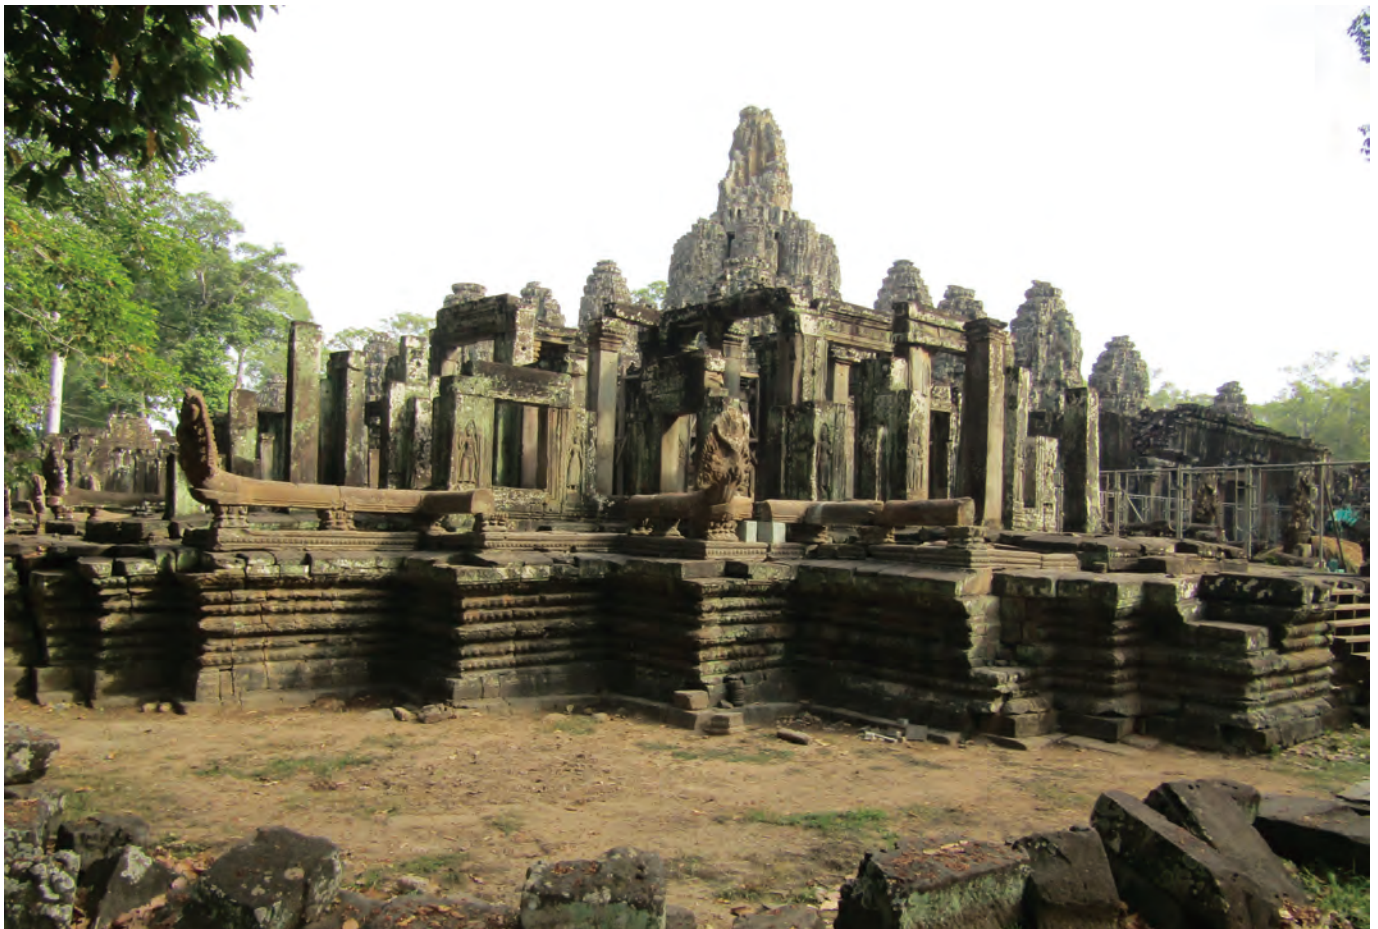
PHOTOS 5 & 6 G65.4, Before and After Restoration

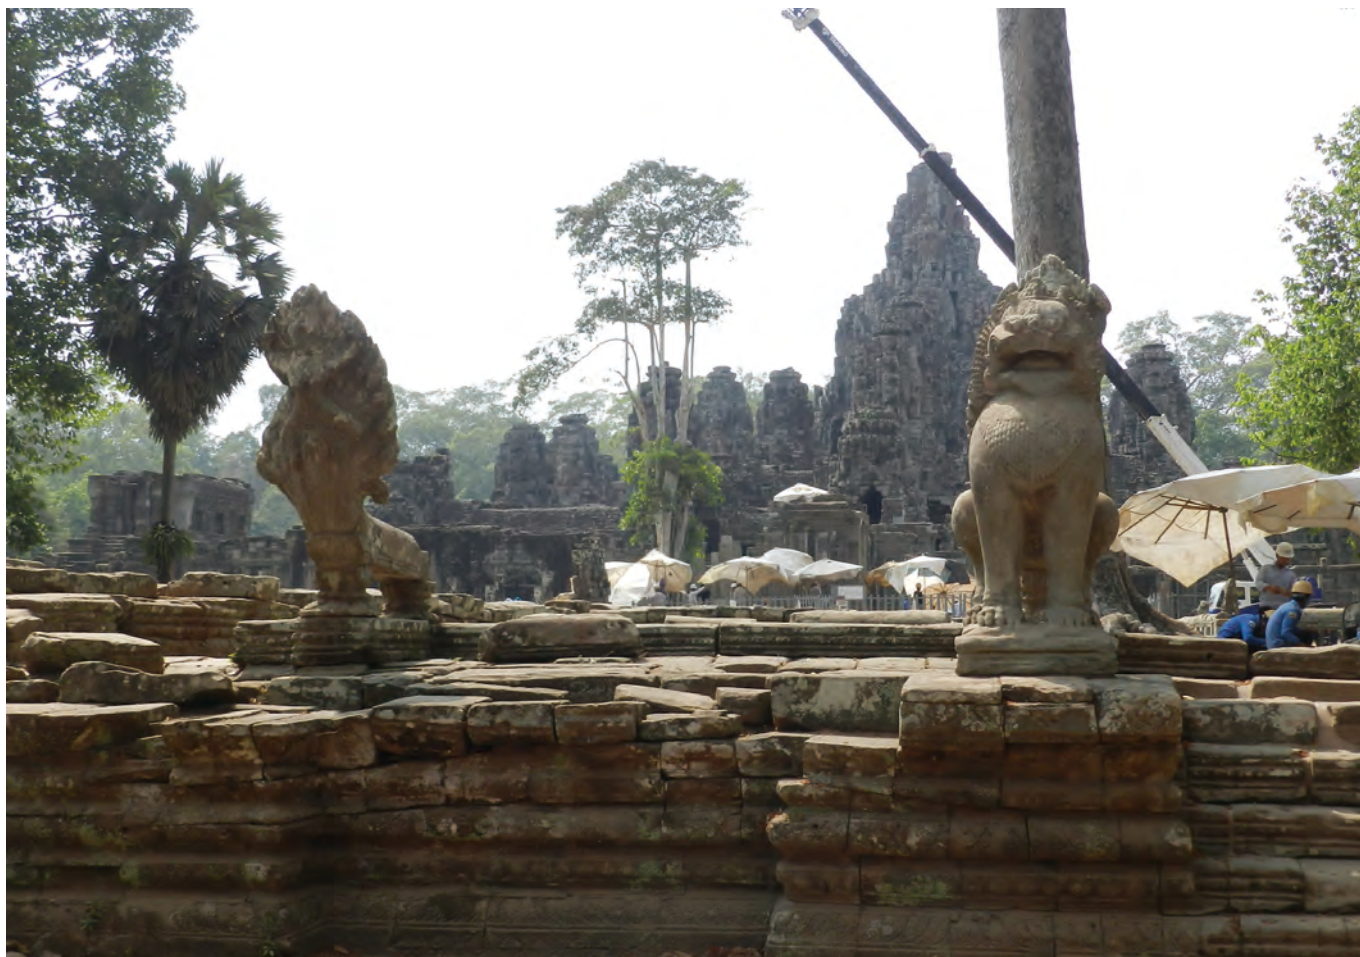
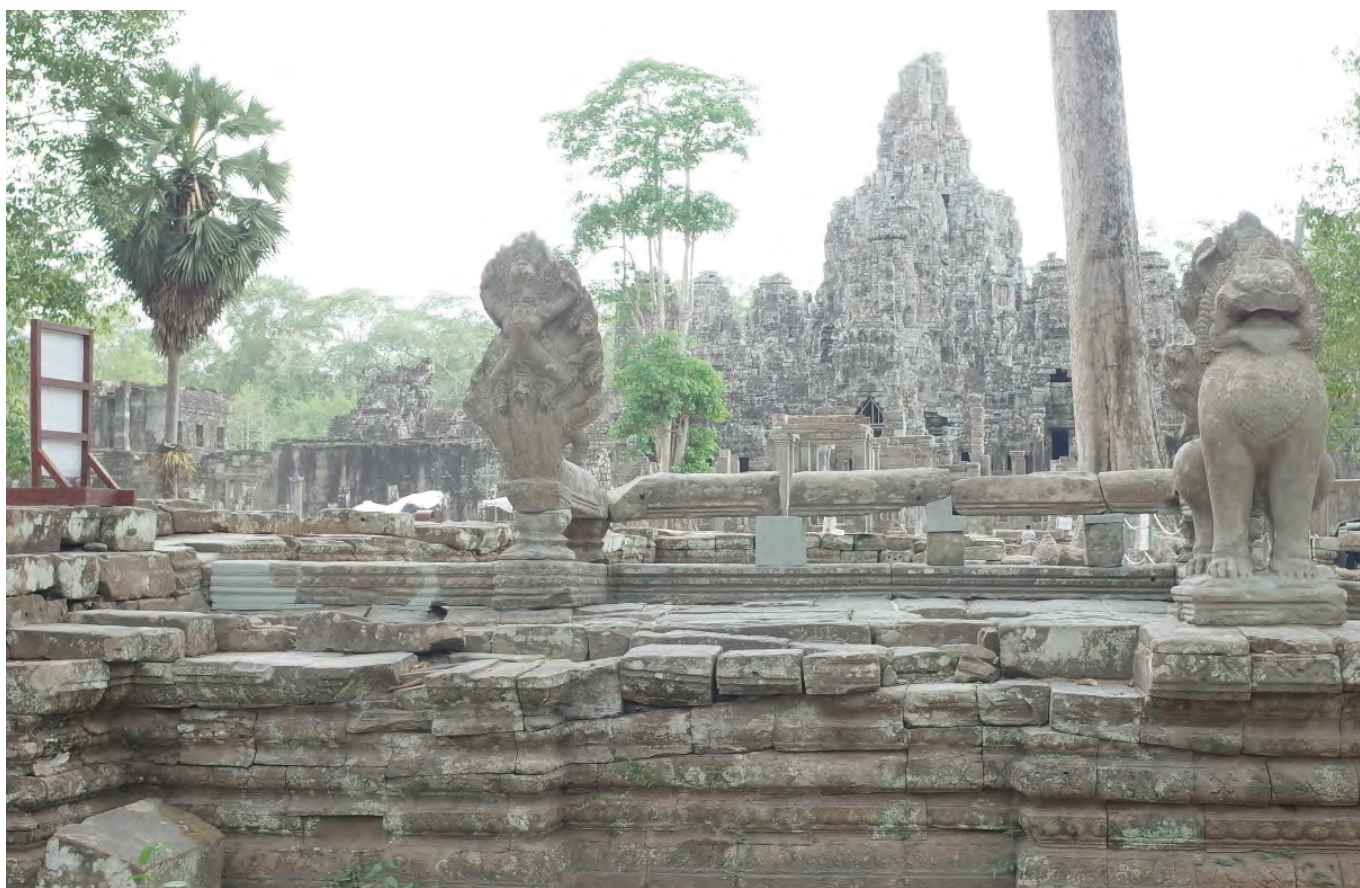
PHOTOS 7 & 8 T71.1.1, Before and After Restoration

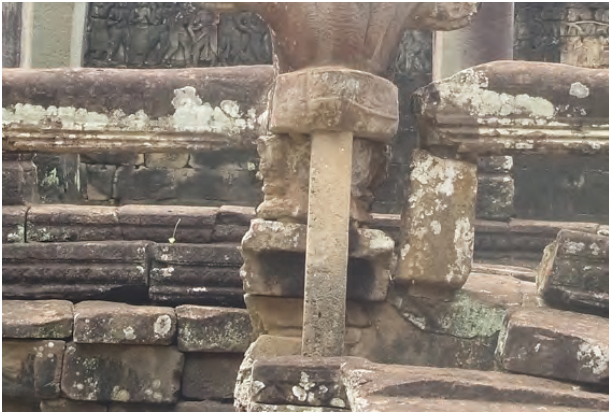
Fig.2.1 Concrete support under Naga

concrete mortar and iron pins and belts. Some iron pins were processed into staple shapes to ensure they stayed in place. Iron belts were used to stabilize the rails by securing them to the coping stones or platforms. Where rails or naga statues still exist without supporting coping stones or posts, substitute materials or concrete supports were used (Fig. 2.1-2.6). This project's restoration policy had to be considered based on these existing restoration conditions.

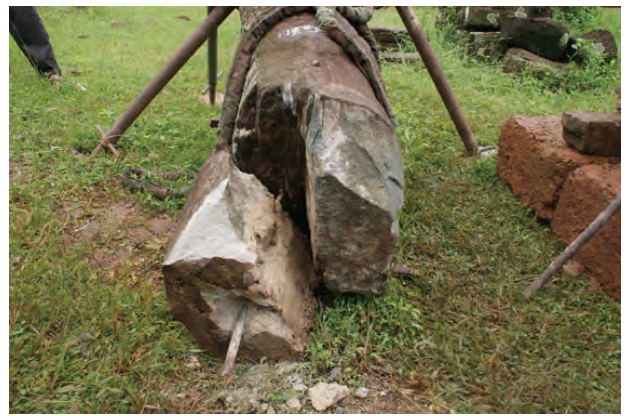
Fig.2.2 Collapsed section due to deterioration of restoration material

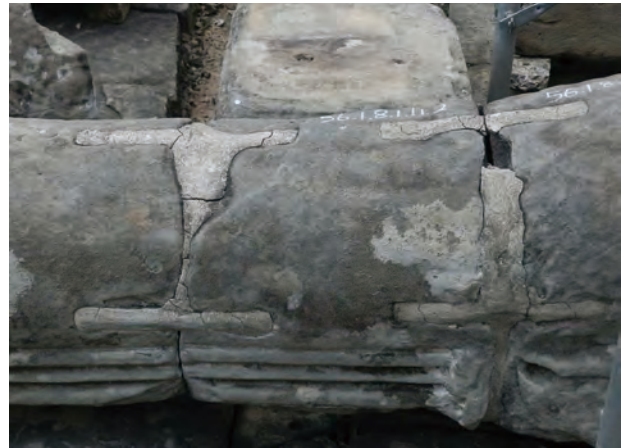
Fig.2.4 Iron pin connection

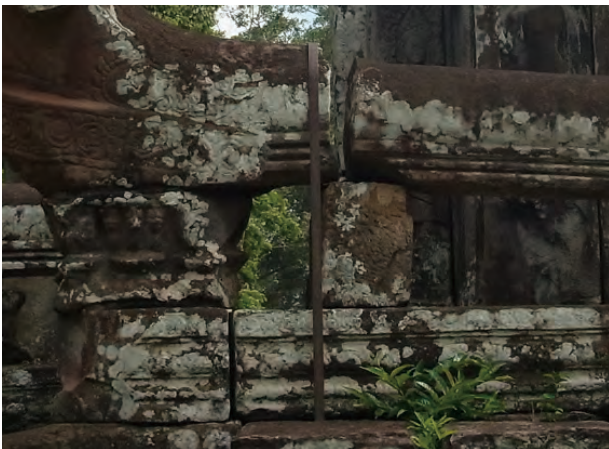
Fig.2.5 Iron belt support

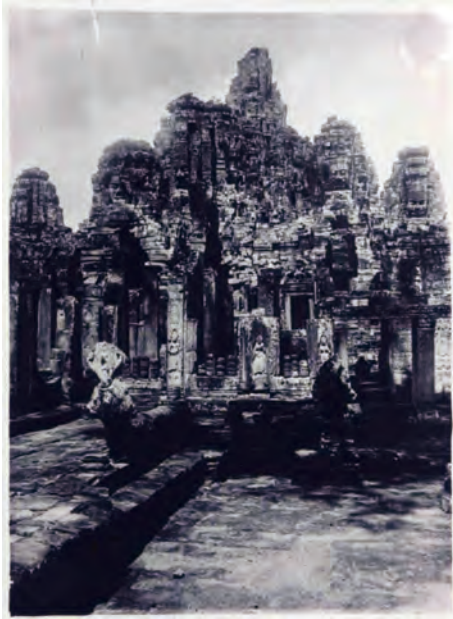
Comparing old photos from the early 1900s stored by EFEO with current photos reveals that balustrades and statues that had been maintained during EFEO's restoration efforts collapsed again due to turmoil in the 1970s and 80s or natural disasters. Additionally, some components now lost were identified through these old photos (Figs. 2.7-2.12).

Fig. 2.7 Situation after previous intervention
East Causeway, Bayon
(EFEO photothèque, CAM06104)

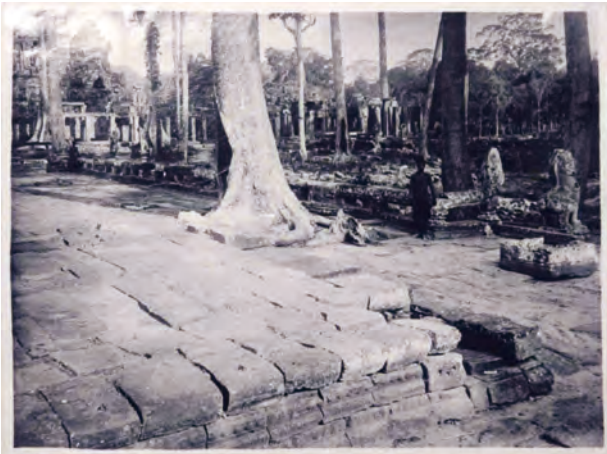
In 1932, the naga balustrades around the eastern causeway and Tower 55 were restored (Fig.2.9). Since most had merely collapsed on the spot without mixing with other scattered stones, the eastern causeway was restored almost perfectly, except for a part on the southern side where stone materials could not be found. However, later the balustrades on the north side of Tower 55 collapsed again due to a fallen tree or some human factor, scattering the stone materials.

Fig. 2.9 Situation after previous intervention
East Causeway, Bayon
(EFEO photothèque, CAM05865)

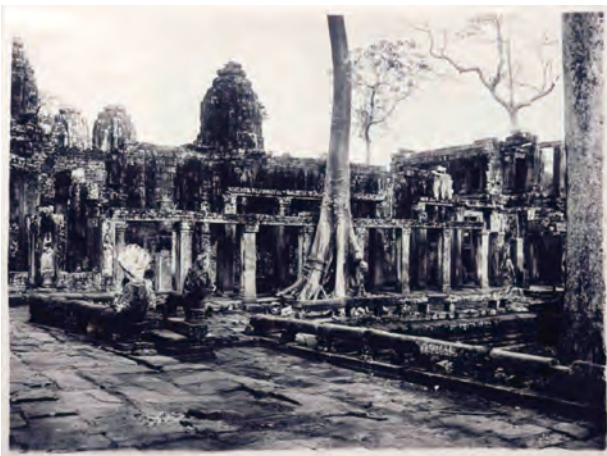
Fig. 2.11 Situation after previous intervention
East Causeway, Bayon
(EFEO photothèque, CAM06147)

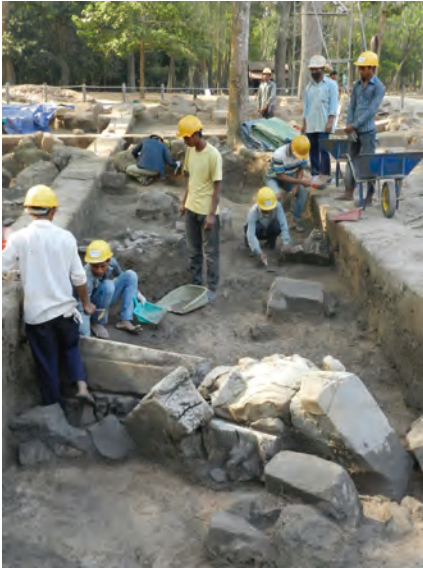
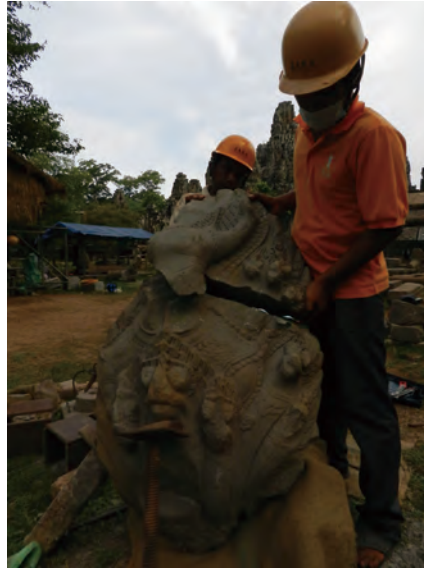
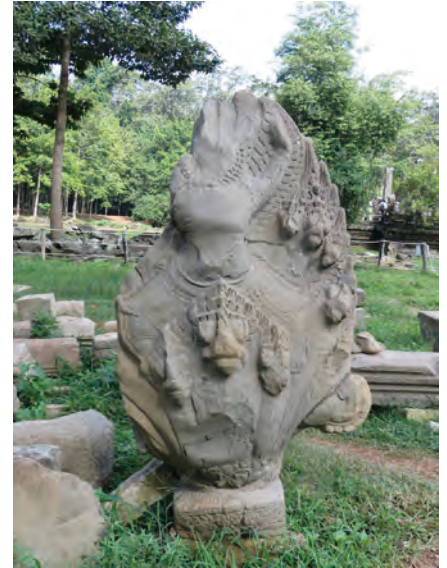
ナーガ部材の再利用事例は、JASA の発掘調査で明らかとなっている。(以下考古発掘ナーガについて) バイヨン寺院外回廊 57 塔 の東側で実施された 17 次発掘調査では、寺院の建設部材のほか、寺院の外回廊にたつナーガ彫像や獅子彫像、欄干の断片が多数出土している。そのほとんどが、寺院にすでに設置されている彫像や欄干の一部であるが、彫刻が施された寺院のいくつかの部材とともに南池の南辺部の新期堆積層 (17SXO25) において、ほぼ完形を保つナーガ彫像が新たに確認された。このナーガ彫像は一部表面に研磨材として使用した痕跡が認められ、この部分は精緻なナーガ彫像の模様が磨滅してしまっている。この彫像の周囲から発見された、バイヨン寺院の一部と思われる石材も、同じく摩滅の痕跡が認められた。つまりこの地域で石材の切断や研磨はおこなわれていたことを示しており、石材加工の作業場が往時この周辺にあったことが推察される。擦痕が残された理由としては 2 つ考えられる。一点は完成に近づいた段階で何等かの石材の割れやひびなど重大な損傷がおこり、使用できなくなったため研磨材として使用した、2 つ目は前述の再利用の事例のように、ナーガ彫像の重要性が失われ、単なる研磨剤として再利用した可能性である。50 以上の破片に破断していたこのナーガ彫像は、ナーガ・シンハ彫像修復プロジェクトおよび JASA のメンバーらによって修復が施された (Figs.3.9~3-11)。

Fig.3.9(left),3.10(middle), 3.11(right) Unearthed Naga Statue at 17th excavation of JASA

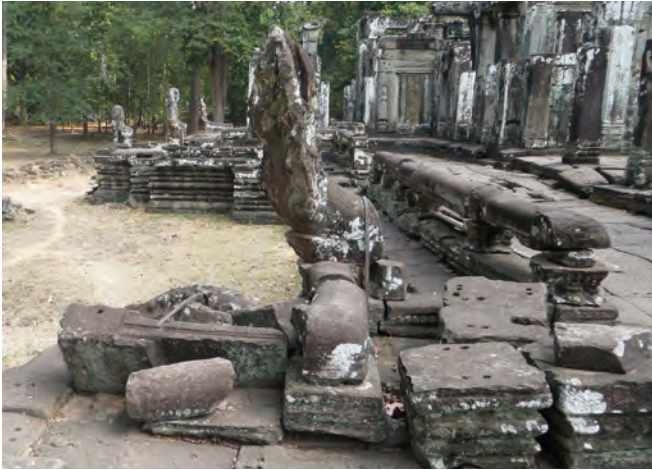
Fig.3.16 Example of N-2, N-3 (T64-2)

classification N-2: Area of which durability of the past treatment for the Naga balustrade (iron pin, iron belt and concrete mortar etc.) are lost and in danger of falling or already collapsed.

classification N-3: Area of which Naga balustrade (especially handrail) are broken and in danger of falling. There are cases that already collapsed and scattered around the platform.

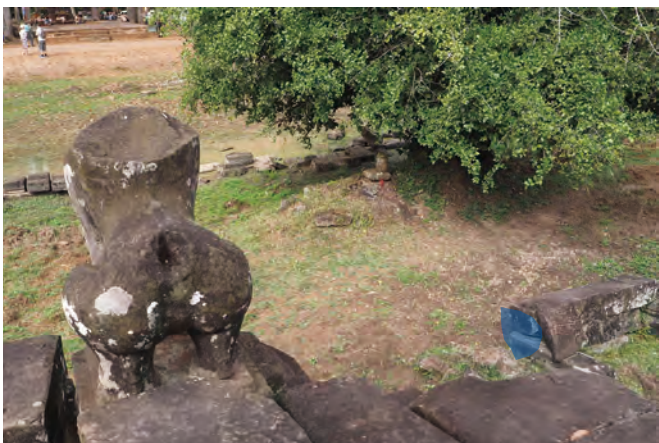
Fig.3.21 Example of L-4(T61-3)

classification L-4: Lion statue that already broken and collapsed part are scattered around platform.

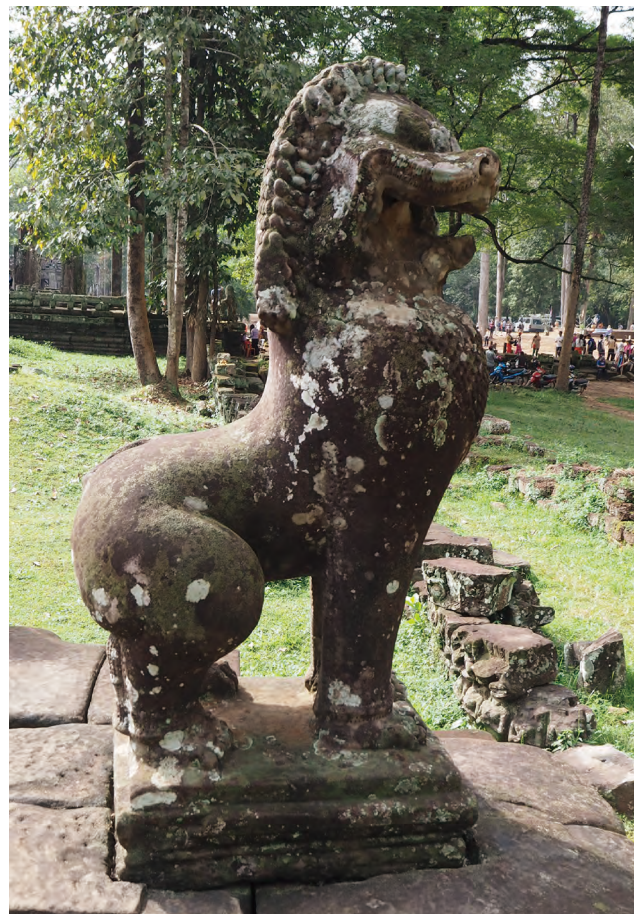
Fig.3.22 Example of L-2(T67-1)

classification L-2: There are no serious breakage, but split and crack are in progressing and in danger of breakage in the near future.

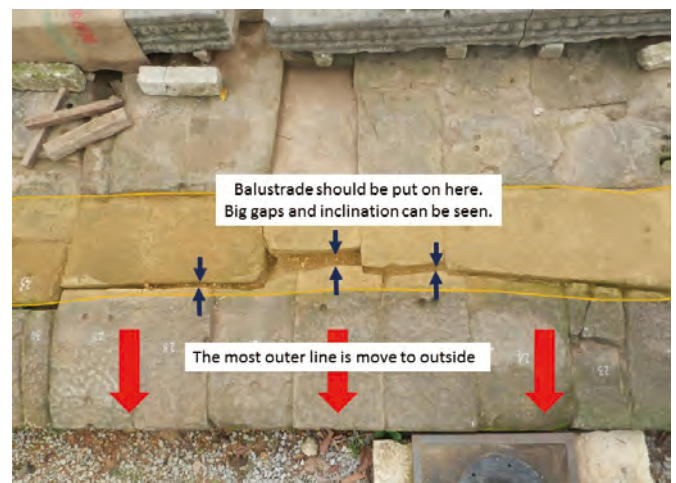
Preliminary survey revealed that the surface of the platform faced the problem of horizontal opening gaps, inclination by displacement of floor elements. In particular, the most outer line of the surface layer were moved to the outside and causing the big gap with inner line where balustrade should be set on. Also, certain inclination could be seen that was too unstable to reconstruct without any treatment (Fig.4.8).

Fig. 4.8 Gap of the floor under the Balustrade

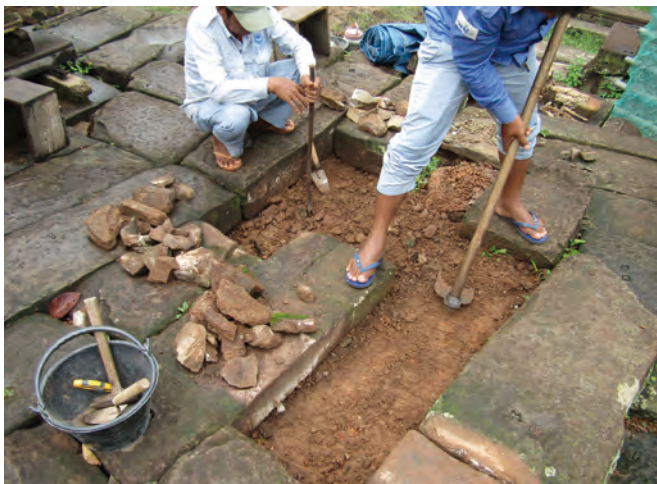
Fig. 4.9 Improvement of platform

the soils between the gaps and beneath the surface stones. (Fig.4.9) Also deteriorated platform elements received appropriate treatment and put back these elements. By these works, we could eliminate big gaps by pushing back the stones (Fig.4.10), though even there were still certain size of horizontal gaps remained were filled by laterite chip and soil 4.

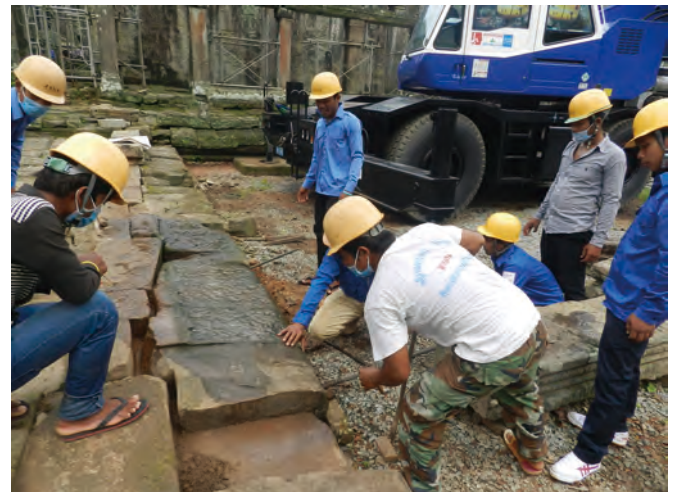
Fig. 4.10 Improvement of platform

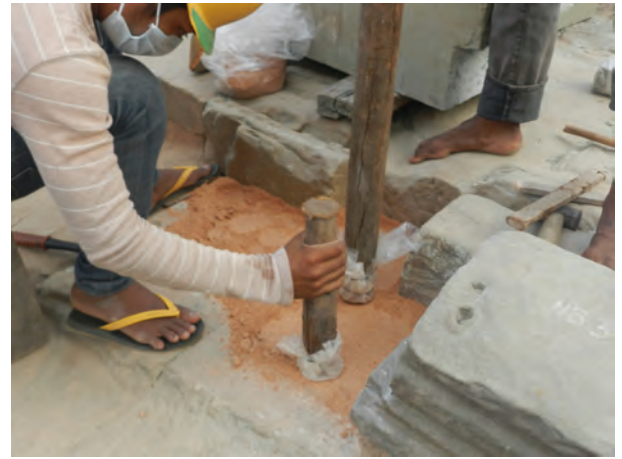
Fig.5.5 T58.1: Improvement of Platform

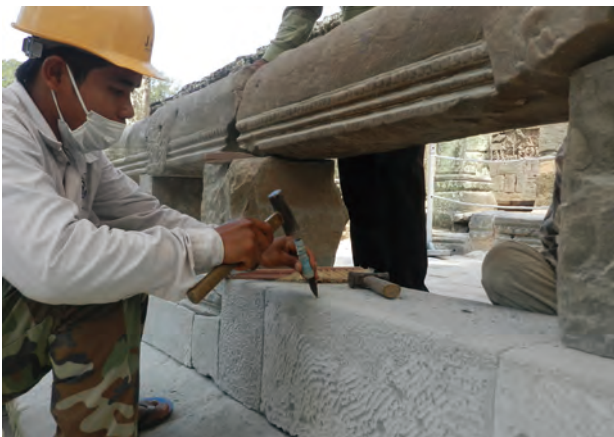
Fig.5.6 T.58.1: New sandstone supply for basement

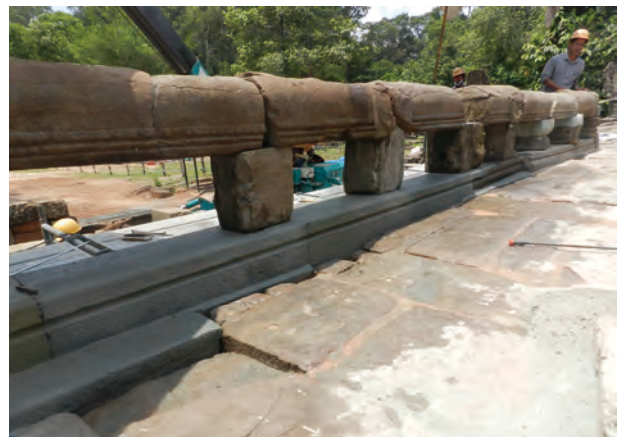
Fig.5.7 T.58.1: Finished of installation of balustrade

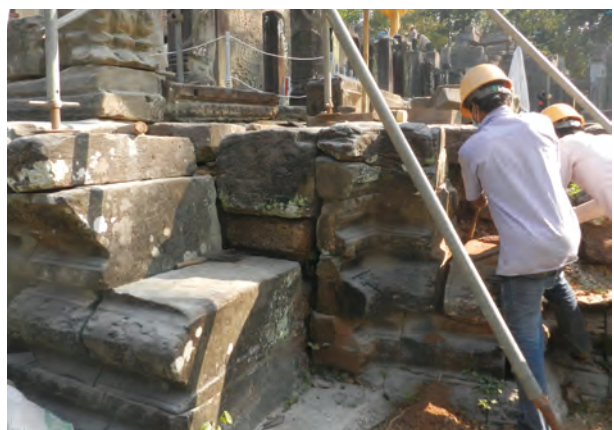
Fig.5.8 T.56.2: Improvement of Platform around Stair

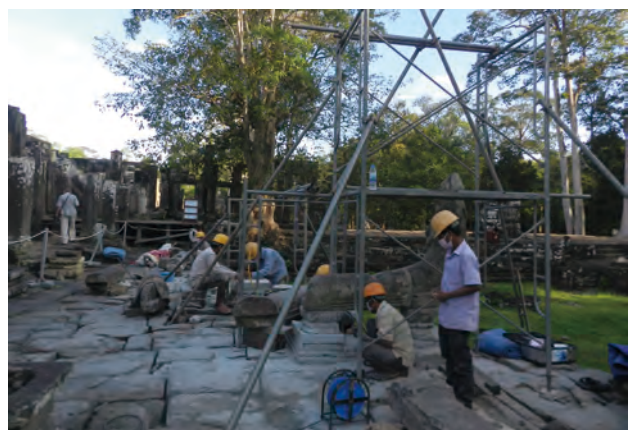
Fig.5.9 T.56.2: Reconstructing work

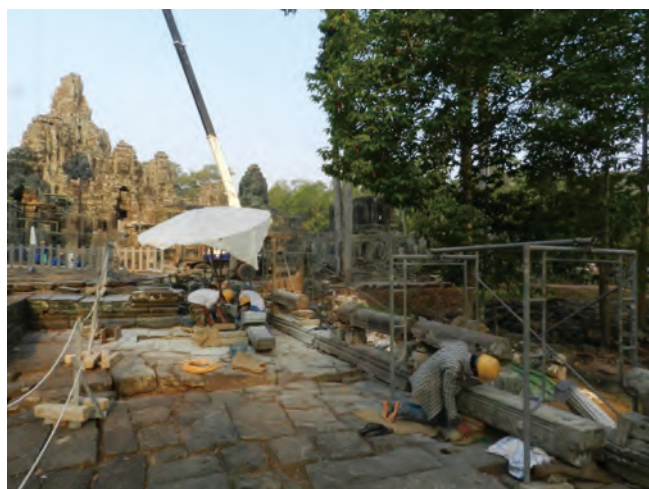
Fig.5.11 C71.4.1:Reconstructing work

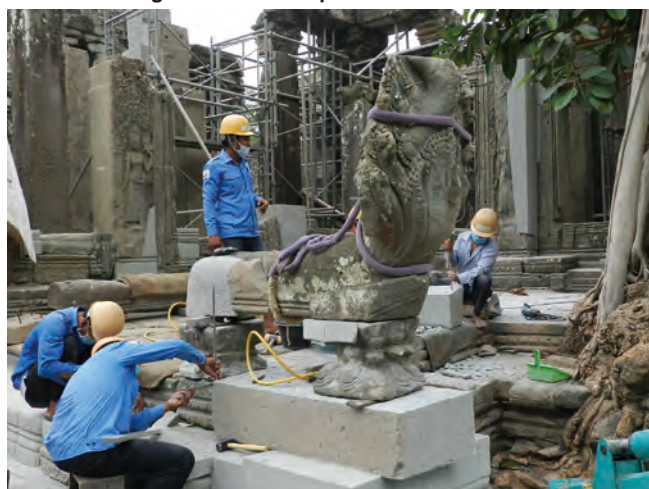
Fig.5.12 C71.3.2: New Sandstone Supply for Naga

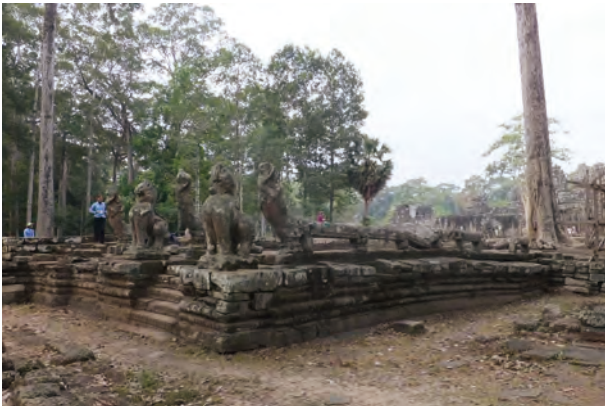
2016年4月からは、2016年2月から図面記録、欄干部材の解体、修復が開始されていたエリア C71.1-1 北東半分（このエリアの西半分は第2フェーズで完了）のナーガ欄干の修復が進められた。当エリアの作欄干や彫像の崩落の要因の多くが基壇の不同沈下にあったことから、当プロジェクトで可能な範囲で基壇の水平化を行い、それでも安定性が十分でない箇所には嵩上げ材としての砂岩板を挿入するなどした。本プロジェクトの方針として、オリジナルの斗束が見つからない限りは、既往修復にて挿入された代用斗束を再利用することとしているが、新たに整備された基壇状況や、欄干の原位置特定に伴い、これらの代用斗束の位置は適宜変更された。北東の角にあるナーガ像については特に注意が必要であった。このナーガ像については、既往修復で本来同一部材でない2つの部材同士が1つのナーガ像パーツとして連結されていた。ナーガ像が安定した状態で設置できるように、この2つのパーツは再び接続しないことにし、ナーガ頭部の胴体部分を新たに製作した。ナーガの胴体の長さは、地覆にのこされた斗束の痕跡を参考にして決定された (Fig.5.18)。

Fig.5.15 Before restoration at Northeast part of C71.1-1 .Platform was heavily distorted.

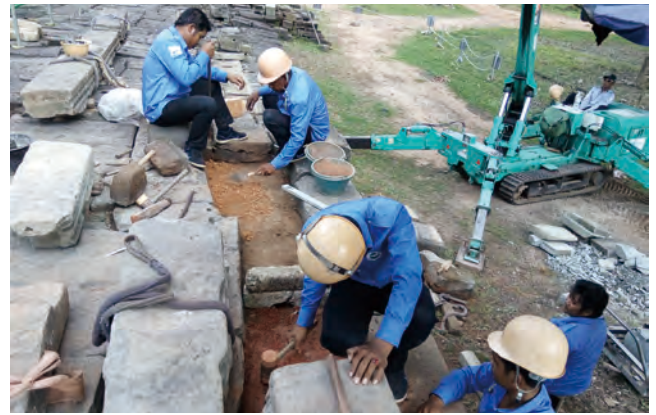
2016年6月末に前述の C71.1.1 北東エリアでの全ての修復作業が完了したため、続いて C71.2-1 の南東部での6月から解体前の調査と図面による記録を開始した。その後、欄干の解体、各部材修理と、欠損部分の新しい砂岩補填加工を進めた7月下旬から基壇の整備と再構築を開始した。参道の他のエリアと比較して、特に階段付近で基壇の不同沈下の範囲が広く、欄干直下のみのメンテナンスを実施することが困難であったため、欄干の2m内側までメンテナンスを行った (写真 5.16)。基壇構造物の不同沈下は、土手道南東階段の欄干西端で最も顕著であった。ここでは60cm以上の沈下が見られた。このため、ナーガ像を含む欄干が非常に不安定な状態になり、すべての欄干を同じ高さに保つために大規模な調整が必要となった。そのため、ラテライトブロックや改良土⁴で表層の縦横の隙間を埋め、また、ナーガ欄干の高さを他の箇所と合わせるために基壇に新たに砂岩ブロックを4個挿入した (Figs.5.23-5.28)。最終的に、9月末に C71.2-1 の南東部全体の復元作業が完了し、10月に復元後の図面による記録を行った。

Fig.5.16 Maintenance were performed 2 m inside the balustrade/71.2.1.

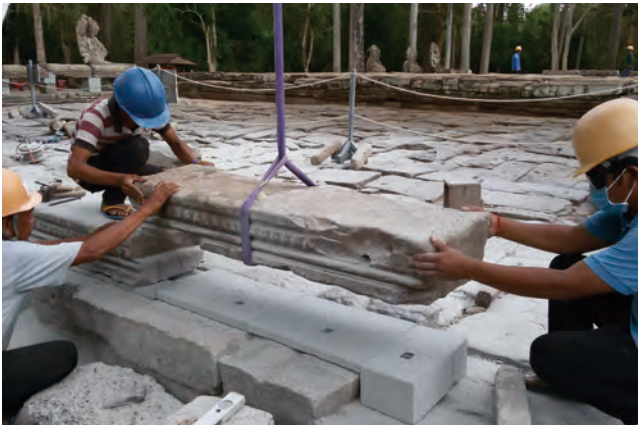
Fig.5.17 Insert new sandstone plate for support under the basement /71.1.1

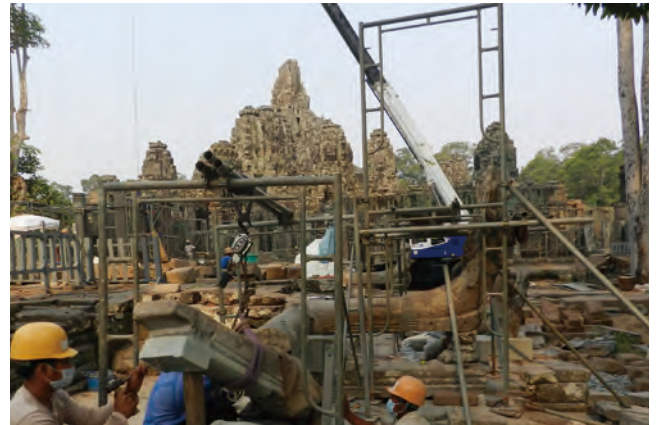
In April 2016, the restoration of the Naga balustrade in the northeast half of Area C71.1-1 (the west half of this area was completed in Phase 2), where drawing records, dismantling of balustrade elements, and restoration had begun in February 2016, proceeded. Since the collapse of the balustrades and statues in this area was caused mostly by the uneven settlement of the platform, the platform was leveled to the extent possible in this project, and sandstone slabs were inserted as bulking materials in areas where the stability was still insufficient. However, the locations of these substitute bundles were changed as necessary to accommodate the newly developed platform and the original location of the balustrade. Special attention was paid to the Naga statue in the northeast corner. For this Naga statue, two parts that were not originally identical in the previous restoration were joined together as a single Naga statue part. To ensure that the Naga statue could be installed in a stable condition, these two parts were not connected again, and the body part of the Naga head was newly fabricated. The length of the Naga's body was determined by referring to the traces of the funnel bundle left on the ground cover (Fig.5.18).

Fig.5.18 Reconstruction work/ 71.1.1 west part

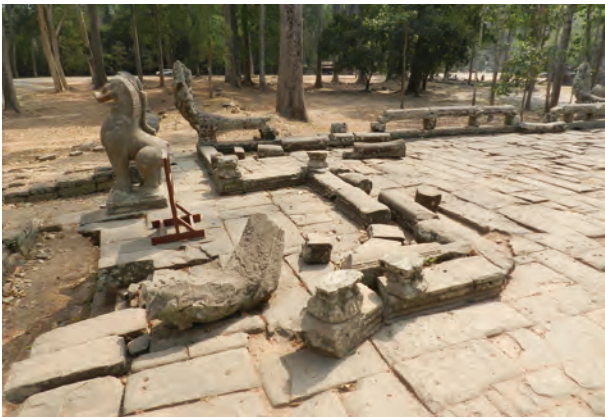
Fig.5.19 Before restoration at East gateway of causeway/ C71.2-1

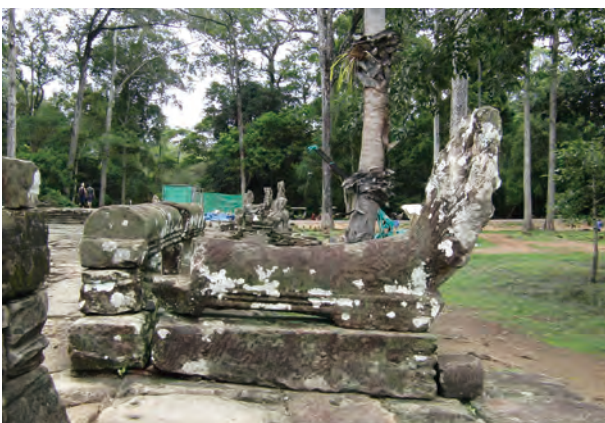
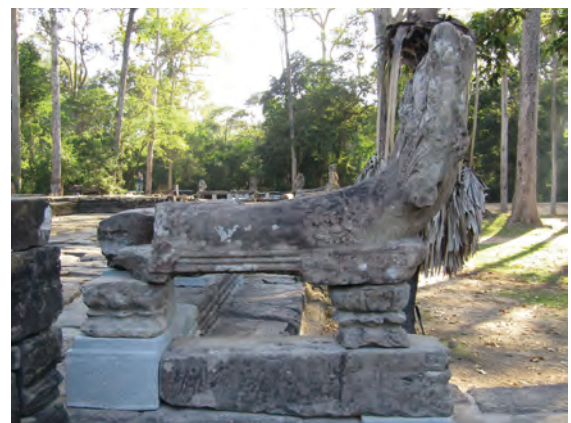
Fig.5.21, 5.22 Before and After restoration, Newsandstone bansement was inserted instead of substitute element/ 71.2.1

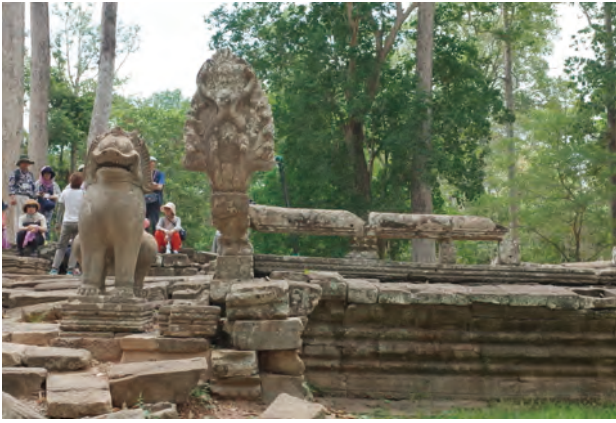
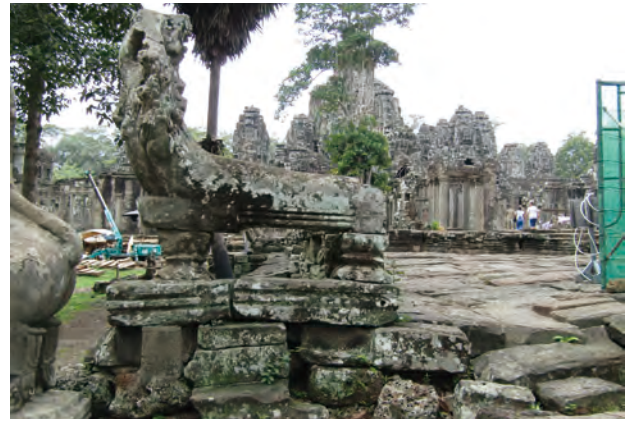
Fig.5.23, 5.24 More than 60cm subsidence at southeast gate of causeway(71.2-1). Naga and Lion statues are at danger of collapse.

platform to match the height of the Naga balustrade with the other sections (Figs.5.23-5.28). Finally, the restoration of the entire southeastern portion of C71.2-1 was completed at the end of September, and the restoration was documented with drawings in October.

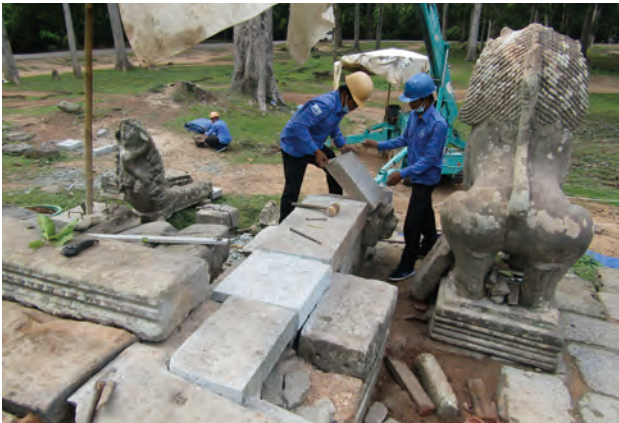
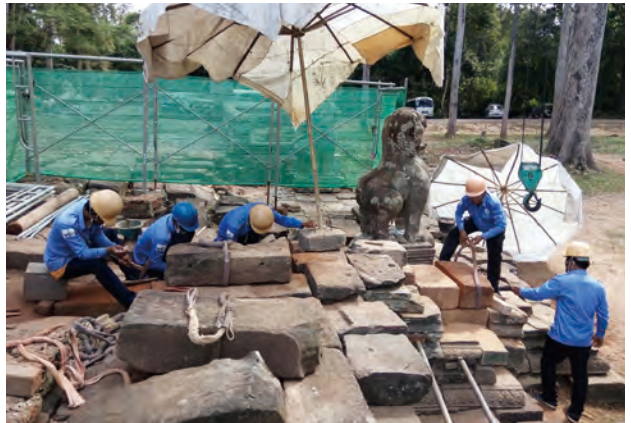
Fig.5.25, 5.26 Large scale platform improvement was implemented. Laterite and Sandstone were inserted under the Balustrade.

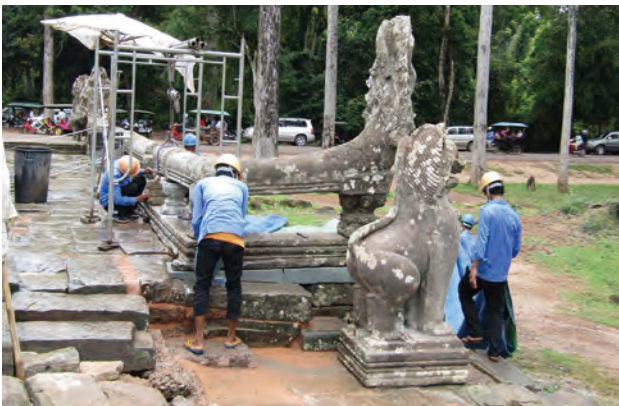
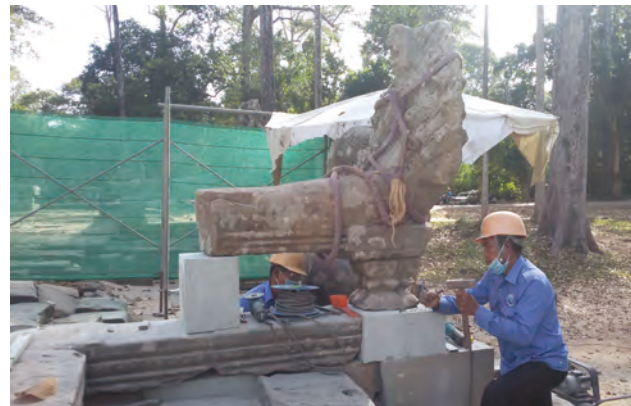
Fig.5.27, 5.28 After improvement of platform, Naga Balustrade were reconstructed. New sandstone was added for Post and Basement in need.
