REPORT ON THE CONSERVATION AND RESTORATION PROJECT OF
LION AND NAGA BALUSTRADES

AT THE CAUSEWAY AND OUTER GALLERY OF BAYON
ANGKOR, UNESCO WORLD HERITAGE SITE,

2012-2020

November 2024

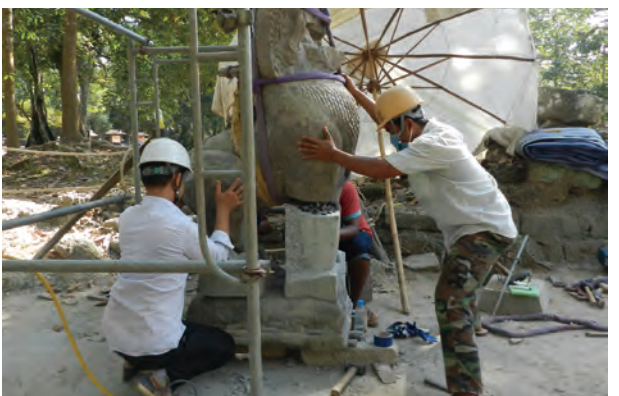
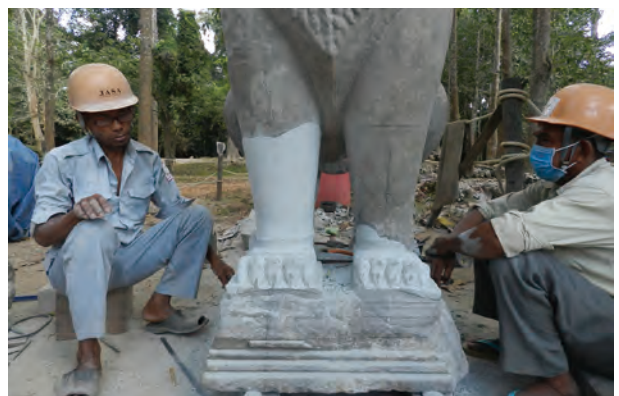
Fig.5.29, 5.30 Due to the deterioration of the concrete material from the previous restoration and the danger of collapse, the lion's four legs were replaced with new sandstone.C71.1-1(71.1.1.9.1.4)

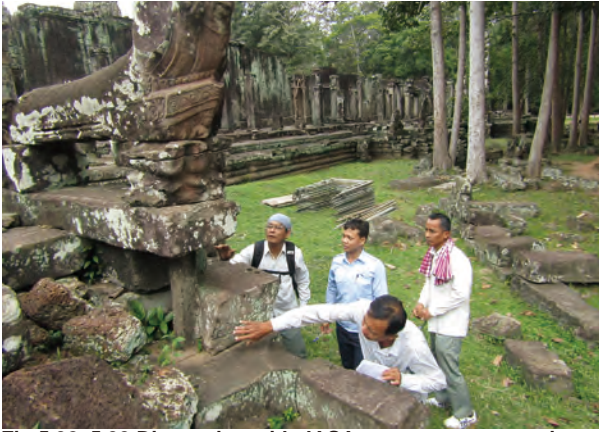
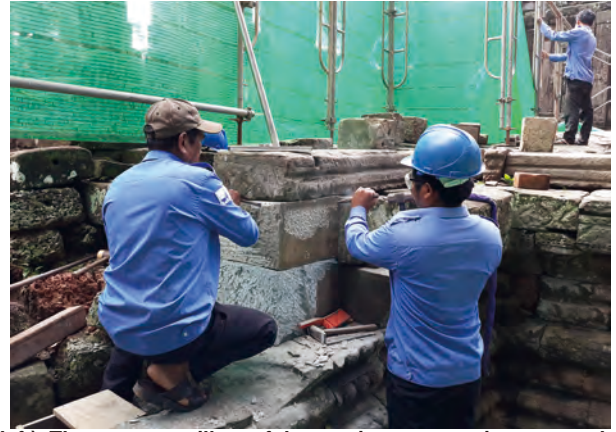
Fig.5.32, 5.33 Discussion with JASA experts on restoration methods(left). The concrete pillars of the previous restoration were to be removed and new sandstone material was to be inserted into the platform(right)/T67.2.

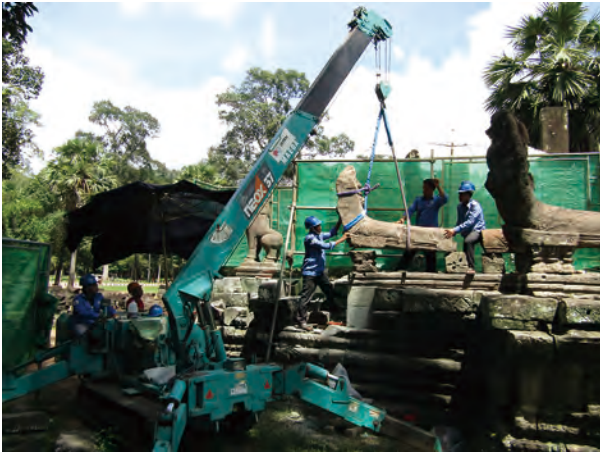
Fig.5.34 Reconstruction of balustade/T67.2.

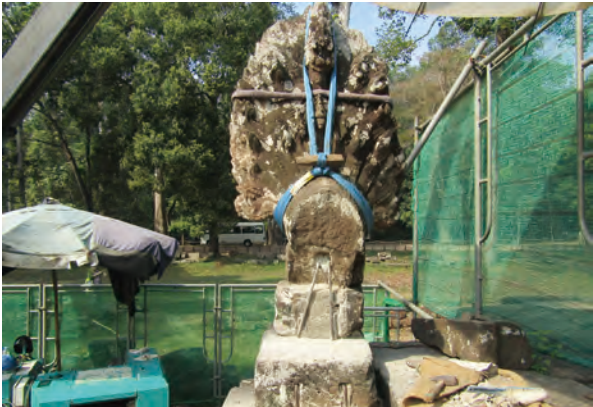
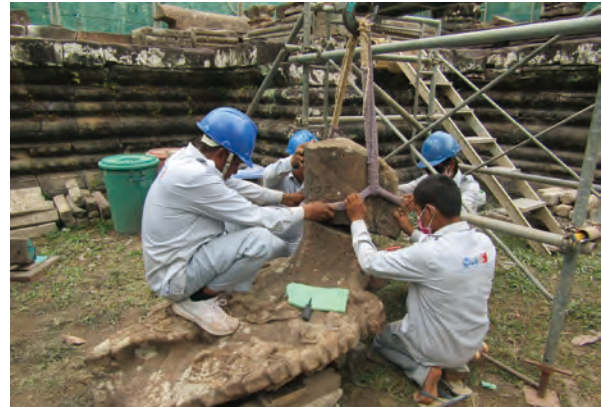
Fig.5.36, 37 Before restoration, the Naga statue at T65.3 had no trunk and couldn't stand without many iron pin inserted in previous restoration. However, we could found piece of trunk from scatter stone near this area, so that this statue could stand without support oafter restoration.

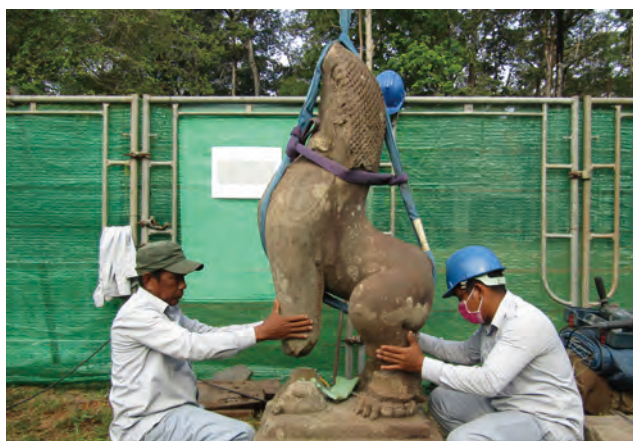
Fig.5.40 [T61.3] Trial Connecting of Lion Statue(61.3.9.1.1)

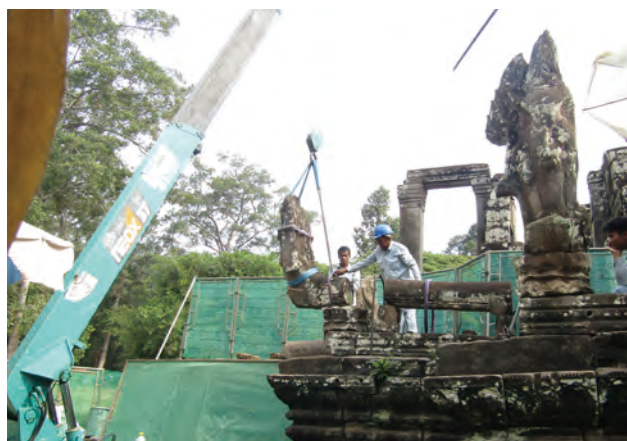
Fig.5.41 [T61.3] Dismantling of Naga Statue

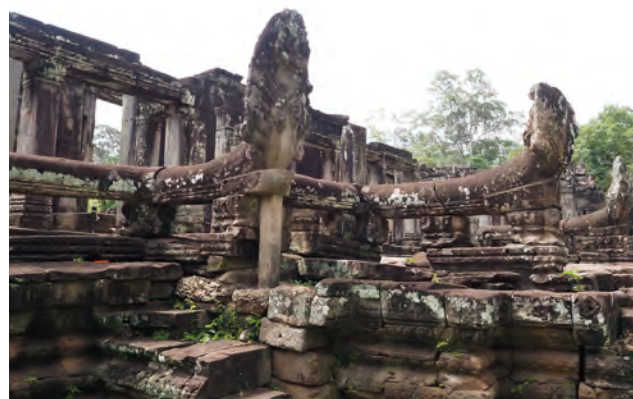
Fig.5.42 [T62.1] Before restoration, Support by concrete pillar was deteriorating.

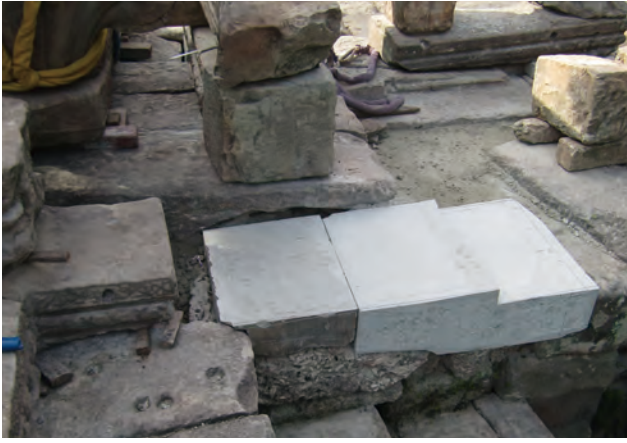
Fig.5.44, 45 [T62.1] Insert new sandstone block in order to make a level and stable floor surface

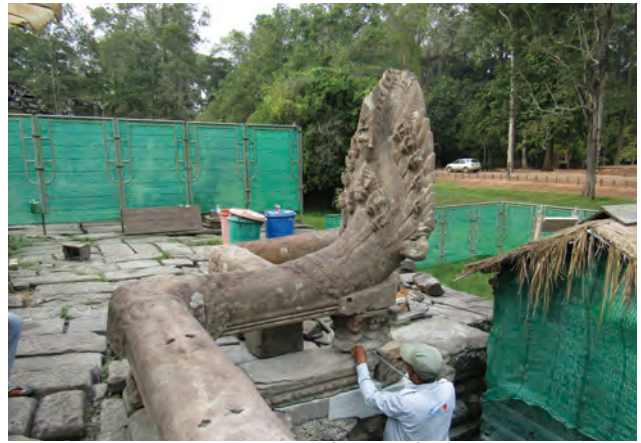
Fig.5.47 [T60.2] Reconstruction of balustrades

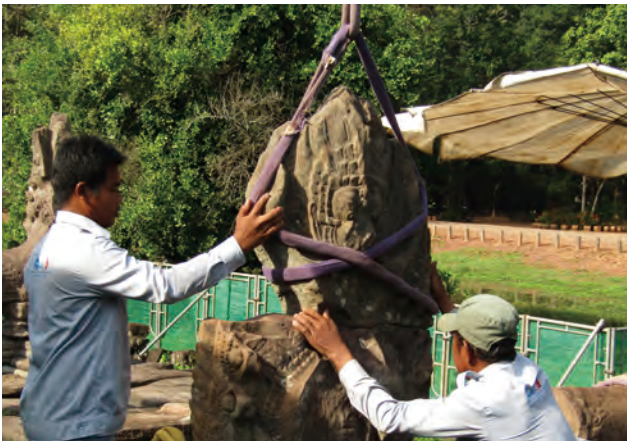
Fig.5.46 [T62.1] Connecting Naga statue

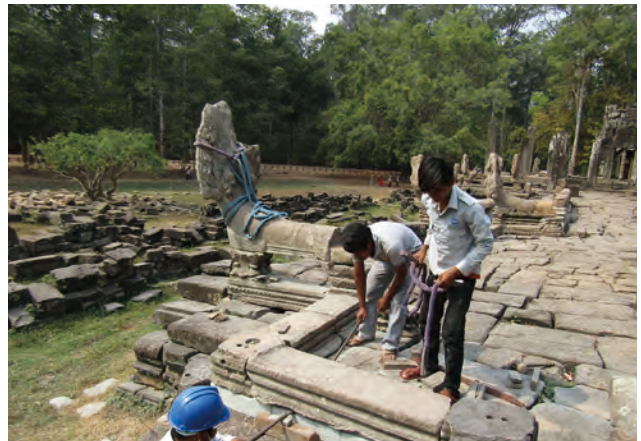
Fig.5.47 [T60.2] Reconstruction of balustrades

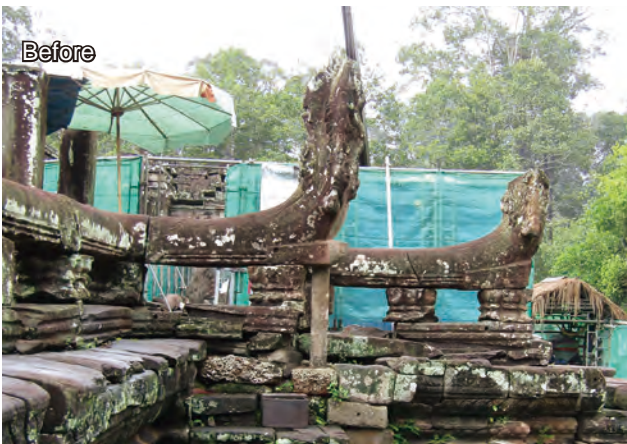
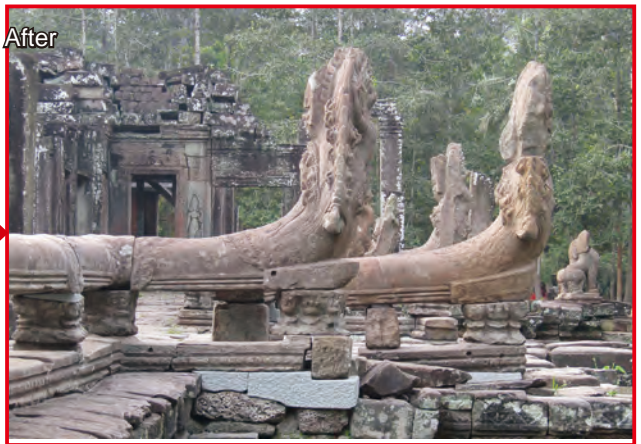
Fig.5.48, 49 [T62.1] Before(left) and after(right) resotration

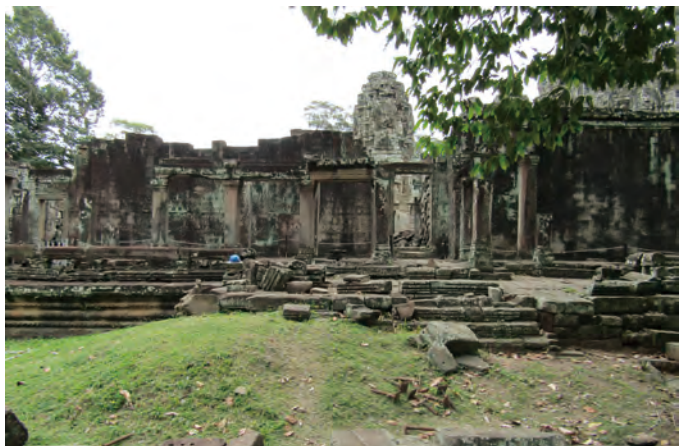
At T64, a large amount of earth and sand had accumulated next to the stairway porch, and the sides of the base were almost completely buried. Some naga statues and balustrade elements were found partially buried in the mound (Figs. 5.53-5.55). In order to improve the landscape and environment of this area, and to recover the lintel materials that are thought to be related to T64, clearance work to remove the earth and sand from this mound was carried out from August 15, 2019 to September 30, 2019. The work was carried out mainly in the following processes.

Fig. 5.53 Situation before work at T64

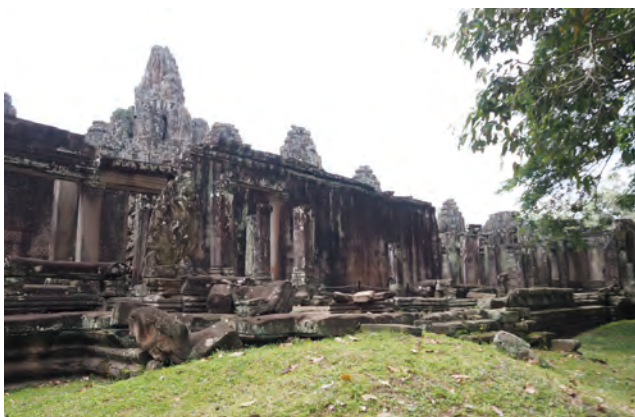
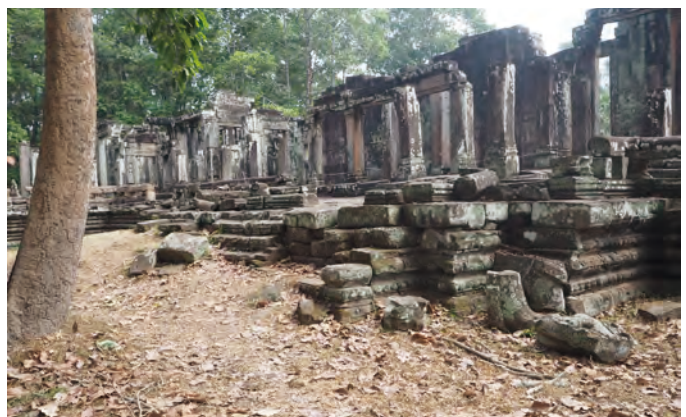
Figs. 5.54 Situation before work at T64

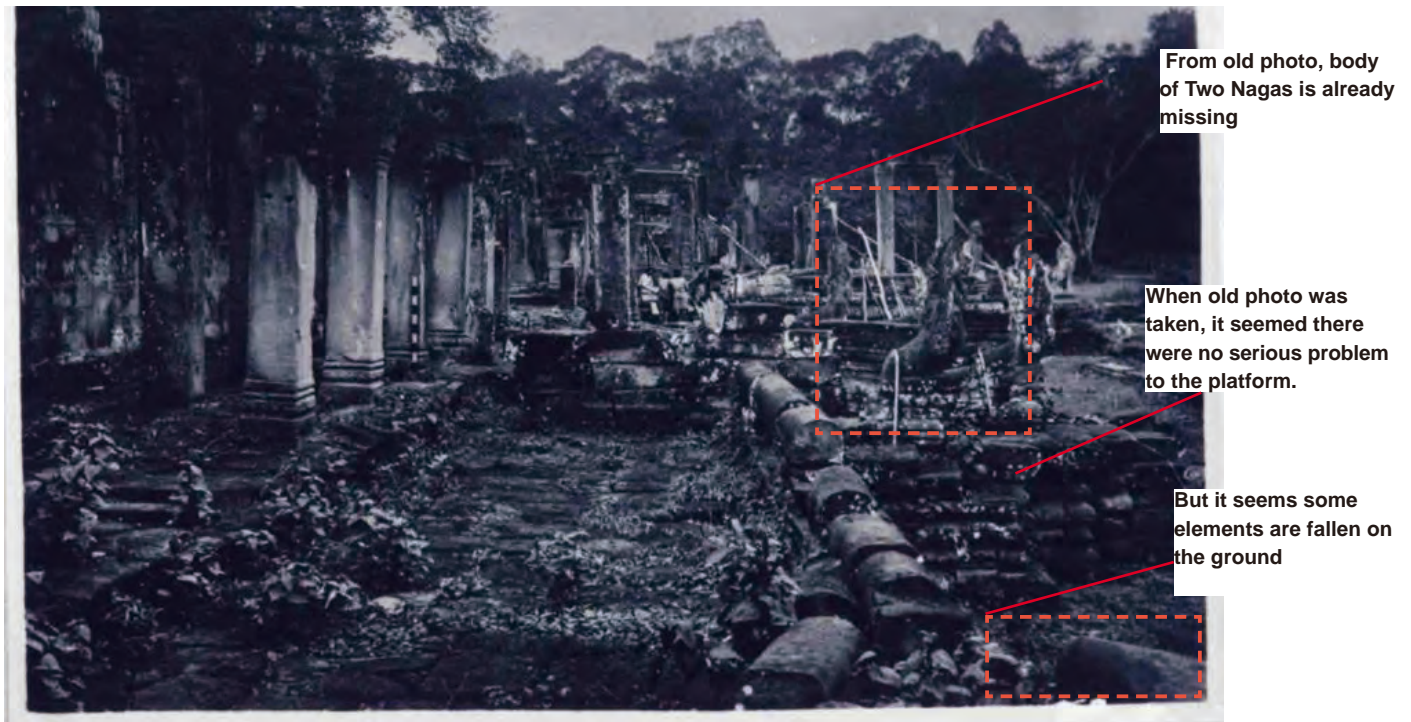
Fig. 5.55 During Improvement and Restoration work in 1930s by EFEO
(EFEO photothèque, CAM06130)

Around T64, an old photo taken just after previous restoration by EFEO in the beginning of 20 century have exist. Before starting clearance work, we have compared this old photo and present situation and confirmed some fact as below(Fig.5.55).

- Two Nagas at this area was once restored and part of these head were broken after the previous restoration. Also, the bodies of two Nagas were already missing when EFEO restored this area.
- It seems that some elements of bluastrade were fallen on the ground.

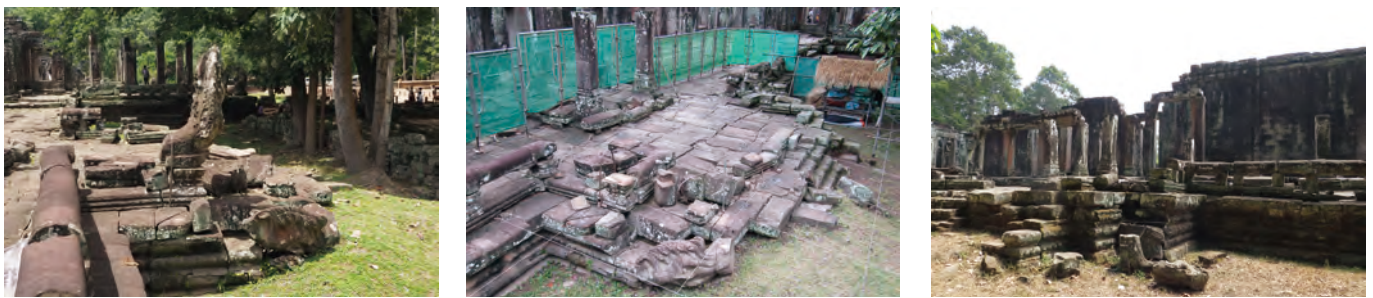
Fig. 5.56(left), 5.57(middle), 58(right) Situation Before Mound Clearance

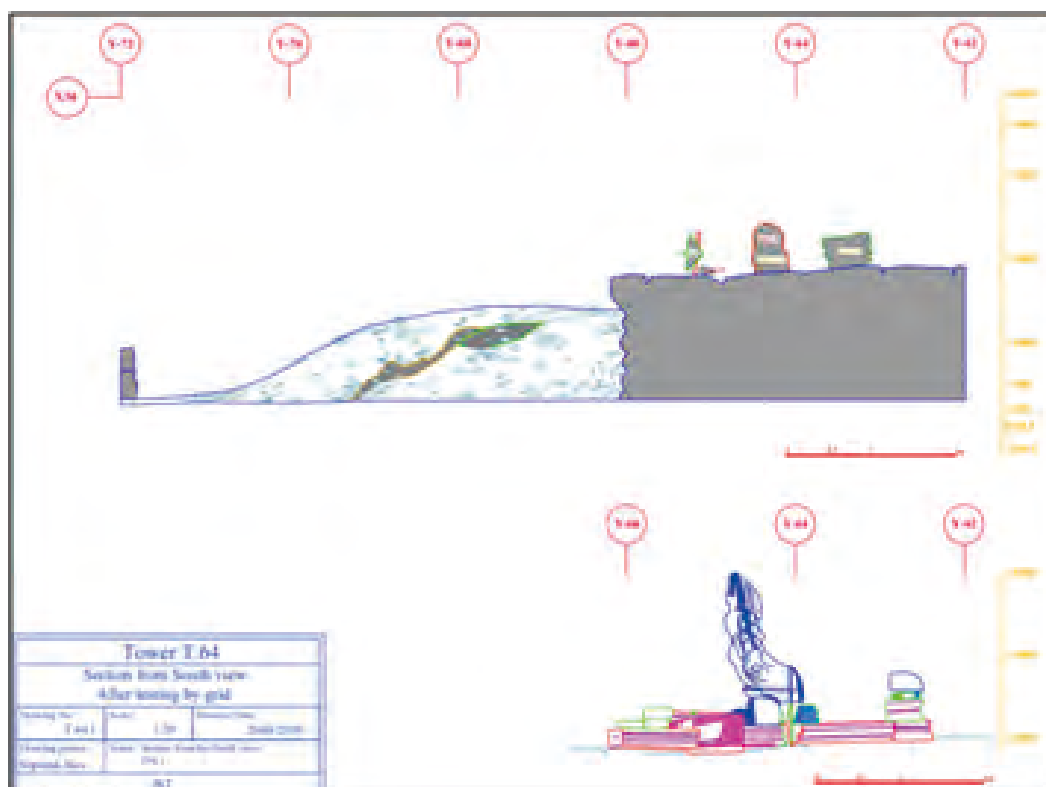
Fig. 5.59 Soil stratigraphy of north wall of test trench

- Layer I: 10 YR, 3/4 (dark brown), clay, many big and small sandstone chips are mixed.
- Layer II: 7.5 YR, 5/8 (bright brown), sand clay, sandy clay, small amount of scattered stone chip is mixed
- Layer III: 10 YR, 3/4 (dark brown), clay, clay, similar to layer I and IV but mixed new sandstone is less than these layers.
- Layer IV: 10 YR, 3/6 (dark brown), clay, similar to Layer I but small laterite chips are mixed.
- * Except for layer II, soil of tree layer is similar to foundation soil under stone structure. Therefore, it seems that this soil might be thrown away here from some excavation work in temple complex.

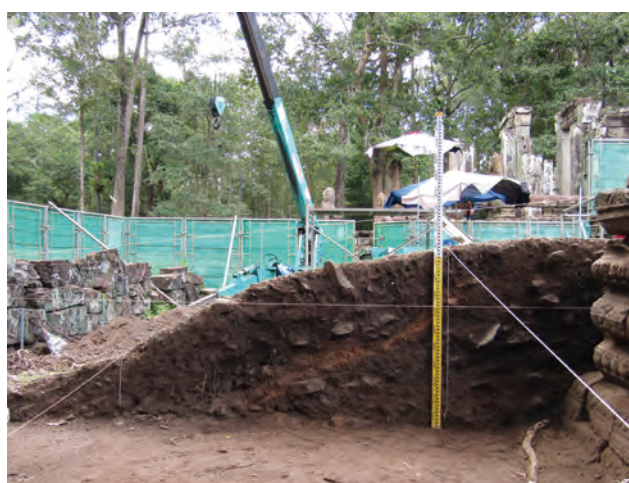
Fig. 5.61 Photo of north wall of test trench

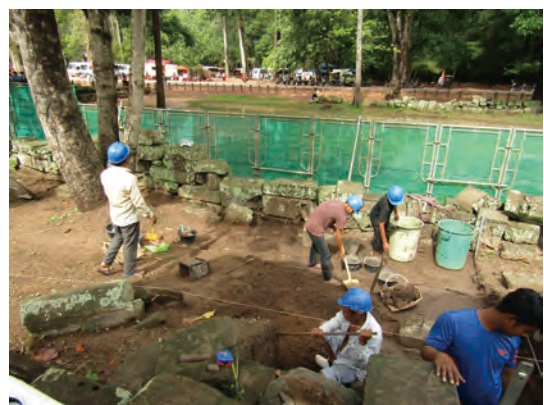
Fig. 5.62 Extension from test trench to south

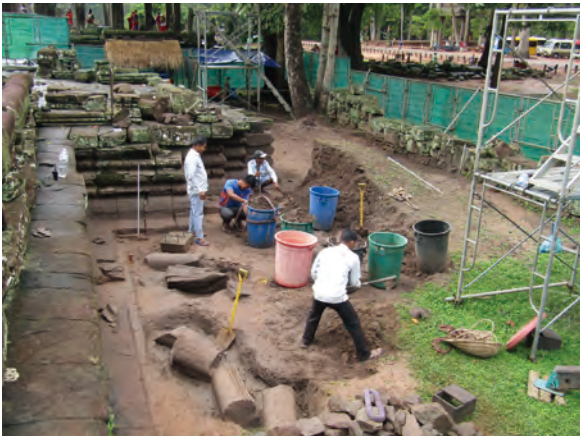
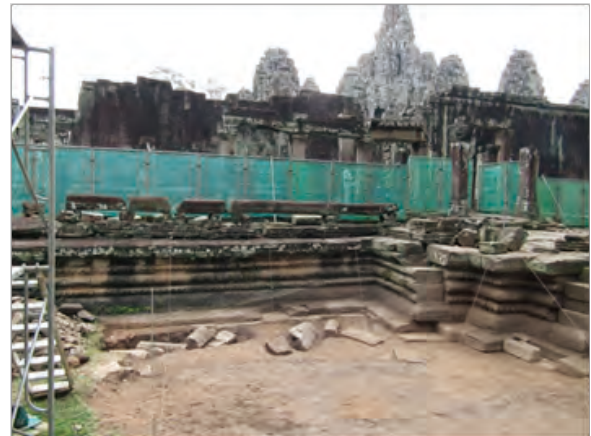
members were scattered under the soil (Fig.5.63, 5.64).

Fig. 5.63 Finding of balustrade elements around T64.1

This made it possible to fully repair and reinstall the T64.1 parapet (Figs.5.65, 5.66). In addition, parts of the parapets of T63.4 and T65.4 in the vicinity were also discovered and their original locations were identified, which enabled the replacement of the materials in these areas and many of the parapet members to be returned to their original positions. As for the Naga statue, in addition to the head that was already visible on the mound, another head fragment was excavated from within the mound, so it was joined and reinstalled on the base. As described above, this clearance work resulted in the excavation of many parapet members and the removal of the mound, leading to a significant improvement in the landscape around the T64 area (See p.6 Photos 3, 4).

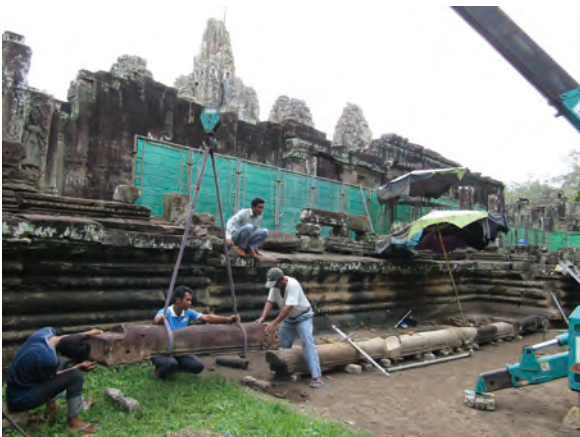
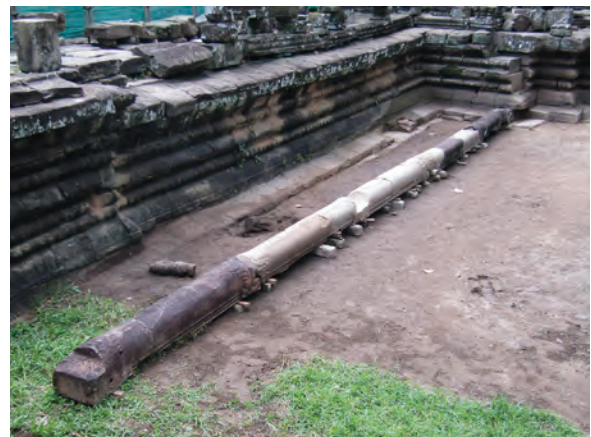
Fig. 5.65(left), 5.66(right) Trial Assembling work on the ground including found elements

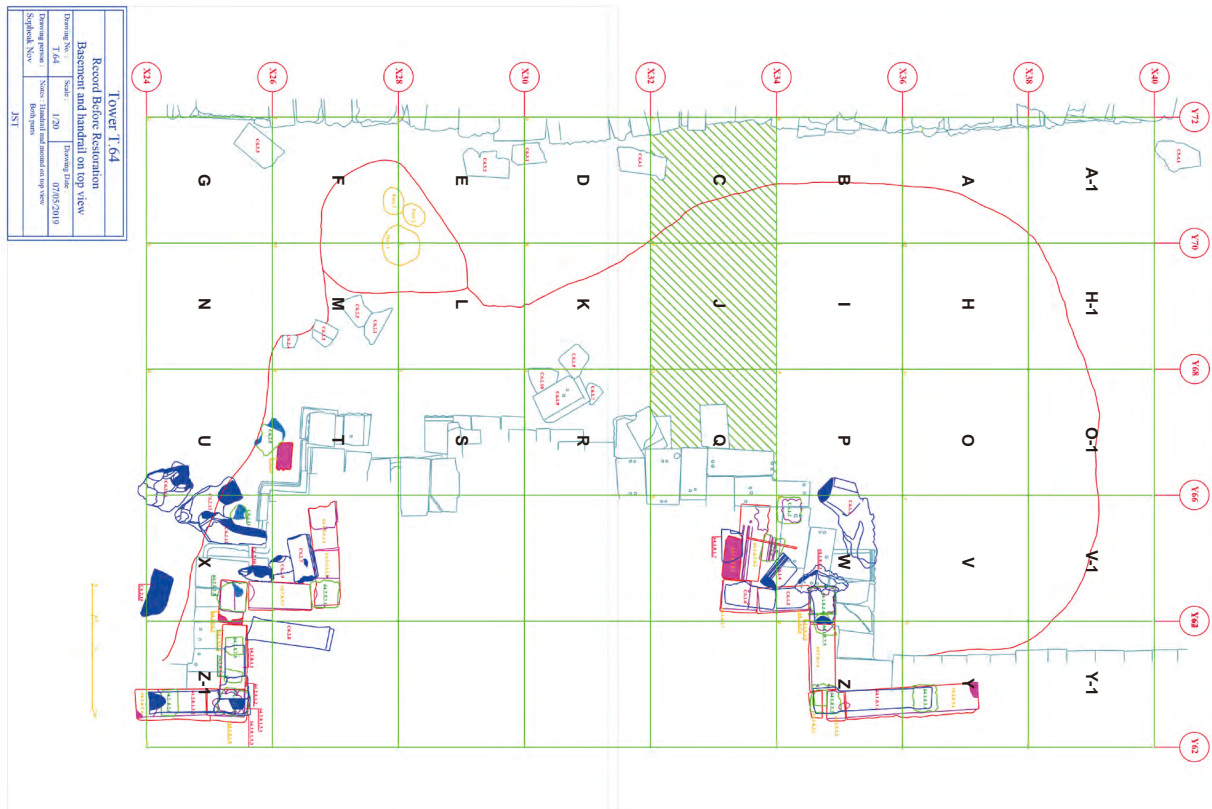
Fig. 5.67 Top Plan before mound clearance at T64

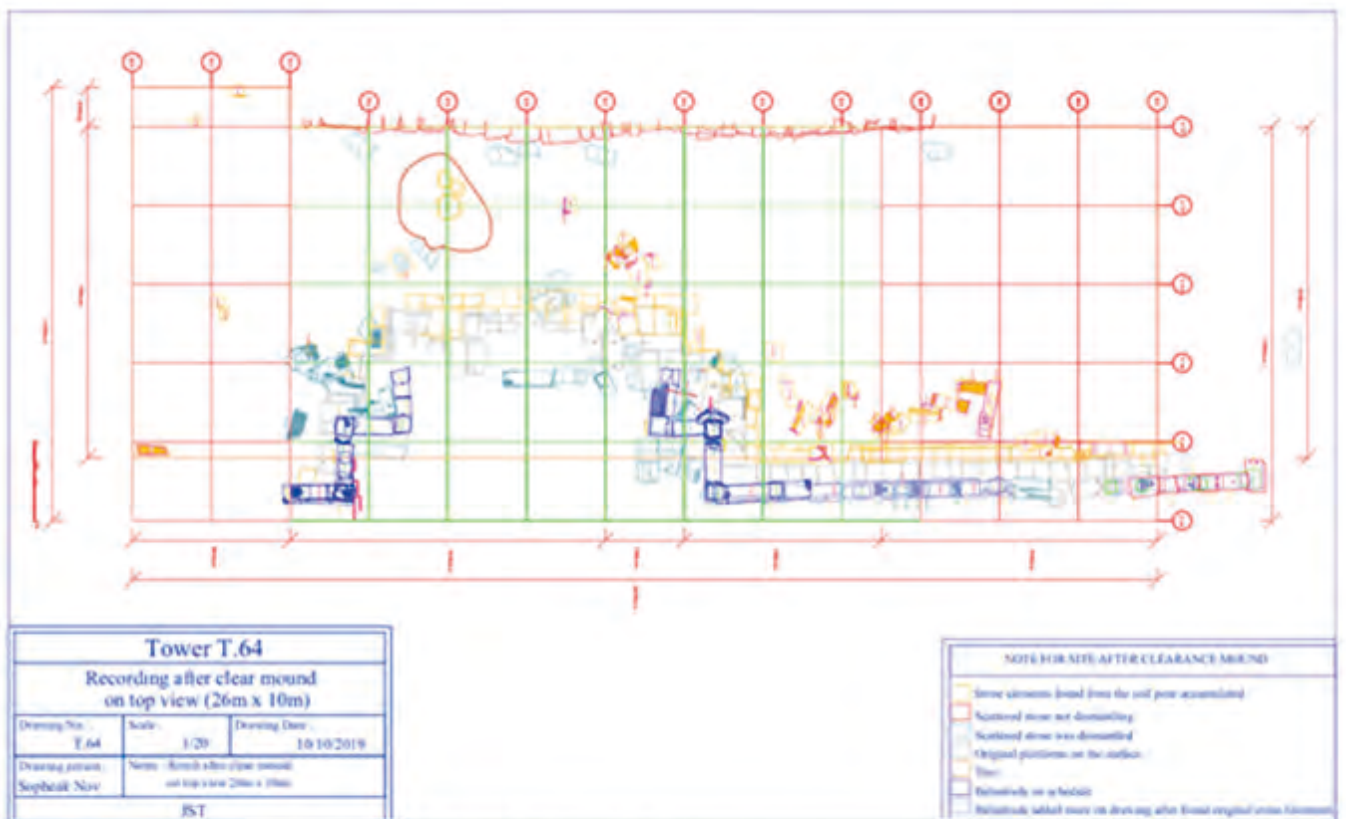
Fig. 5.68 Top Plan After mound clearance at T64

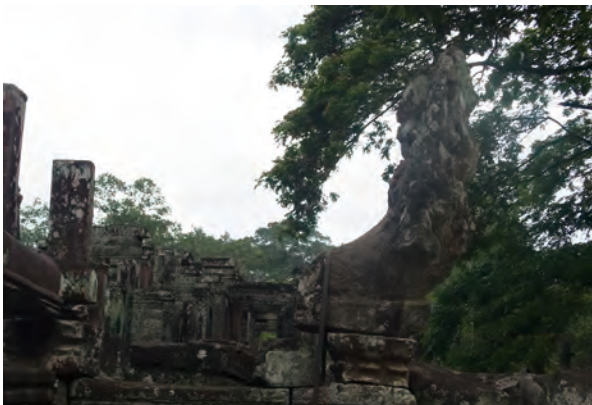
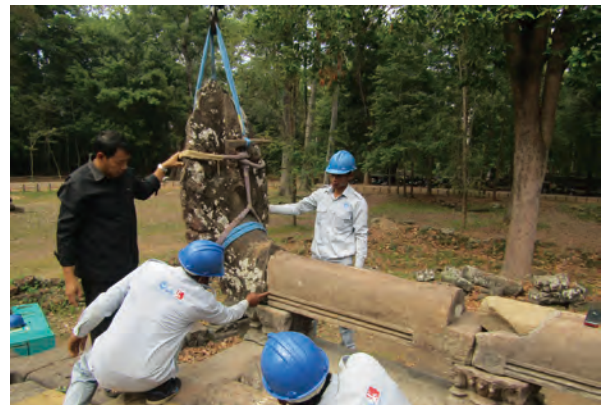
Fig.5.75(Left, before restoration at T63.4), 76(right, During installing Naga from T64.2)

It became clear that Naga statue installed at T64.2 in previous restoration (left) was original installed at T63.4, and connected with the body scattered on the platform of T63.4

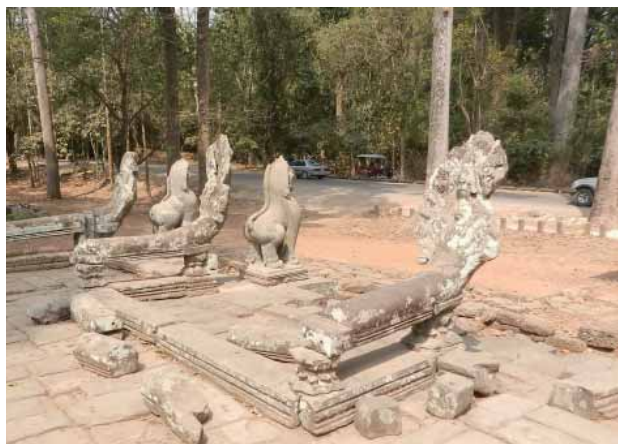
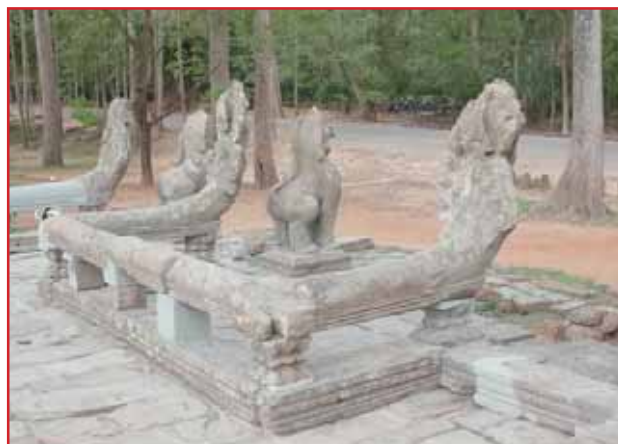
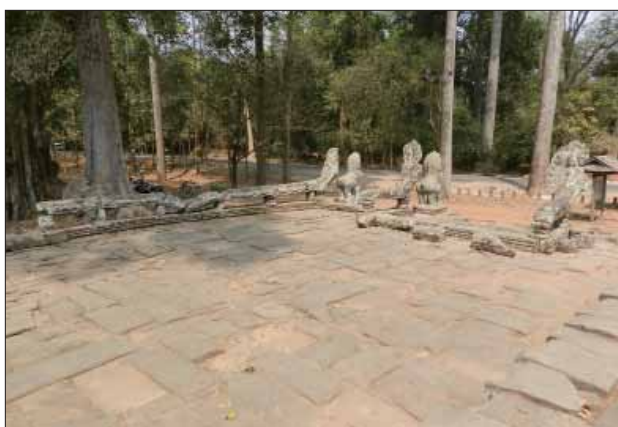
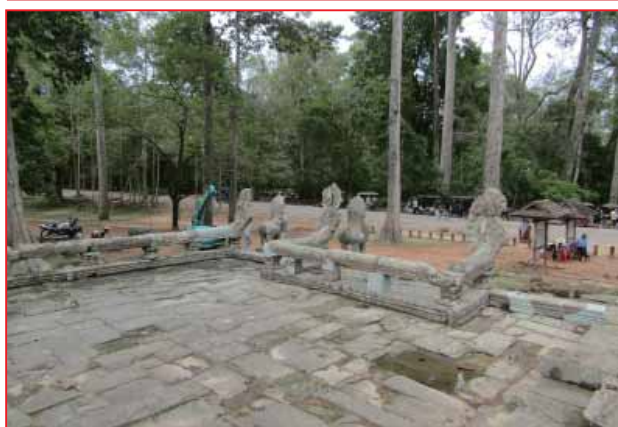
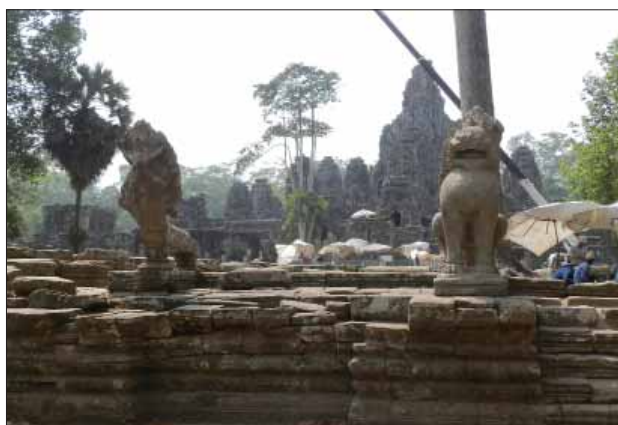
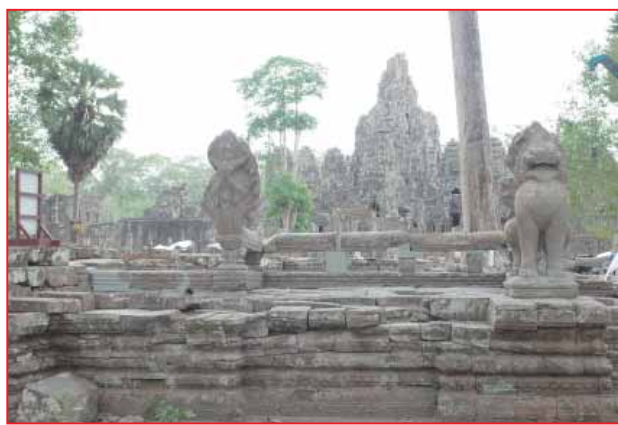
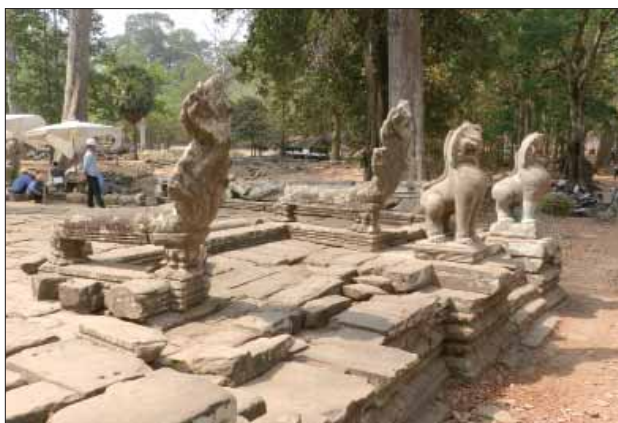
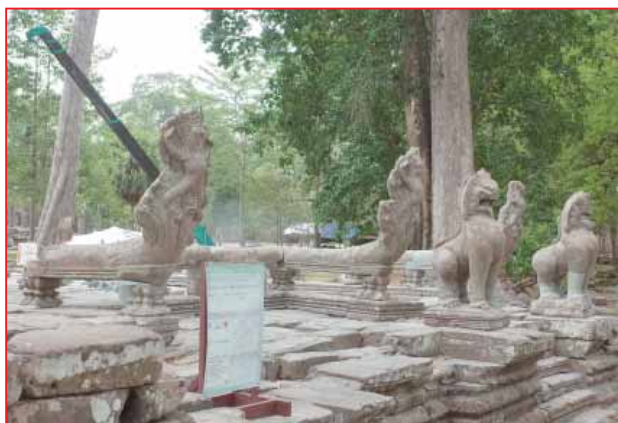
Area : T71.1-1/NorthEast Operated Term : 5 month

<Before and after restoration>

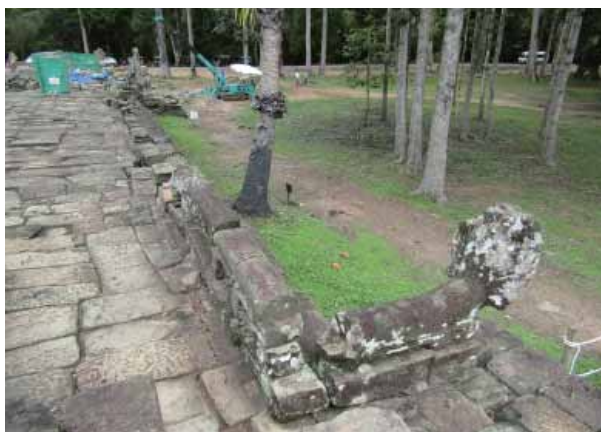
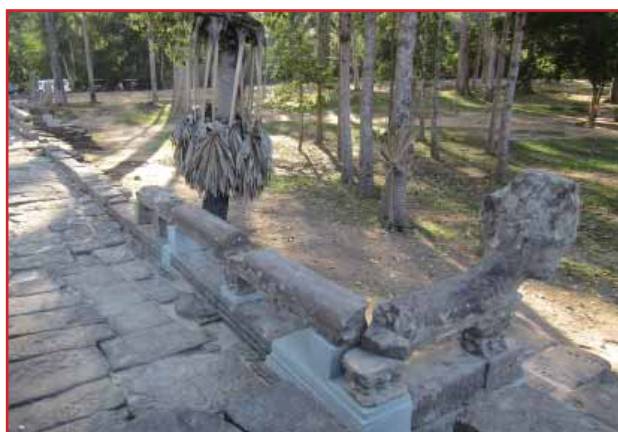
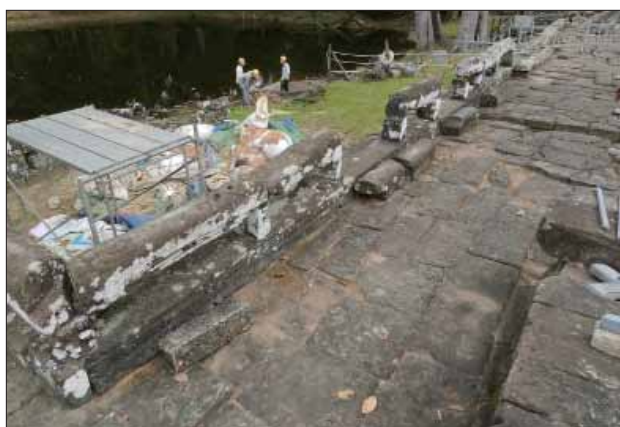
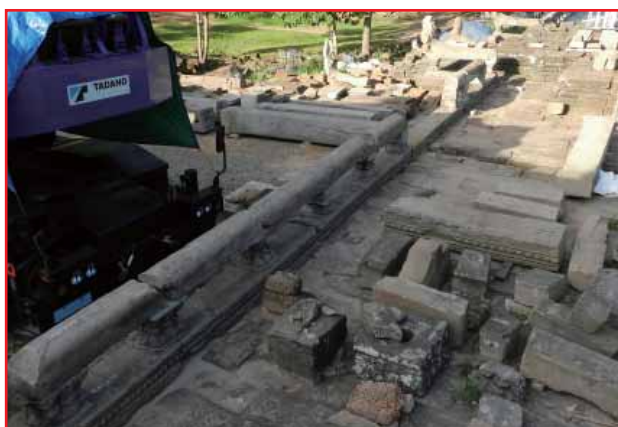
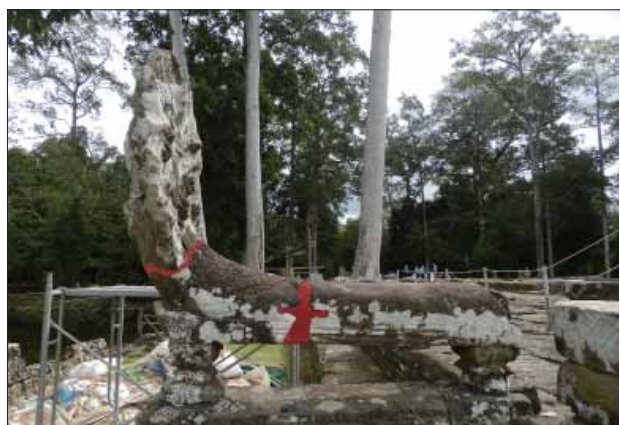
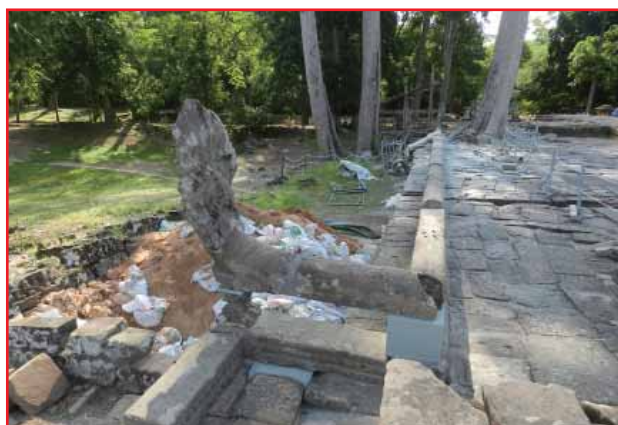
Area : T71.1-1/West part Operated Term : 8 month

<Before and after restoration>

In this area, 1 Lion statue was restored. This lion statue which lay down on the platform we decided to produce a new support pedestal for this statue and make a statue rise, for we judged that it would cause further degradation of a statue if we left the statue in the state.

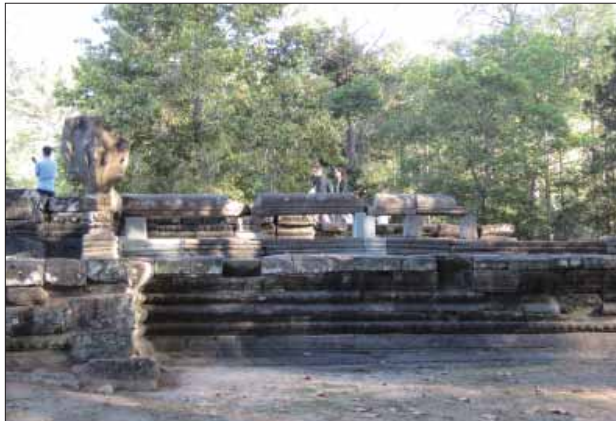
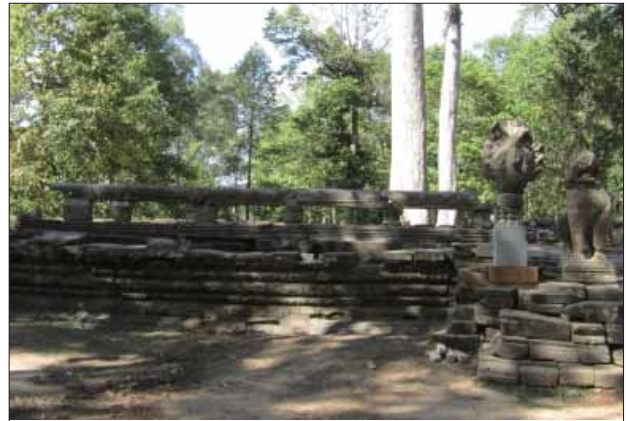
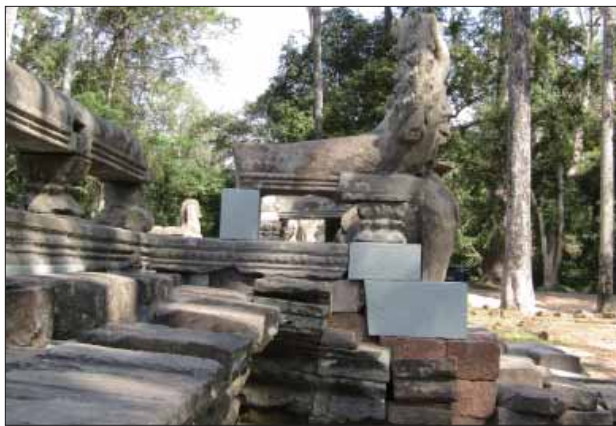
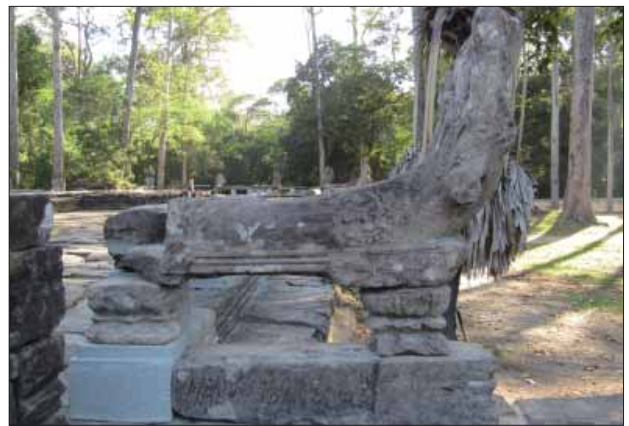
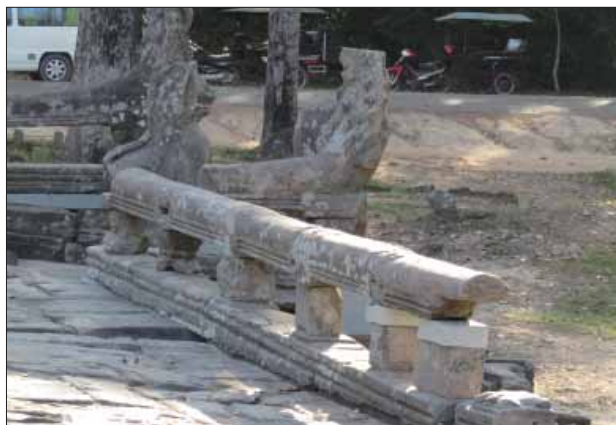
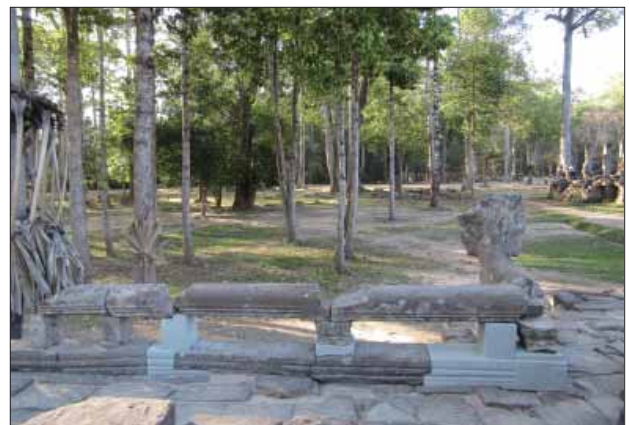
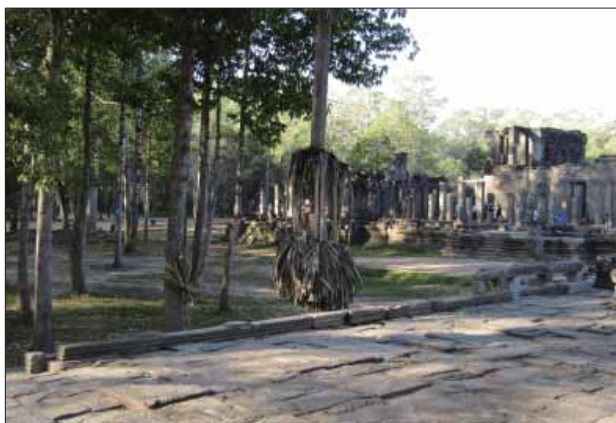
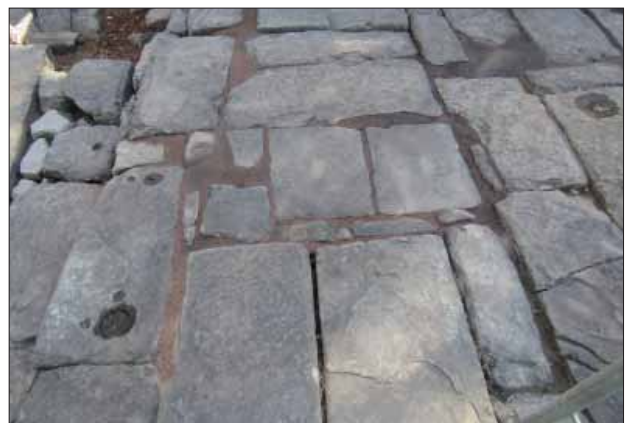
Area : C71.2-1 / West part Operated Term : 3 month

<After restoration>

After finished repairing all the elements, direction of the reconstructing was decided through trial assembling work. At west corner, we confirmed that to some of the substitute post would be difficult to reuse, we decided to make new substitute posts by new sandstone for supporting handrails. Also, new sandstone was supplied to some basements which were partially missing. At east corner, in order to stably install heavy Naga head, we judged the minimum platform improvement would be necessary to correct the distortion of the floor. Thus, in the range of 1.5 meter across the balustrade were dismantled. Also, some new sandstone support inserted under this Naga head for support.

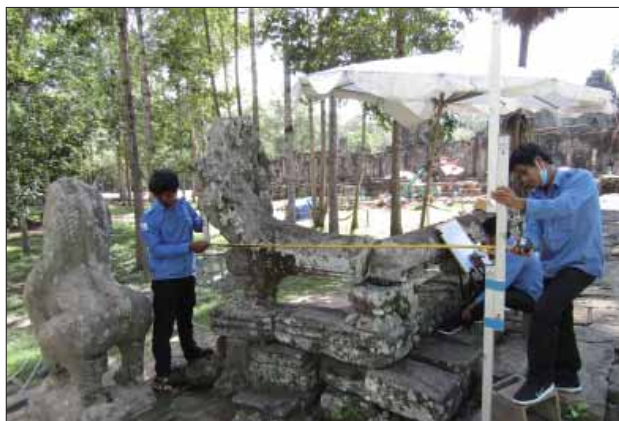
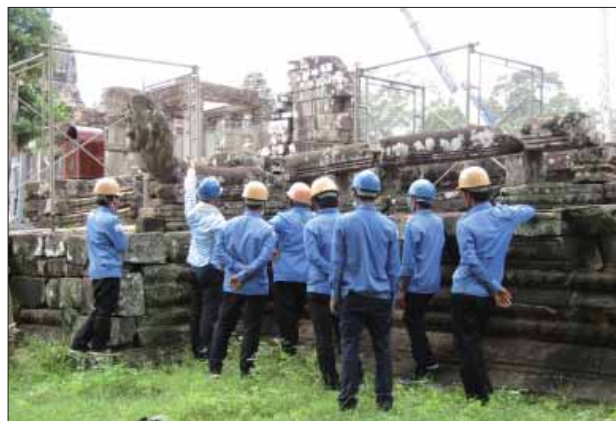
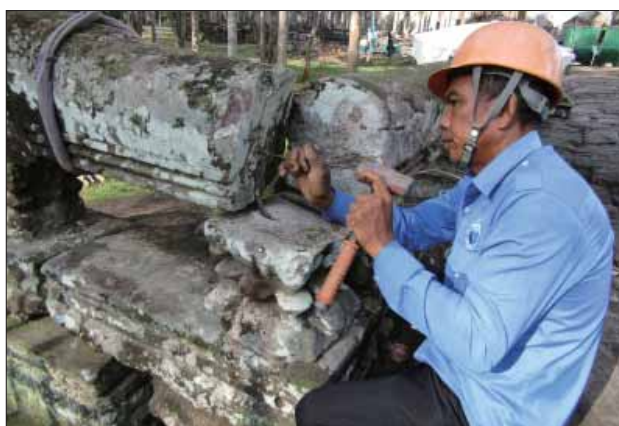
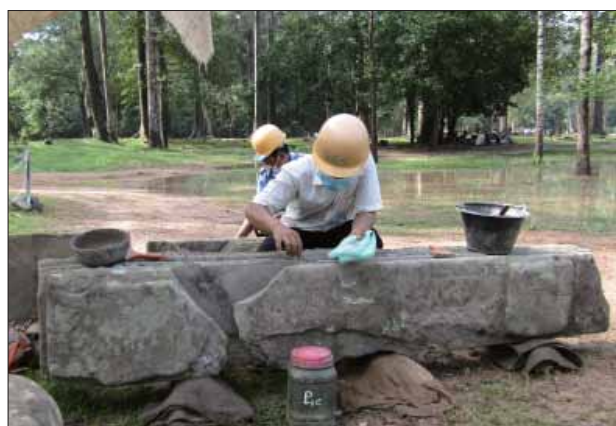
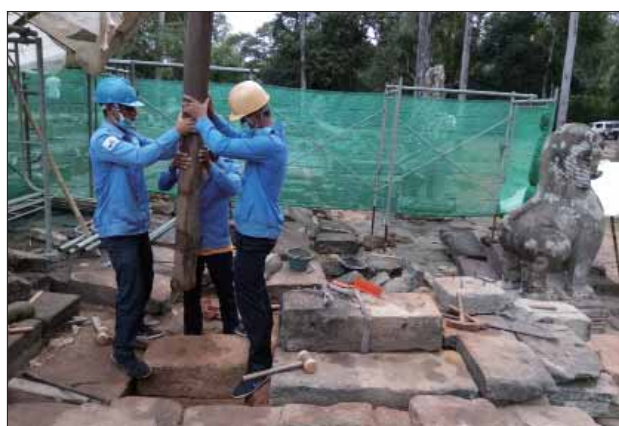
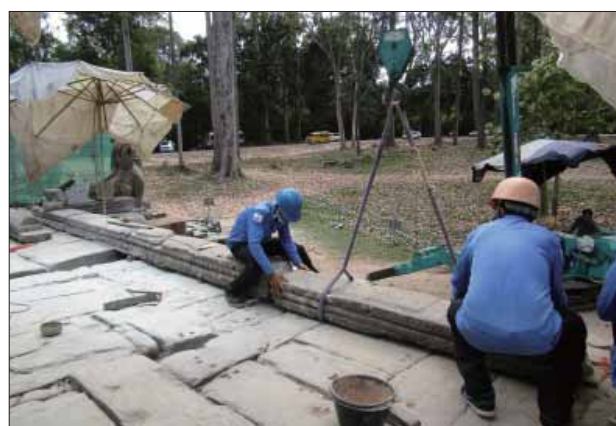
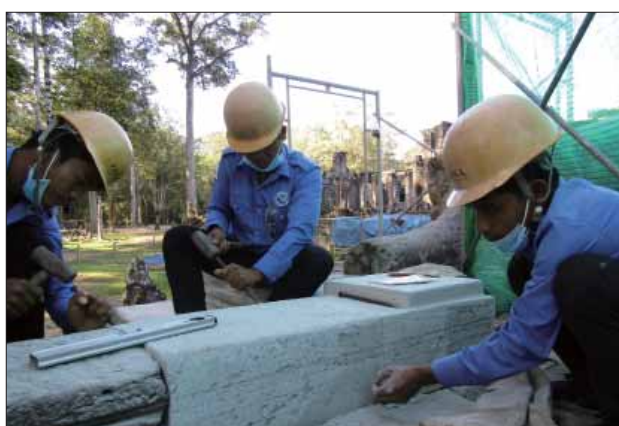
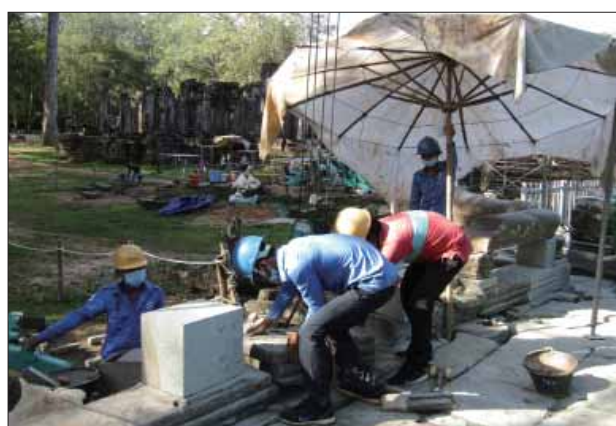
Area : C71.2-1 / West part Operated Term : 3 month

<Photos during restoration>

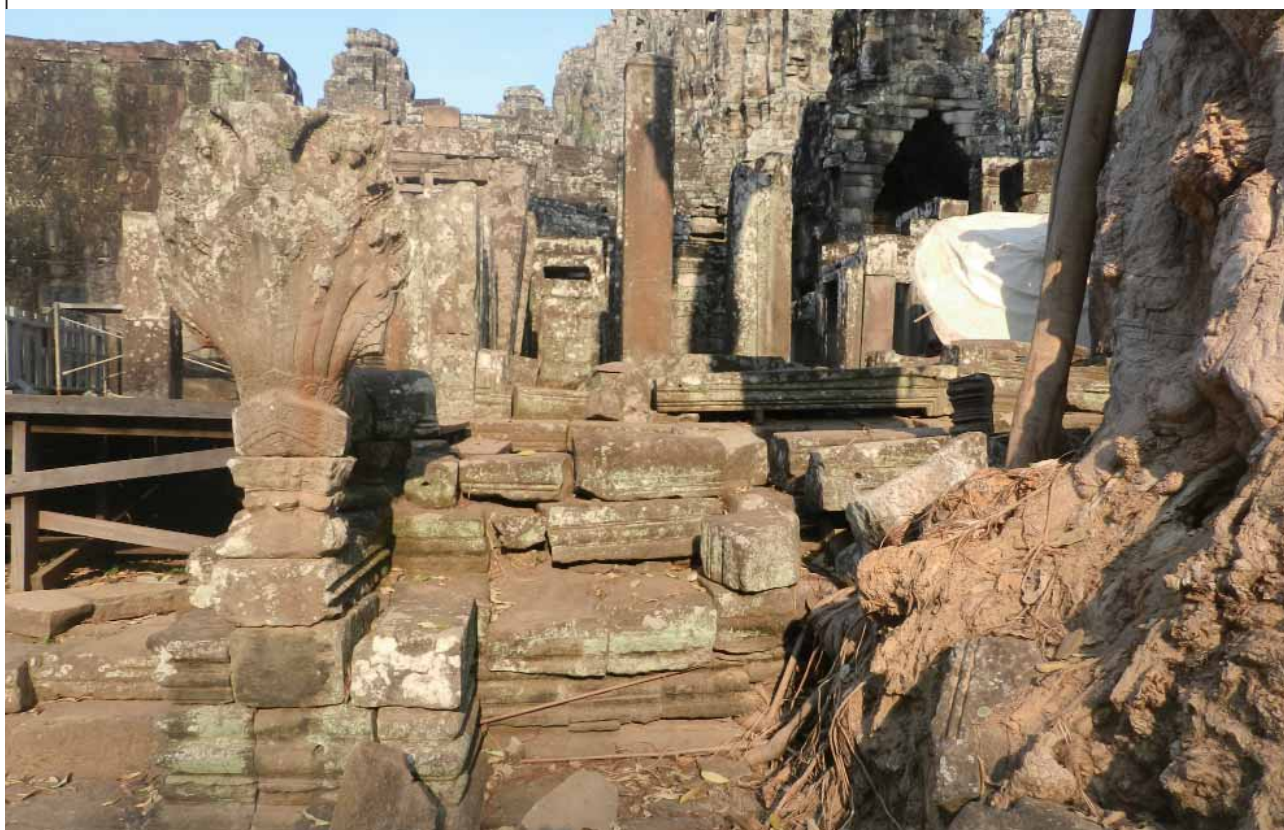
Area : C71.3 / Working Term : 5 month

Before Restoration
