REPORT ON THE CONSERVATION AND RESTORATION PROJECT OF
LION AND NAGA BALUSTRADES

AT THE CAUSEWAY AND OUTER GALLERY OF BAYON
ANGKOR, UNESCO WORLD HERITAGE SITE,

2012-2020

November 2024

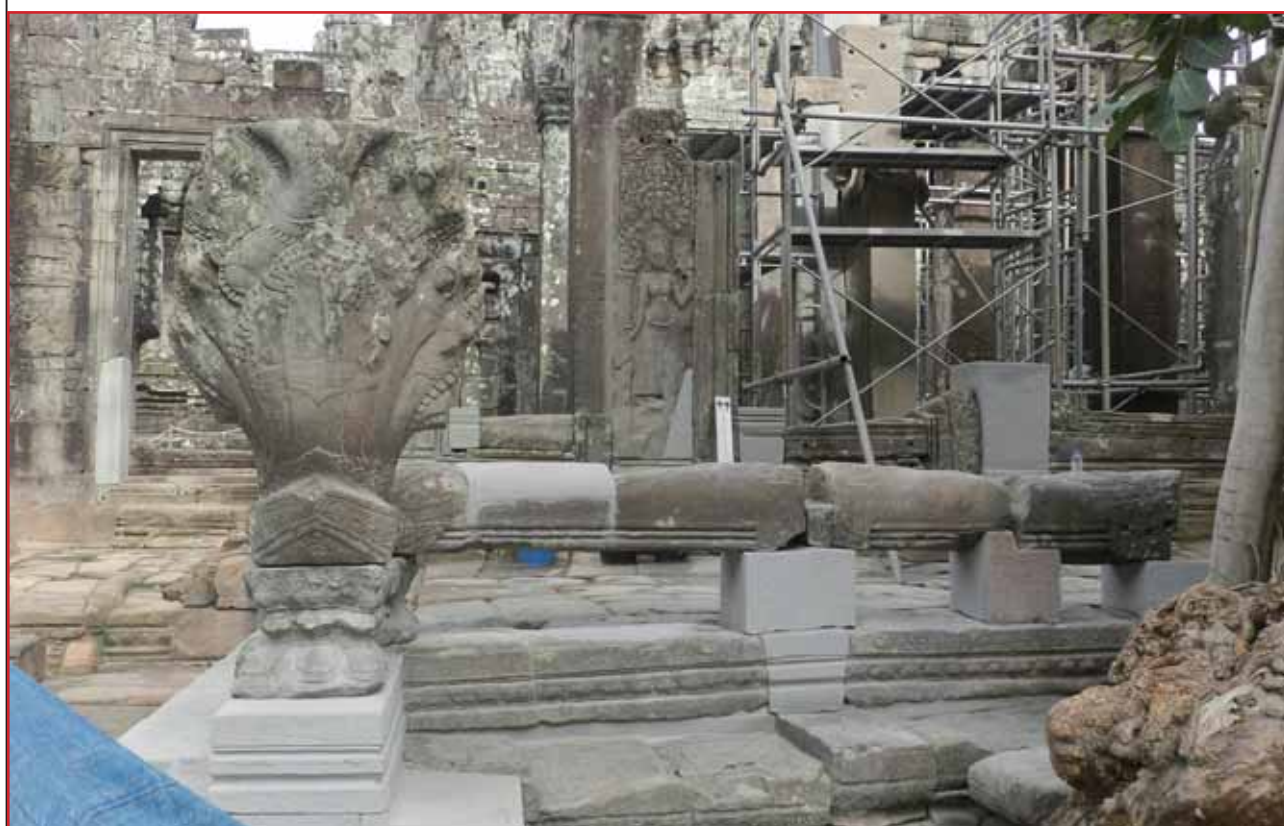
After Restoration

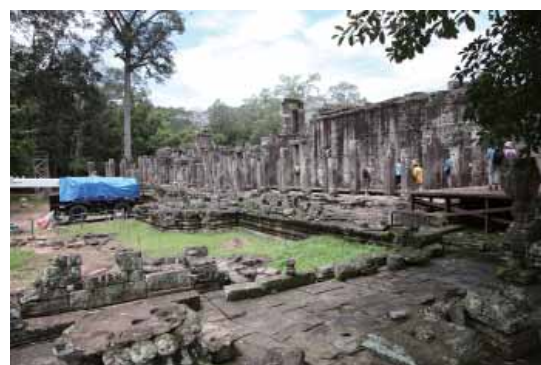
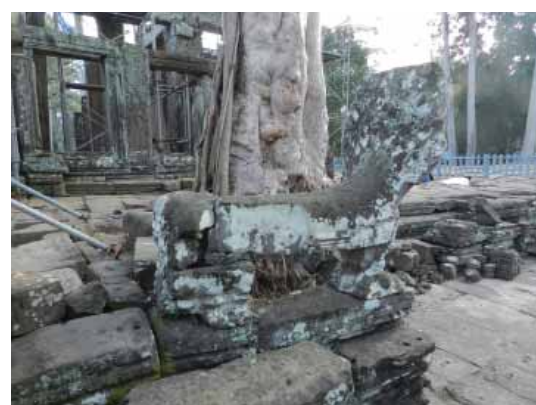
Area : C71.3 / Working Term : 5 month

<Before restoration>

Area 71.4.1 is the place where we could see vivid influence of damage by fallen tree in some decades ago. Many elements of balustrade and Naga statues were broken and fell down on the platform. Platform was distorted by the changes over years, in particular, the most outer line of the surface layer were moved to the outside and causing the big gap with inner line that balustrade should be set on. Also, certain inclination could be seen that was too unstable to reconstruct without any treatment.

After basements finished put back, we start to back handrails. 3 of the posts need replacement by new sandstones because it was too unstable to use former substitute elements. Also one post out of 7 original posts need to fill with new sandstone to the missing part. Some of Naga body we put back as same place before dismantling, but some we changed the place according to the situation of the area. Such as; stone from scatter stones that we just found and connect, need to find the places to back it all.

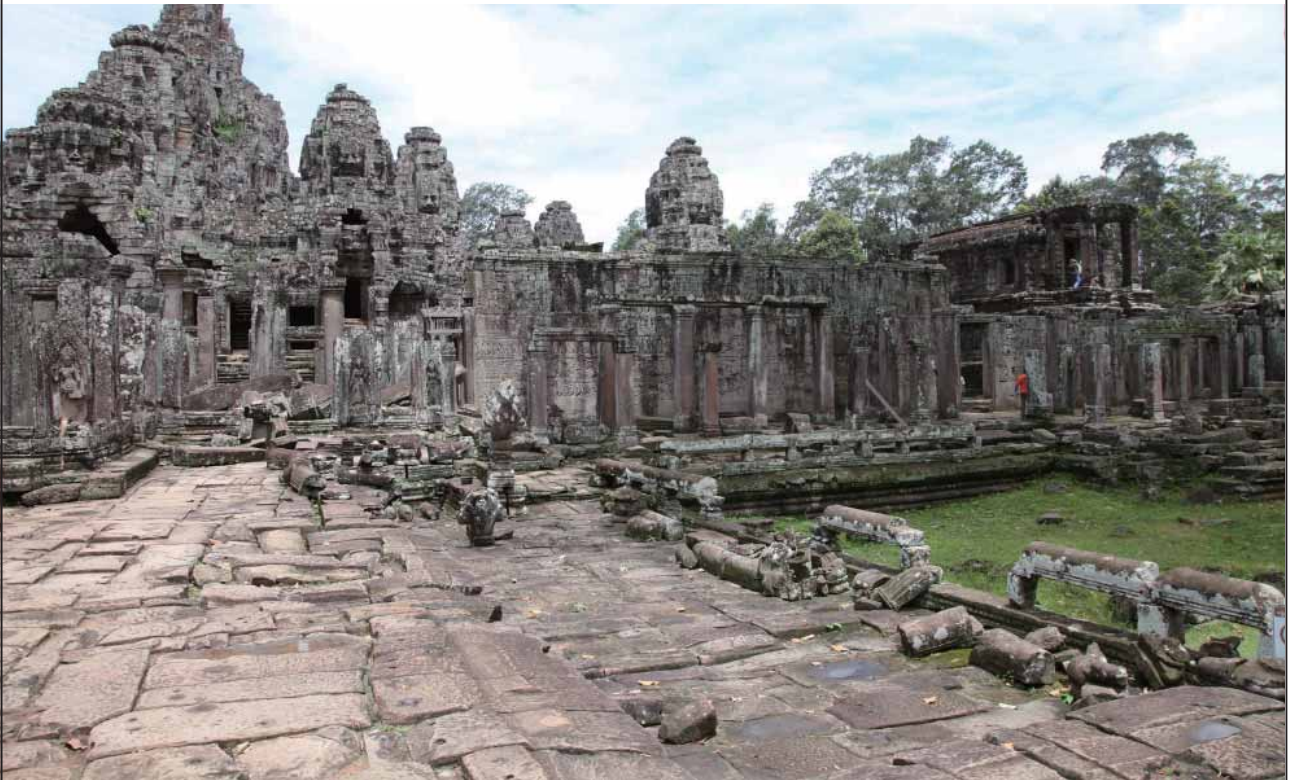
Before Restoration

Area 71.4.1 is the place where we could see vivid influence of damage by fallen tree in some decades ago. Many elements of balustrade and Naga statues were broken and fell down on the platform. Platform was distorted by the changes over years, in particular, the most outer line of the surface layer were moved to the outside and causing the big gap with inner line that balustrade should be set on. Also, certain inclination could be seen that was too unstable to reconstruct without any treatment.

After basements finished put back, we start to back handrails. 3 of the posts need replacement by new sandstones because it was too unstable to use former substitute elements. Also one post out of 7 original posts need to fill with new sandstone to the missing part. Some of Naga body we put back as same place before dismantling, but some we changed the place according to the situation of the area. Such as; stone from scatter stones that we just found and connect, need to find the places to back it all.

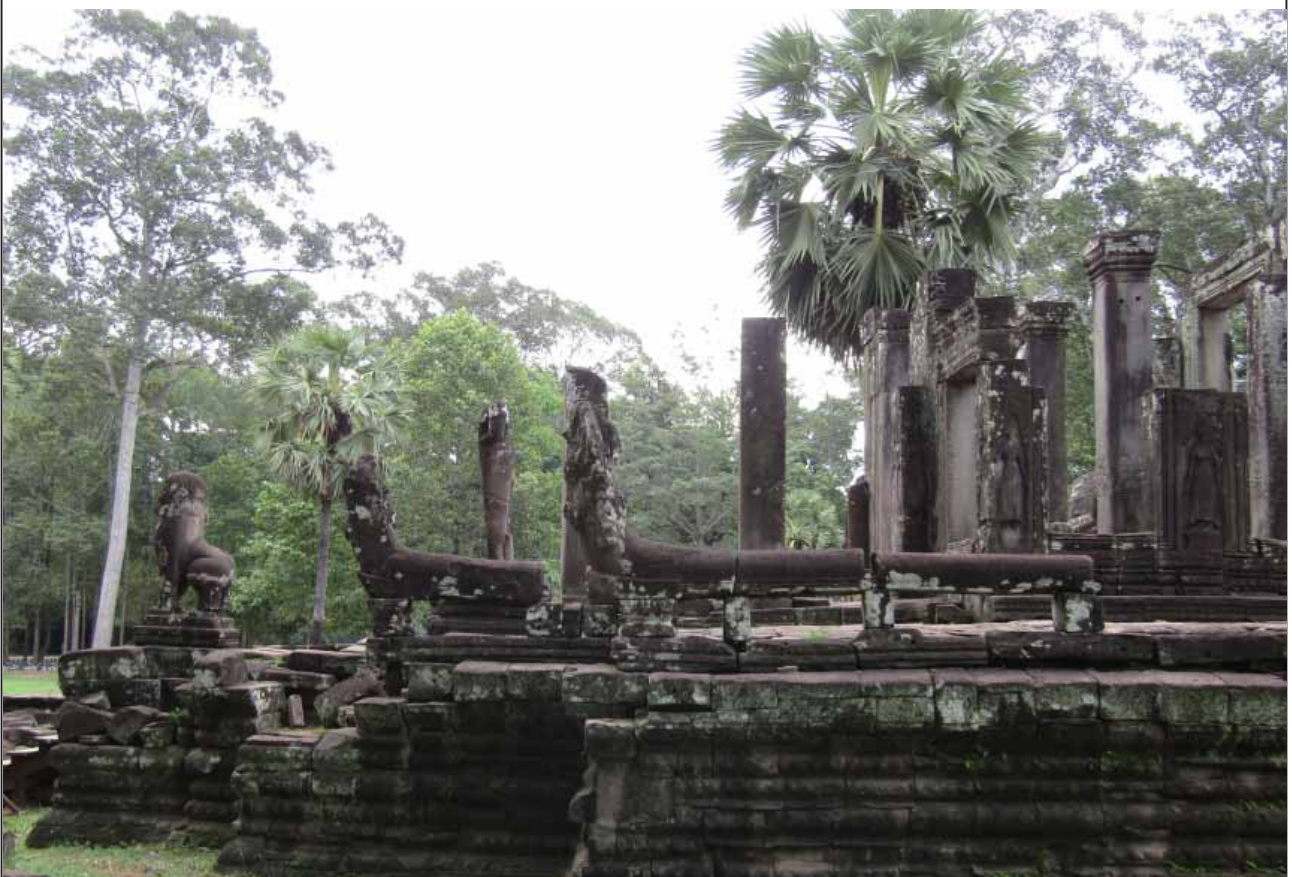
Before Restoration

There are 2 Naga statues in this area. For the eastern Naga statue(67.4.8.1.1), two elements of the platform directly under the Naga statue's basement were missing and concrete support was inserted under the basement of Naga statue. However this concrete support was deteriorate and needed replacement with new sandstone supports. Also, the trunk of the other western Naga statue (67.4.8.1.4) was broken and had no previous repairing, just supported by substitute post. Thus we decided to connect this broken Naga statue and so that we could remove substitute support.

Also, one lion statue in this area was broken into two pieces(front legs and pedestal was separated) and also very unstable situation caused from uneven subsidence around the statue.

There were scattering stones around this are, thus first of all, we had to secure the space for set mini crane. We took photo records before moving these scattering stones and move to other place. Also many tourist walk pass T67 for gate, we set temporary enclosure around restoration area in consideration of safety and noise. After that, we carefully dismantle lion statue and other balustrade. After repairing of each elements, we confirmed how much and where sandstone plates and lead plates should be inserted. From discussion with JASA experts, we decided to insert two new sandstone support under Naga statue 67.4.8.1.1. For this new supports, we mark rough texture for surface finishing. Naga statue 67.4.8.1.4 was connected and install without substitute post when reconstructing.

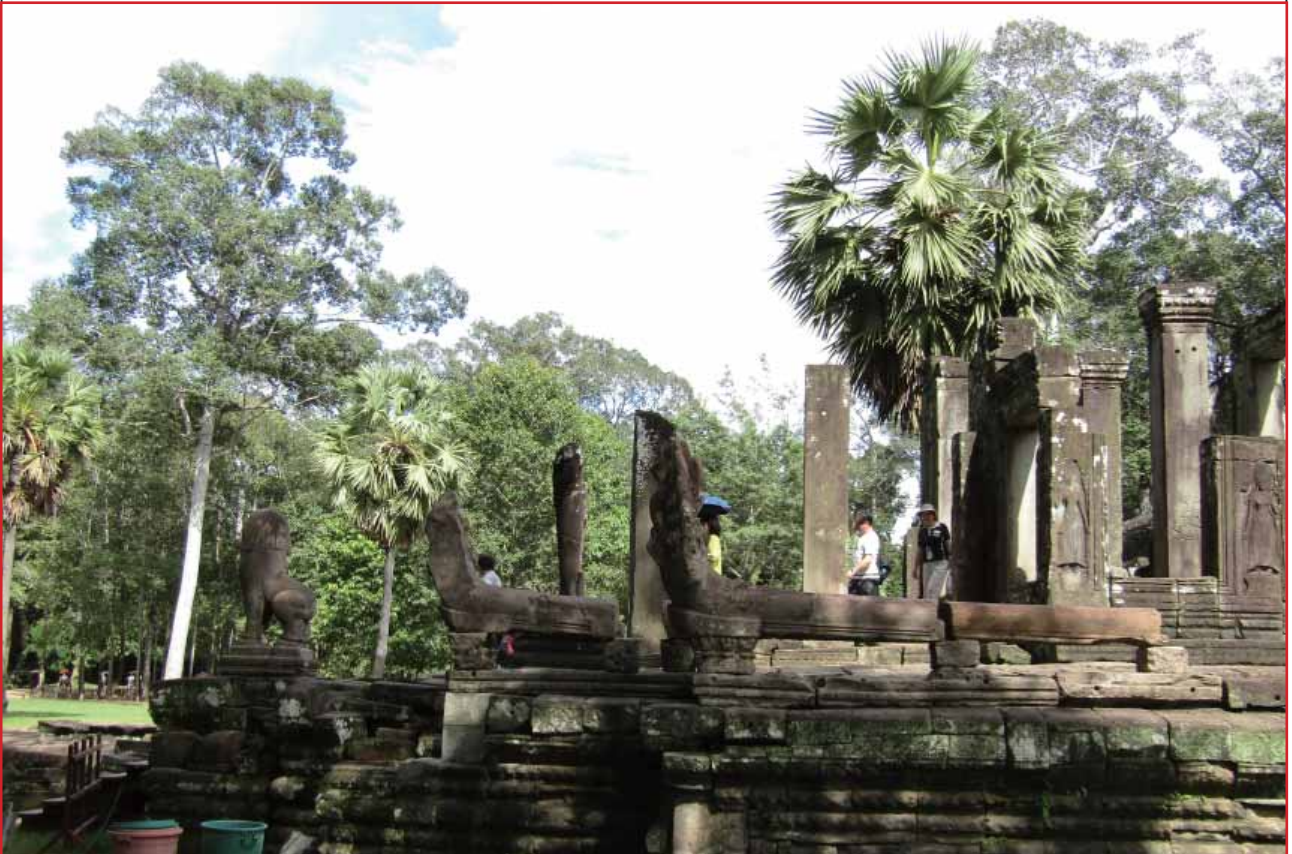
After Restoration

■Lion Statue	1
■Naga statue	2
■Other Balustrade elements	
Handrail.....	3
Post.....	10
Basement.....	2
<u>Total 18 elements</u>

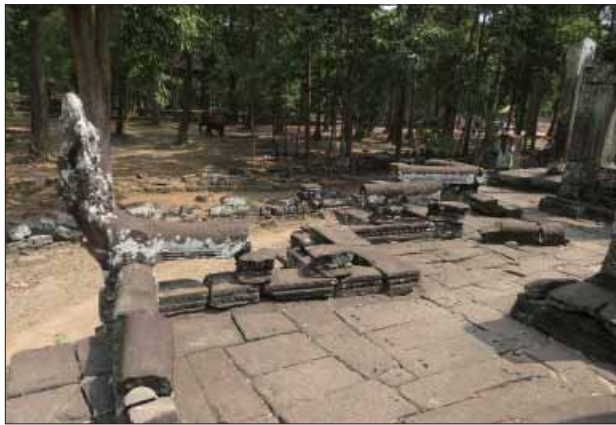
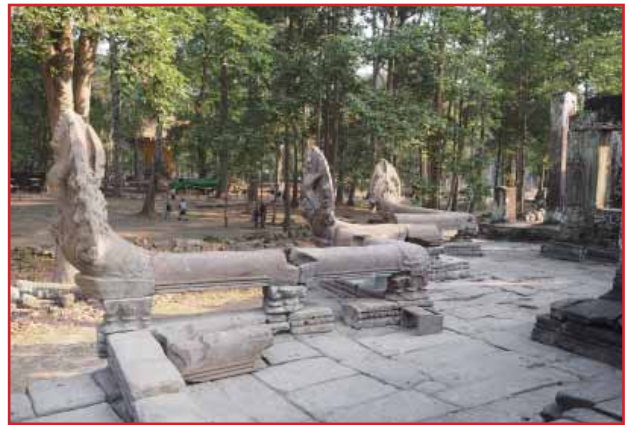
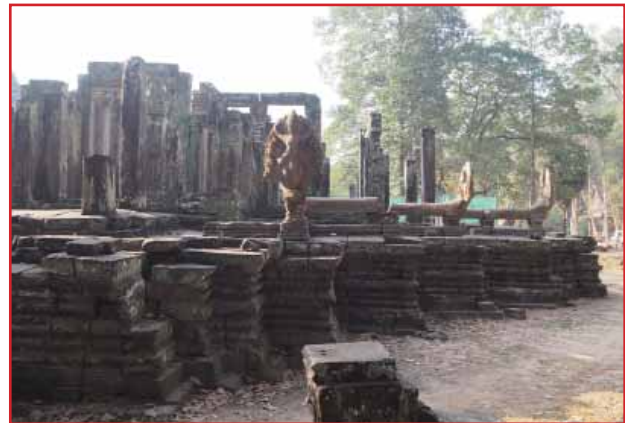
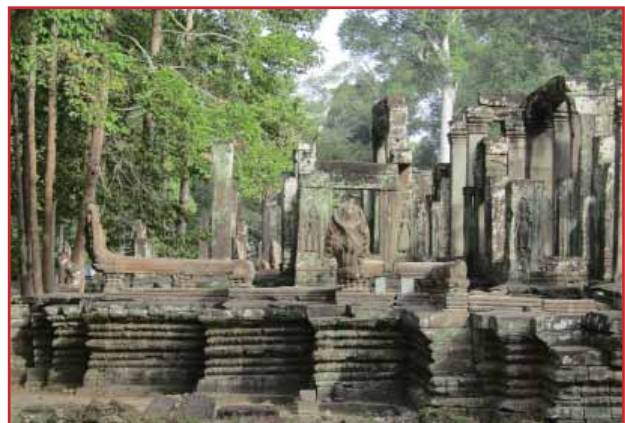
Area : T65.4 work period : 20 weeks

Uneven settlements of the platform forming big gaps and breakage of the basement, and caused many falling of handrails and posts. Also, it was clearly visible that rest unfallen NAGA statue was installed at unoriginal position by previous restoration. Furthermore, in the rain season, ground around this area was covered with rain water, these fallen elements was also submerged in water and causing further deterioration.

First of all, we begun from setting site around this area after records of the scattering stone. Specific work was which find the combination of fragments that could be joined and identification work of the original position was carried out carefully. One of the largest progress in this work is we found that one Naga statues installed at T64.2 and piece of handrail could be joined and originally positioned at western edge of balustrade in this area. Finally all scattering stones on the ground and platform could installed in this area. Also simple platform improvement was done before reconstructing work.

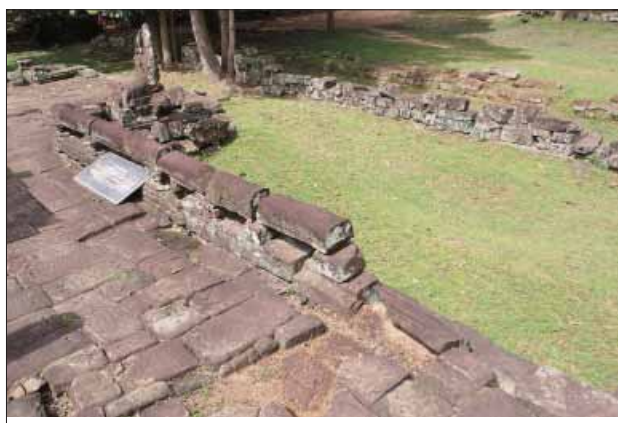
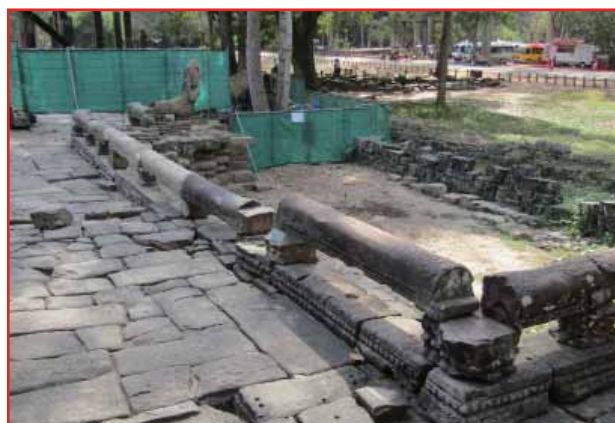
Area : T64.1 work period : 8 weeks

Restoration work in this area began in October 2019, after the completion of the earth clearance work around the platform of Area T64. As a result of the clearance work, many balustrade elements and fragments related to the Naga statues were found, so investigations were carried out in T64.1, T64.2 and the adjacent area T63.4 to determine which elements could be combined and to identify their original locations. Finally, it was found that many elements could be returned to the previously missing parts, in particular, all the elements of the T64.1 Handrails were found in perfect order. Also, many small fragments were found that could be joined to the Naga statues that had collapsed on the platform.

<Before and after restoration>

- One collapsed Naga statue □ C6.1.1, can connected not only with also collapsed body, but also with small head pieced found from mound by clearance work.
- It was confirmed that C6.1.19, C6.1.12-15 were joined with 64.1.8.
- C5.2.10 + C5.1.11.1 + C5.1.11.3, C5.2.8.1 + C5.2.9.1, were also confirmed to have formed a single handrail element, so they were joined and installed.
- In order to install the newly discovered handrail in places where had been lost, a new sandstone basement (N64.1.8.3.1) was inserted.

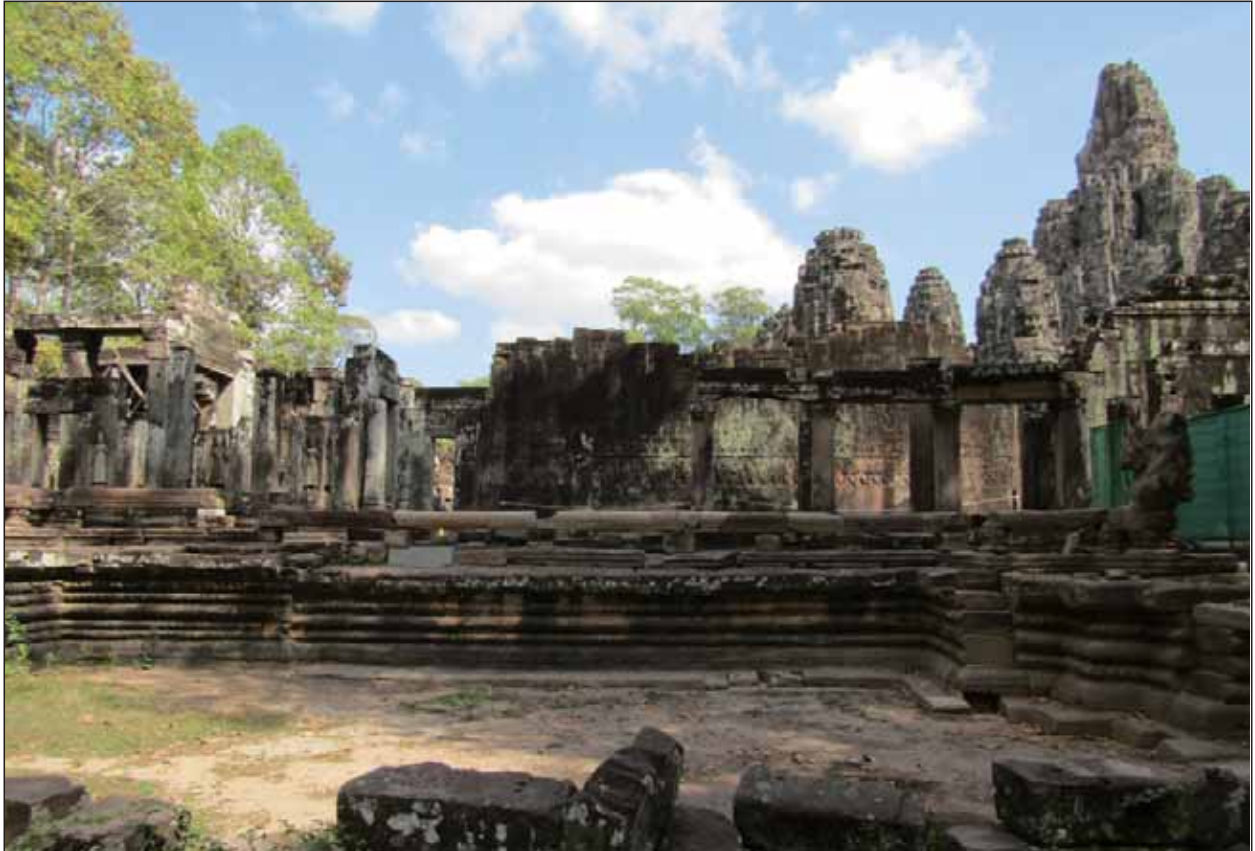
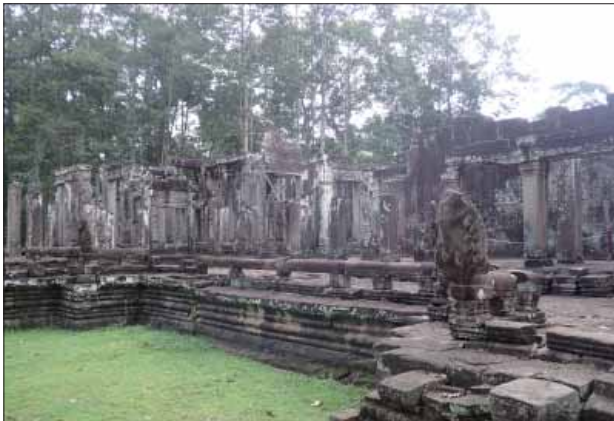
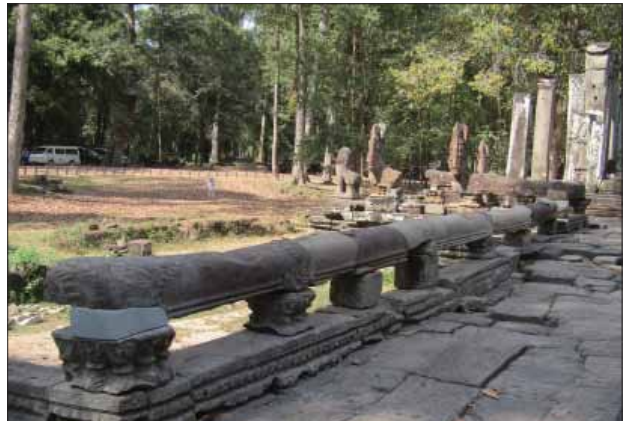
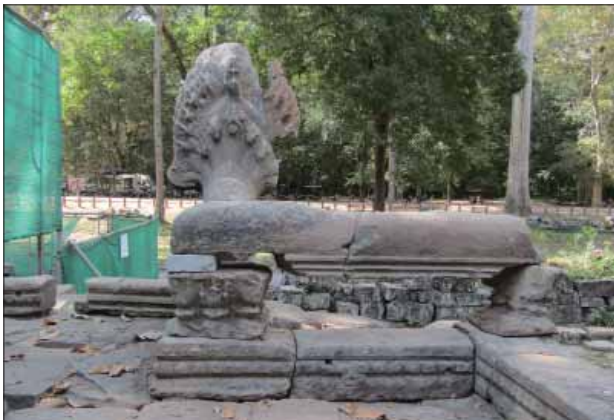
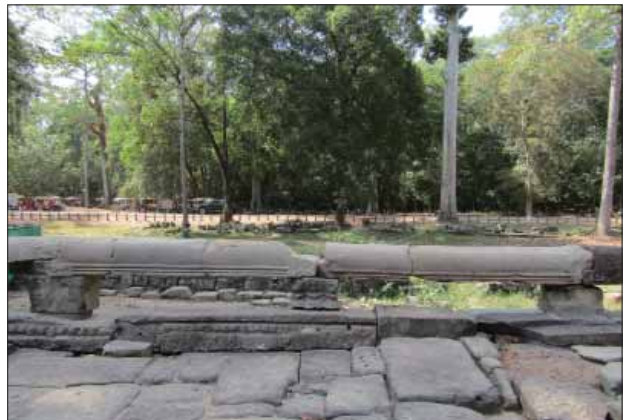
Area : T64.1 work period : 8 weeks

<After restoration>

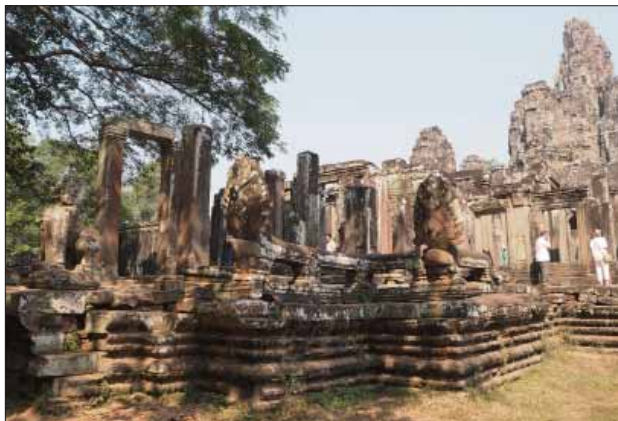
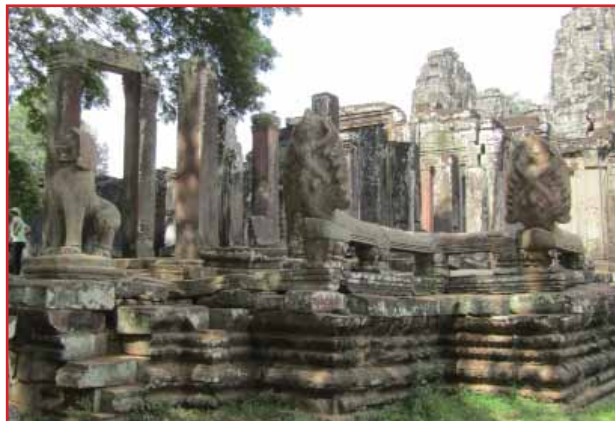
Area : T63.3 work period : 4 weeks

The Lion and Naga statues were not initially planned to be dismantled, but during the process of dismantling the balustrade elements, it was confirmed that these statues were also in a serious condition, so it was decided to carry out dismantling and repairs. The treatment of the statues is as follows.

Lion statue (No. 63.3.9.1.1): many cracks were found on all four legs, which were already nearly broken and threatened to collapse. Therefore, the statue was partially dismantled, the body and pedestal sections, which were on the verge of breaking, were separated, reinforced and then joined together.

Naga statue (No. 63.3.8.1.1): a fragment of this Naga statue could be found in the scattered stone material on the west side of T63.3, so it was joined to the Naga statue. In addition, the previous restoration work carried out on the base of the head of the statue was not in good condition, so it was removed and rejoined.

Naga statue (No. 63.3.8.1.5): the cracks were reinforced by injections.

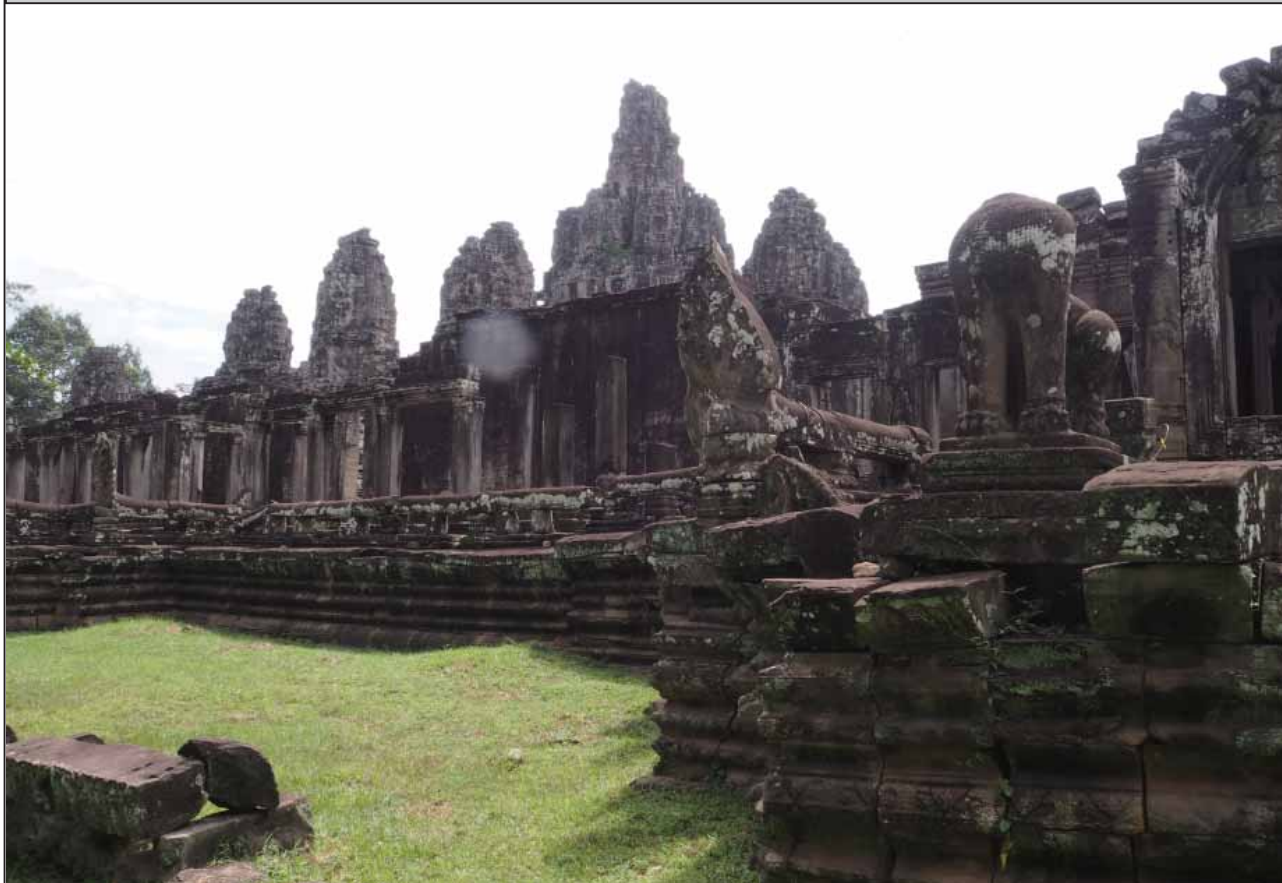
Before Restoration

-Among two naga which existed in this area, the head of southwestern Naga statue(61.4.8.1.8) was broken into two parts, and broken half has fallen into the platform. In addition, the balustrade part was broken on some small pieces and tied up by restoration in the past, but this iron belts were about almost came out, and there was the risk that the whole Naga statue collapsed. After restoration, these pieces of the head and trunk was connected, and it was stable and came to be able to stand without any support.

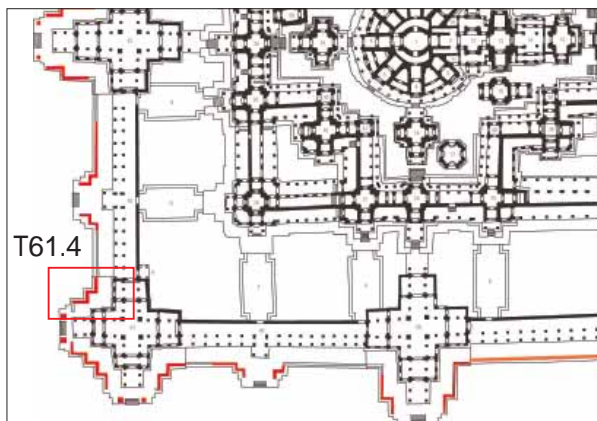
T61.4

- Lion Statue1
- Naga statue 2
- Other Balustrade elements
 - Handrail.....5
 - Post.....7
 - Basement.....6

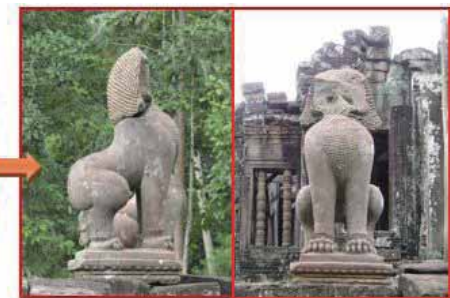
Before restoration

In this area, 1 Lion statue was restored (61.4.9.1.1). The head of this Lion statue was broken and fell down on the ground near the platform. In the rain season, this head part was soaked in the water and caused further deterioration. By the restoration work, this head part could be connected to the body.

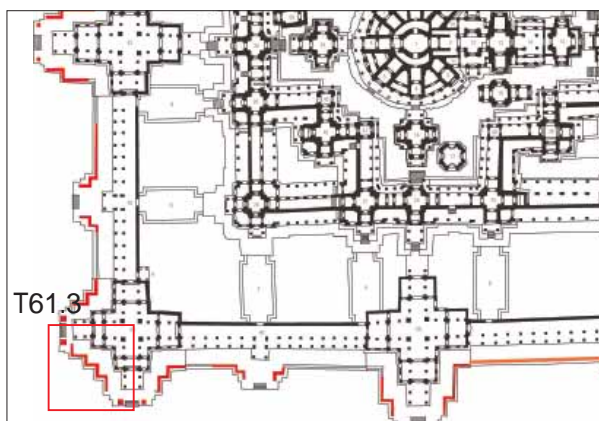
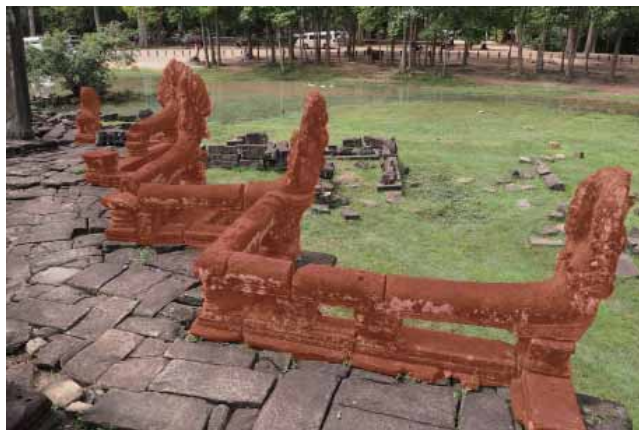
Restoration activity at T61.3

Dismantled part

-One lion statue which all the 4 legs were broken and restored in the previous restoration by cement, but it was already deteriorated, thus we decided to remove previous treatment and connect by using stainless pin.

Although the position of the Handrails and Basements were not changed, many of the elements had been broken, so they were joined and re-installed. The substitute Posts, which was no longer needed due to the jointing of the handrail, was removed. 61.3.8.1.4.1 had an iron belt used in the previous restoration, but the iron belt was removed because it was confirmed that it could be installed stably by jointing it with 61.3.8.1.4.2.

In this area, 2 Lion statue was restored (61.3.9.1.1 & 61.3.9.1.2). 61.3.9.1.1, the statue part and the pedestal part were completely broken at the ankle of the statue and had been joined by previous restoration, but the mortar used here had deteriorated and was in danger of breaking again, so they were rejoined using stainless steel pins. The pedestal was also ruptured and was repaired. 61.3.9.1.2 was injected for reinforcement.

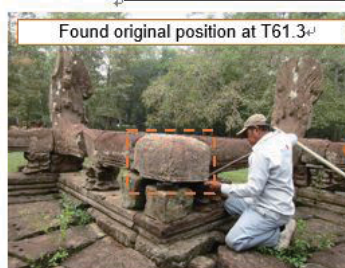
- From our survey, we found that one handrail from T61.2 and one more another handrail from T60.1 could be originally set at T61.3. Thus we set these two handrails to original position at T61.3.

Found original position at T61.3

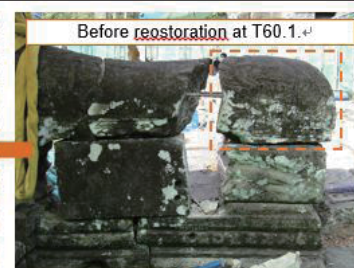
Before restoration at T60.1

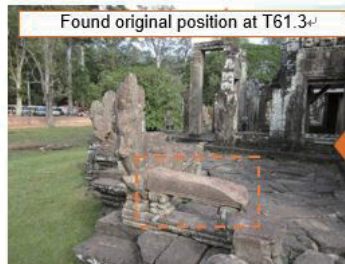
Found original position at T61.3

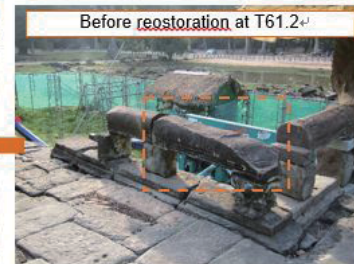
Before restoration at T61.2

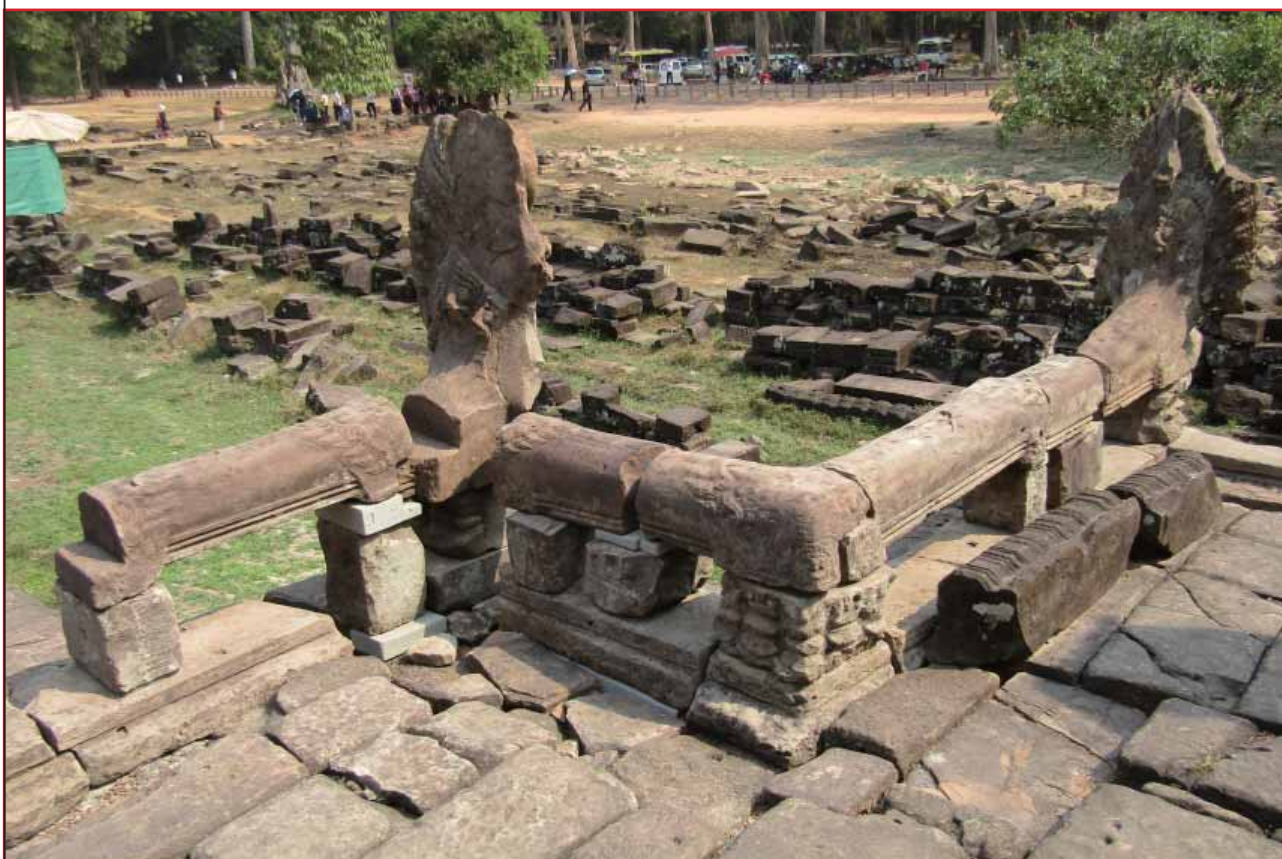
After Restoration

In this area, platform situation was not so bad, though most of the balustrade elements were not in the original position, thus these could only be installed in an unstable form, and cement and iron pin were used to fix these part in the previous restoration which was already deteriorated. Thus we decide to dismantle all of the balustrade and reconstruct at same situation as before. Though when we reconstructing these balustradem we insert new sandstone plate and lead plate instead of previous cement.

We found one of the balustrade piece was originally belongs to 61.3, thus move to the original place.

Also, Lion statue at this area had many small cracks and scaled part, thus we dismantled this statue and appropriate treatment was implemented. When put back this statue, we inserted sandstone plate in order to make stable and fill gaps between platform and statue. Maintenance of platform was needed around Lion statue and Naga statues.

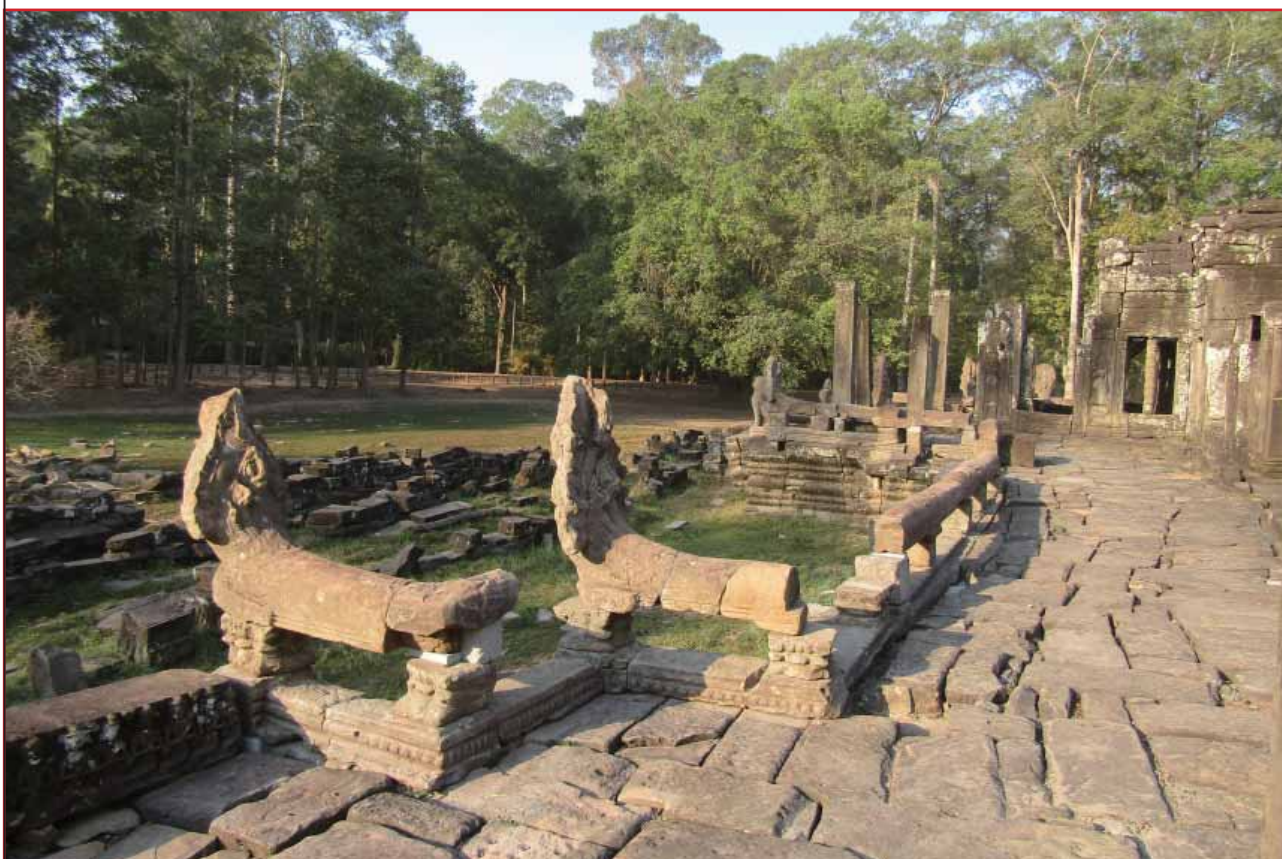
After Restoration

There was no change in the position of the naga head, but there was a significant change in the position of the other rafters. It was confirmed that 60.1.8.1.3, 60.1.8.4 and 60.1.8.1.1, which had been placed separately before restoration, were originally a single piece, so were joined together. It was also discovered that E11.1.2 and 60.1.8.1.6, which had fallen onto the platform, could be joined together. After carrying out these kinds of joins, the original positions of the handrails could be identified by the distance between the post, and the positions of the other joists were changed and installed accordingly.

The many substitute posts that had been used before the restoration became unnecessary due to the repair and joining of the handrails that had fallen to the base of the platform, so these were removed. Sandstone plates were inserted under the basements to stabilize them.

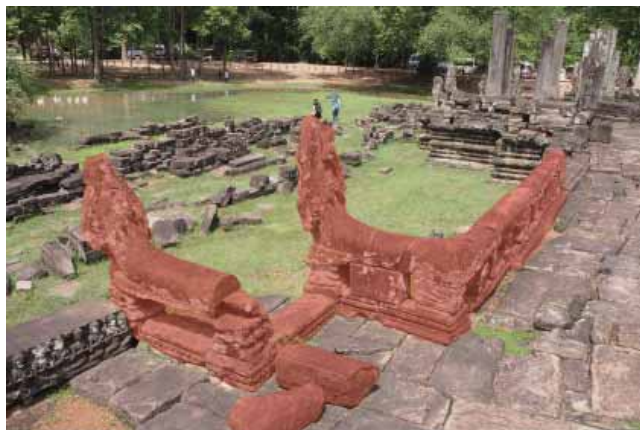
Area : T60.1 work period : 16weeks

For T60.1, the situation before restoration was very complicated, as most of the element of balustrade were moved wrong pieces were connected or lined in not original position by previous restoration. As a result of our survey, we found many pieces that can be connect as an original element, and could identify original position so that can be back to safely. Also, due to uneven subsidence, floor of the platform directly under the balustrade was subsided, thus we had to implement platform maintenance with supplying many new sandstone plate to these subsided line. The process of the work was done with supplying new sandstone plat and lead plate. One more problem at this area was some heavy rain instead of dry season. Due to rain, sometime it was difficult to set up Mini Crane.

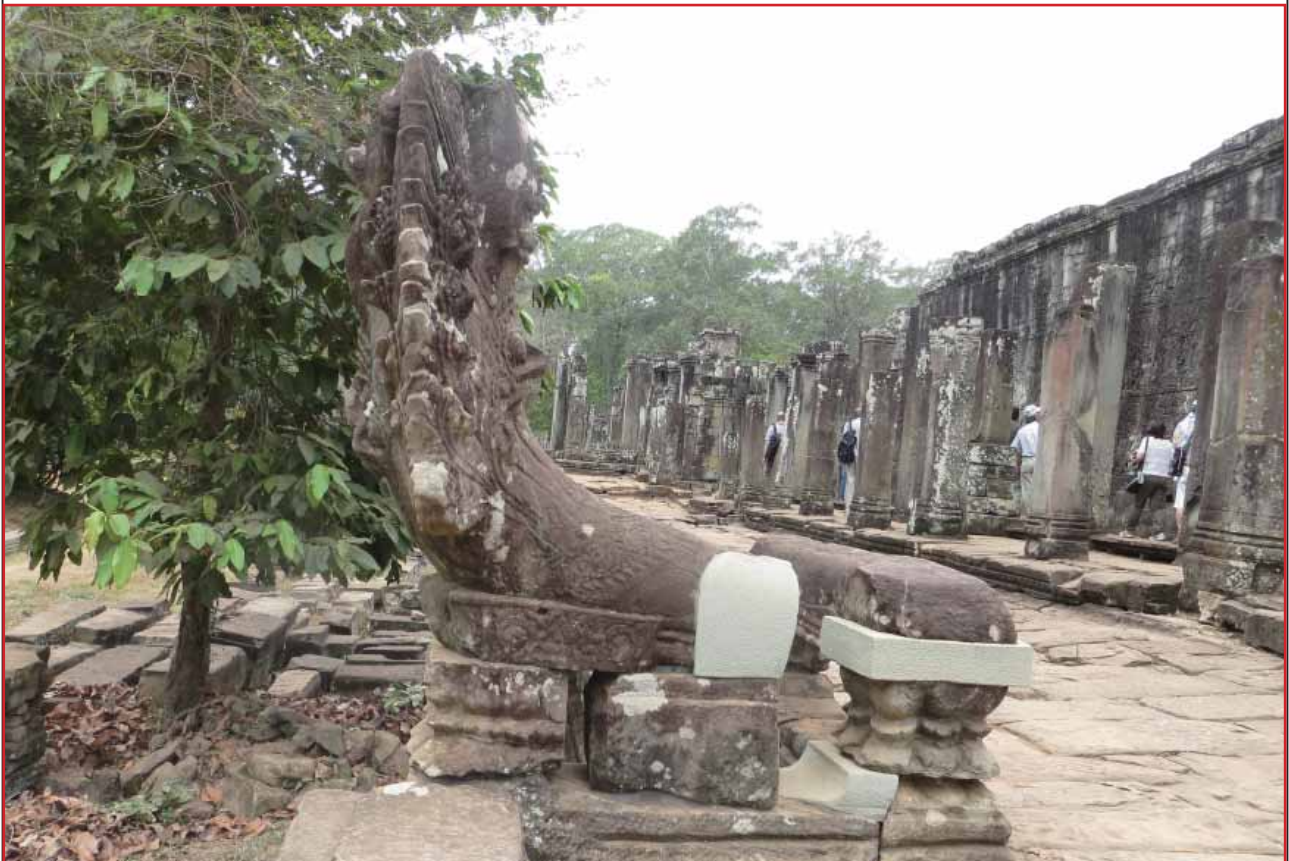
After Restoration

When the third phase of JASA started in 2006, a ramp for bringing in and installing heavy equipment was installed on the south side of the outer gallery of the Bayon (Fig. 1). In the second half of February, the stones of these T58.1 blocks were moved to the restoration site and the stones were repaired, which took about two weeks. The balustrades were then reinstalled at the site where the base had already been maintained.

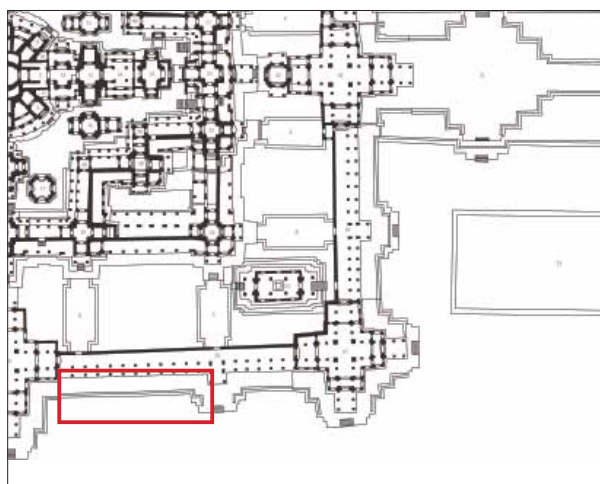
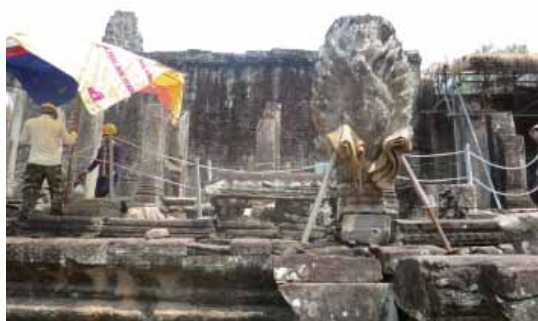
Area : T58.1 / West Operated Term : 2 month

<Before restoration>

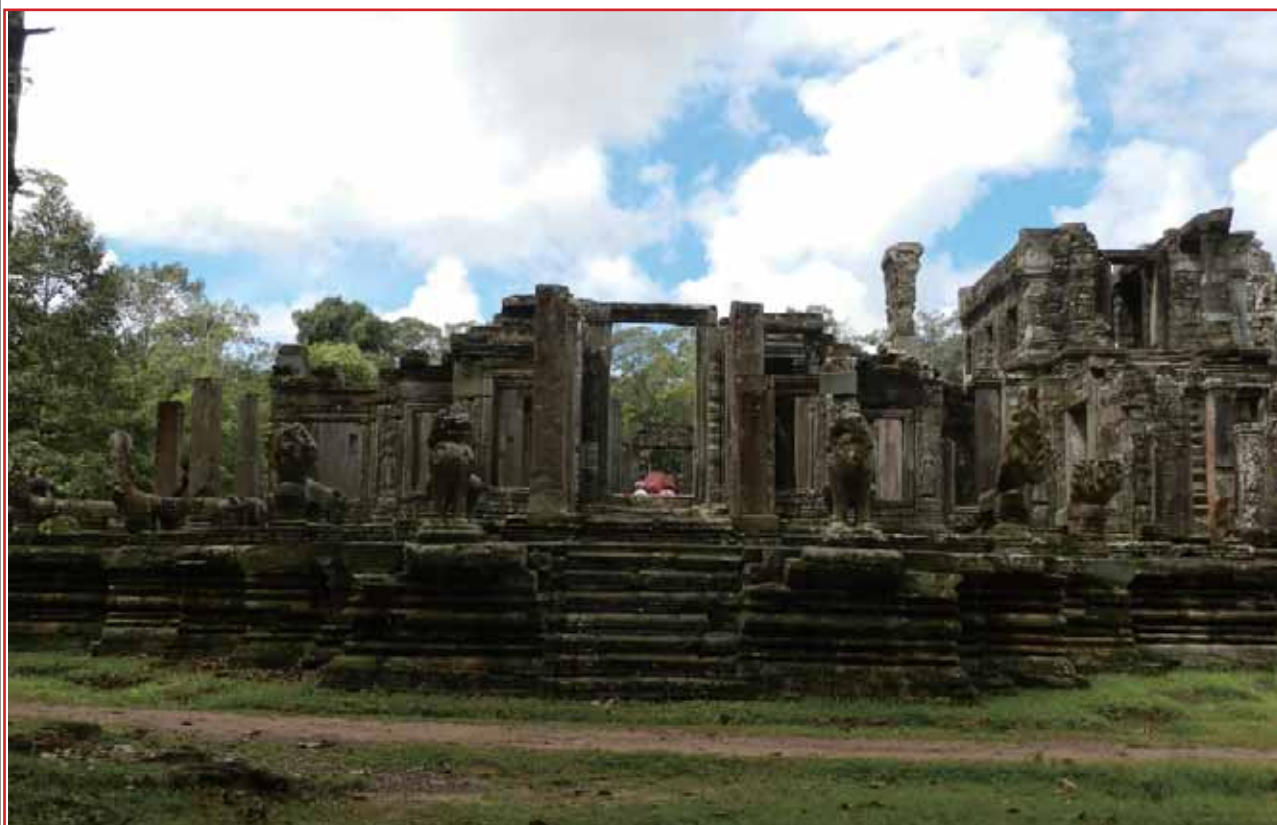
After Restoration

- Lion Statue 1
- Naga statue 2
- Other Balustrade elements
 - Handrail.....1
 - Post.....6
 - Basement.....18

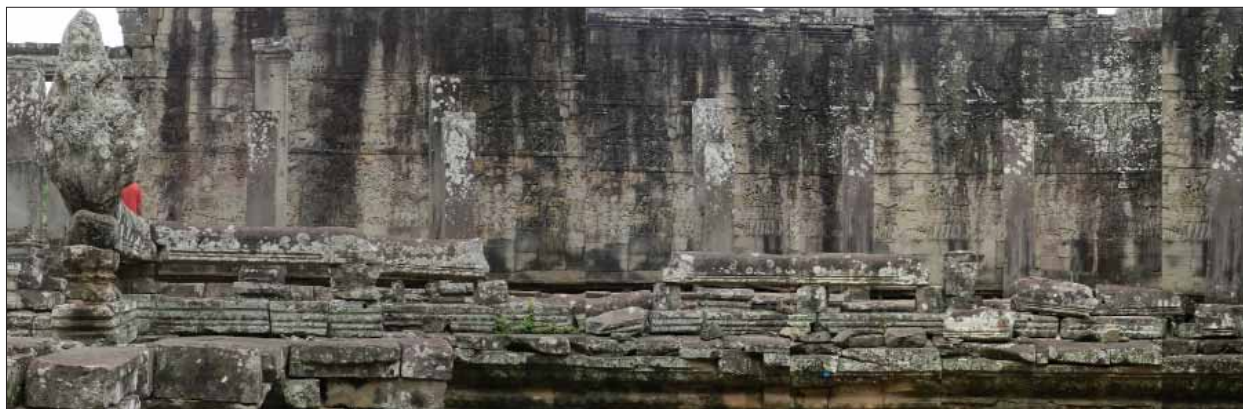
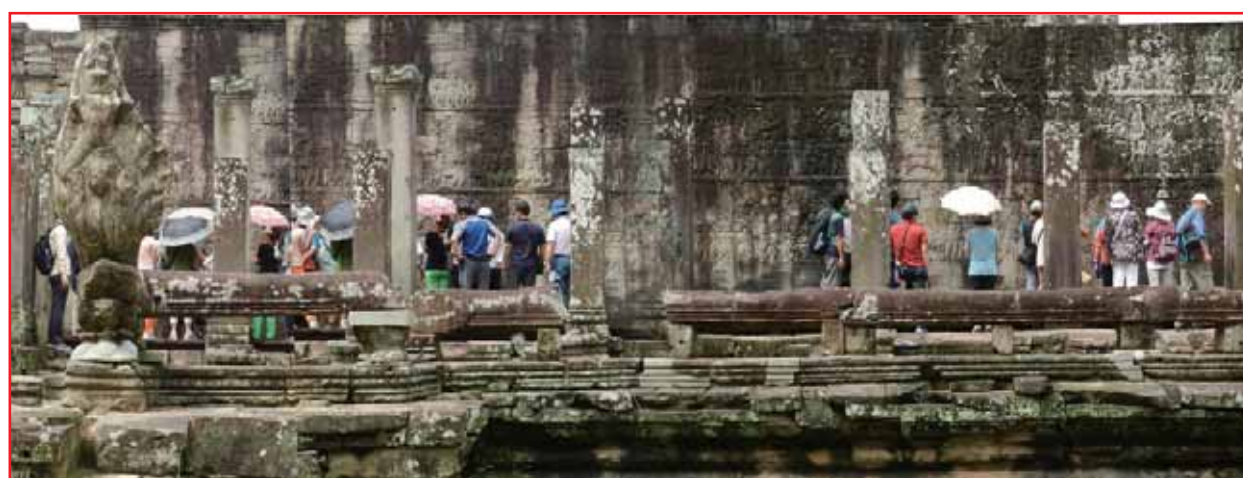
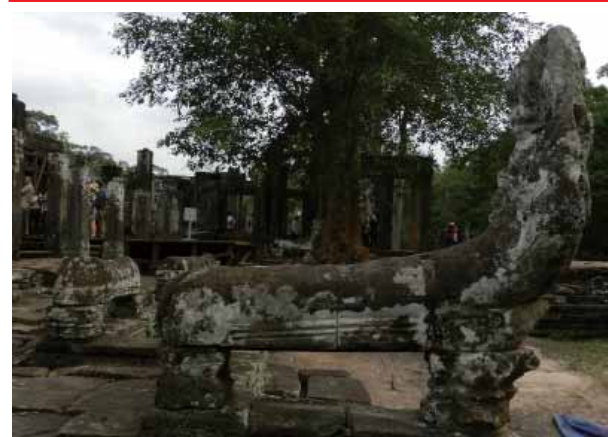
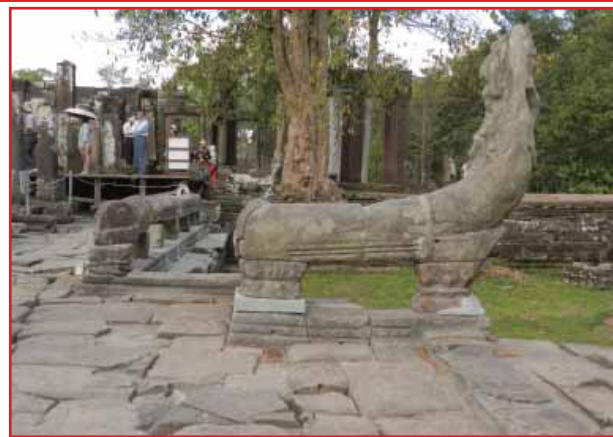
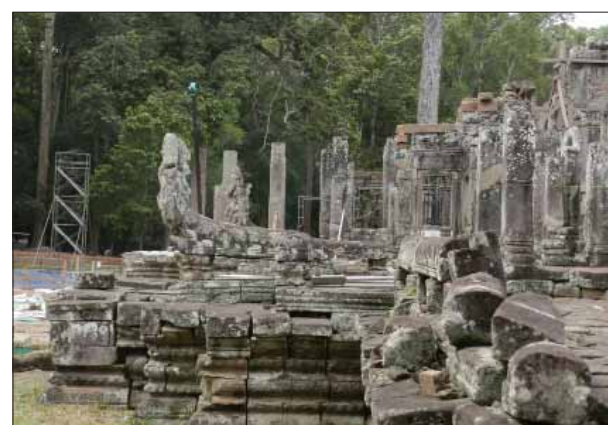
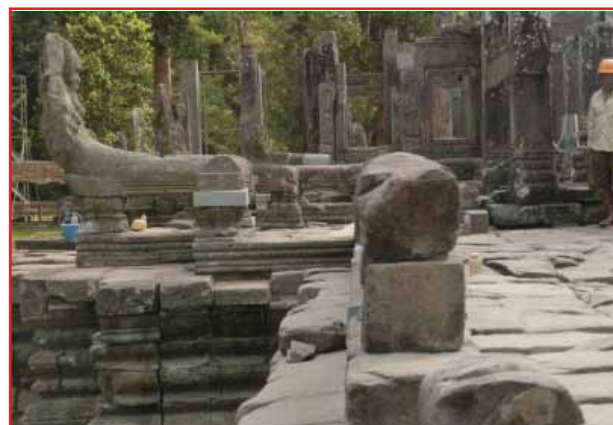
<Before and after restoration>

It was revealed that platform under Naga head has many crack, breakage and has big gaps between elements. Also, some elements of platform are not original that was brought from other place in the past restoration. This area was too unstable to reconstruct balustrade and need some maintenance. Thus discussed with JASA experts, we made decision to do minimum maintenance for platform to make stable enough to reset balustrade. Thus, firstly we dismantled some of outer surface elements of the platform, and gave appropriate treatment to the elements which has problem and then reconstructed. However this project target is to ensure the safety of balustrade, we continue to use the same situation as before and only change position, for example elements that have curve on it (it seems belong to outer gallery relief), we put it on the surface of the platform, so that it is easy to understand in the future. After that, place that has big gaps we filled by laterite and clay powder and also soil 4 on the gaps the top layer.
